Incident Summary (Reference #5618622) FINAL

SUPPORTING INFORMATION	Incident Date	<i>July 21, 2017</i>	
	Location	<i>Vancouver</i>	
	Regulated industry sector	<i>Amusement Devices, Amusement Ride</i>	
	Impact	Qty injuries	<i>1</i>
		Injury description	<i>Bump to occipital region of head, headache and dizziness</i>
		Injury rating	<i>Minor</i>
	Damage	Damage description	<i>None</i>
		Damage rating	<i>None</i>
	Incident rating	<i>Minor</i>	
Incident overview	<i>During a ride cycle a patron standing in the ride queue line was struck in the head by the foot of a rider on a rotating swing type ride (wave swinger).</i>		
INVESTIGATION CONCLUSIONS	Site, system and components	<p>A swing type ride in operation since 1976. (Wave Swinger)</p> <p>The unit is a configuration of single seat carriers that are suspended by chains from an overhead rotating carousel. The rotating carousel rises up and also tilts during the ride cycle.</p> <p>Rotation and lift of the carousel is provided through the use of multiple hydraulic drive and hydraulic control systems.</p> <p>The queue line partially circles around the ride perimeter fencing.</p> <p>A manual brake pedal is located in the ride operating area.

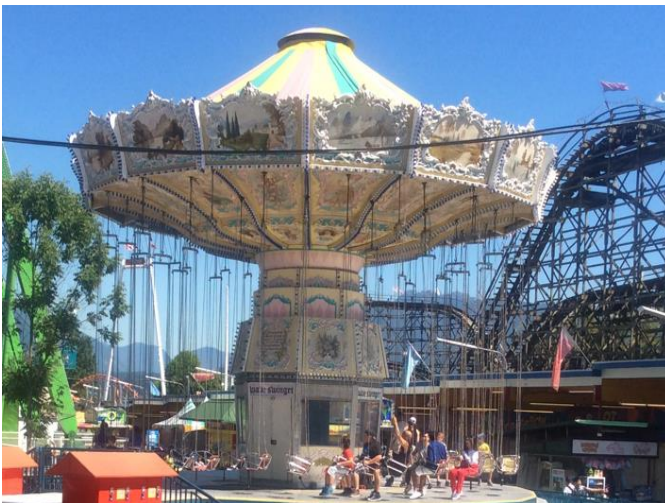
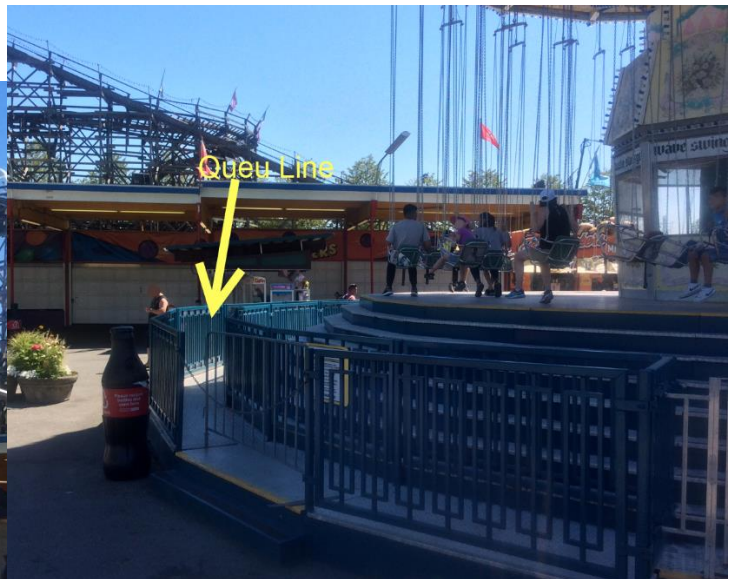
Photos or diagrams (if necessary)

Failure scenario(s)	<i>During the ride cycle the trajectory of the suspended carriers were allowed outside of the ride's safety envelope.</i>	
	Facts and evidence	<ul style="list-style-type: none"> <i>The unit was operating for an adults only event, therefore it is likely that the ride was more heavily loaded than typical.</i> <i>A manufacturer's representative that was engaged by the operator to assess and correct the operation of the unit determined that:</i> <p><i>The manual brake pedal was ineffective in slowing the rotating carousel and was being slowed by the normal frictional drag of the rotation.</i></p>

<p><i>The reason the brake was not effective was due to an error in the orientation of the porting of the brake system (hydraulic line was connected to the incorrect port of the brake control).</i></p>
<p>Causes and contributing factors</p>	<p><i>Likely, due to the brake being ineffective and because of the additional mass on the ride, the carousel rotation decelerated at a slower than normal rate. Because of this, as the carousel lowered, the trajectory of the suspended rotating carriers were forced outside of the normal ride safety envelope (carriers were lower and swinging further outside than the norm.) resulting in an interference condition between riders and the patrons in the queue line.</i></p>
