Incident Summary (5623014)

SUPPORTING INFORMATION	Incident Date			September 27, 2017
	Location			Vancouver, BC
	Regulated industry sector			Natural Gas System
	Impact	Injury	Qty injuries	0
			Injury description	0
			Injury rating	none
	Damage		Damage description	Collapsed venting system on a natural gas fuelled boiler
			Damage rating	Insignificant
	Incident rating			Moderate
Incident overview			Components on venting system serving a central heating boiler was found collapsed. The collapse was due to poor combustion leading to a large explosive discharge within the boiler. As the discharge exited through the venting, the negative pressure created from the event collapsed the venting components..	
INVESTIGATION CONCLUSIONS	Site, system and components			The natural gas fuelled boiler related to this summary is located in a basement mechanical room. The gas supply delivers 5 psi gas pressure to a secondary stage to under .5 psi pressure through a direct acting regulator positioned 48” from inlet port to the unit. The combustion system on this boiler is composed of a flame sensor (flame rod), an ignition device (ignitor), a controlling gas valve, air pressure sensors (to prove combust

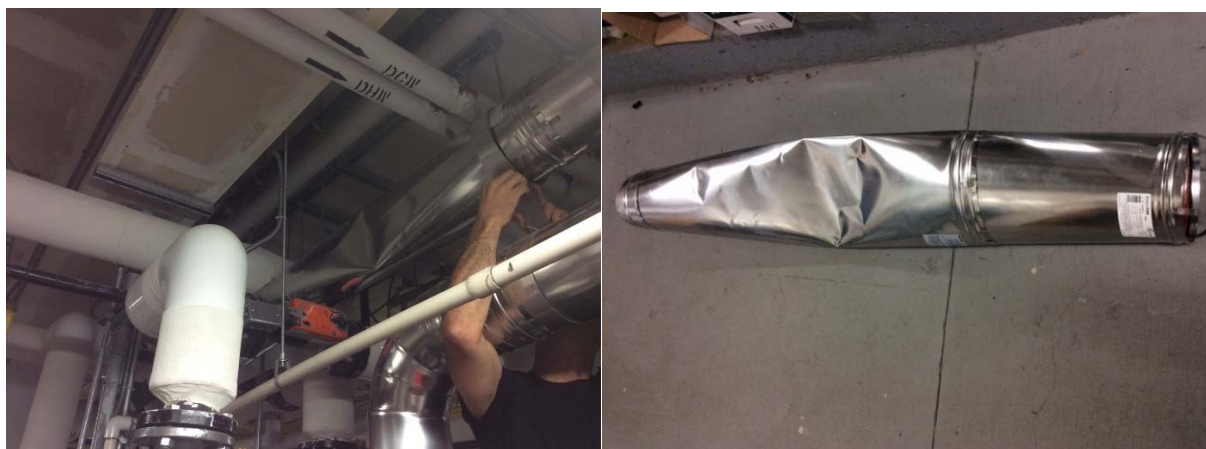
Facts and evidence			<ul style="list-style-type: none">Collapsed venting components

Collapsed venting on horizontal run

Failure scenario(s)			Over a period of time, the boiler burner engaged as expected, to provide heat to the hydronic system for the site. However, gas flow exceeded the maximum level allowed by the manufacturer due to an inability of the direct acting regulators installed on the gas piping to supply a controlled amount of gas. As the gas valve on the boiler opened on a call for heat, more gas than expected passed by the valve seats. When the ignitor lit the air\gas mix, the combustion ignition was greater than the engineered safe level, leading to compounding explosive events within the appliance over multiple start-ups. Although the system contained these poor ignition events, they damaged the ignitor and flame rod over time. Consequently, during a call for heat, the gap created from the previous combustion events caused the ignitor to spark only intermittently, not consecutively as designed. This allowed for unignited gas to stay unlit in the combustion chamber, and as the ignitor sparked, a large explosive event occurred, destroying the flame rod, and passing out through the venting. As it exited, the negative pressure behind the blast collapsed the outer walls of the vent in multiple locations. Due to the collapse, the vent sensors could not verify effective flow, so the BMS shut down the boiler..

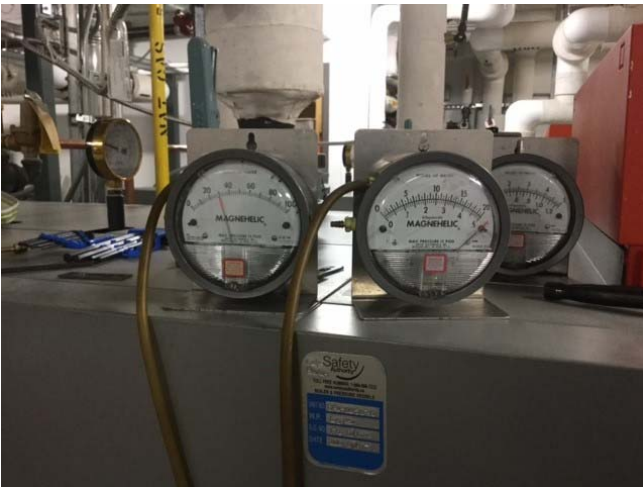
<ul style="list-style-type: none"> • Warped ignitor from the burner with expanded gap from high heat • Cracked flame rod due to high heat • Fault code on BMS indicated • Demonstrated higher than engineered lock up pressure (over twice the maximum allowable) due to the direct acting regulators immediately upstream of the boiler gas inlet
	<p>Causes and contributing factors</p>	<p>The regulator immediately upstream of the gas supply inlet of the boiler was not able to modulate gas pressure as required by the boiler burner due to a limited capability to modulate at the same ratio of demand required by the burner. Over time, poor combustion led to a deterioration of the combustion equipment. As these components deteriorated, the combustion characteristics became worse until finally a large explosive event occurred within the unit that collapsed the venting. Routine maintenance from a knowledgeable and qualified technician could have discovered anomalies within the burner as the continuity of the flame rod is measured and trackable on the BMS control display. Regular service on the burner would have shown the ignitor and flame rod were damaged, leading to further tests of the system before the incident would have occurred. Routine pressure tests at annual service would have indicated the higher than allowed pressure during system lock up. According to testimony by the system operator, this boiler was never serviced over the 3 years since it was installed, even though the manufacturer recommends annual servicing.</p>

Lock up pressure test (right hand side) downstream of regulator, upstream of gas inlet to the boiler
