Incident Summary #II-1644212-2023 (#42077) (FINAL)

SUPPORTING INFORMATION	Incident Date	December 4, 2023	
	Location	Duncan	
	Regulated industry sector	Electrical - Low voltage electrical system (30V to 1000V)	
	Impact	Qty injuries	1
		Injury description	2 nd degree burns to hands.
		Injury rating	Moderate
	Damage	Damage description	Burnt breakers, melted conductors, and buss bars.
		Damage rating	Minor
	Incident rating	Moderate	
Incident overview	A worker at a restaurant caused a line-to-line ground fault when installing an unapproved breaker into a 200amp, 208v panel.		
INVESTIGATION CONCLUSIONS	Site, system and components	<p>The restaurant had a 3 phase, 200amp, Sylvania combination panel, fed from a 600amp splitter. The panel label specified, approved for use with QB or QBH branch circuit breakers.</p> <p>The panel was equipped with a main disconnect and the panel branch circuit breakers were labelled with a Square D panel schedule. The new branch circuit breaker that was attempted to be installed in the panel was a Square D, QO, 2 pole 20amp.</p> <p>2-304 of the BC electrical code states that <i>“no repairs or alterations shall be carried out on any live equipment except where

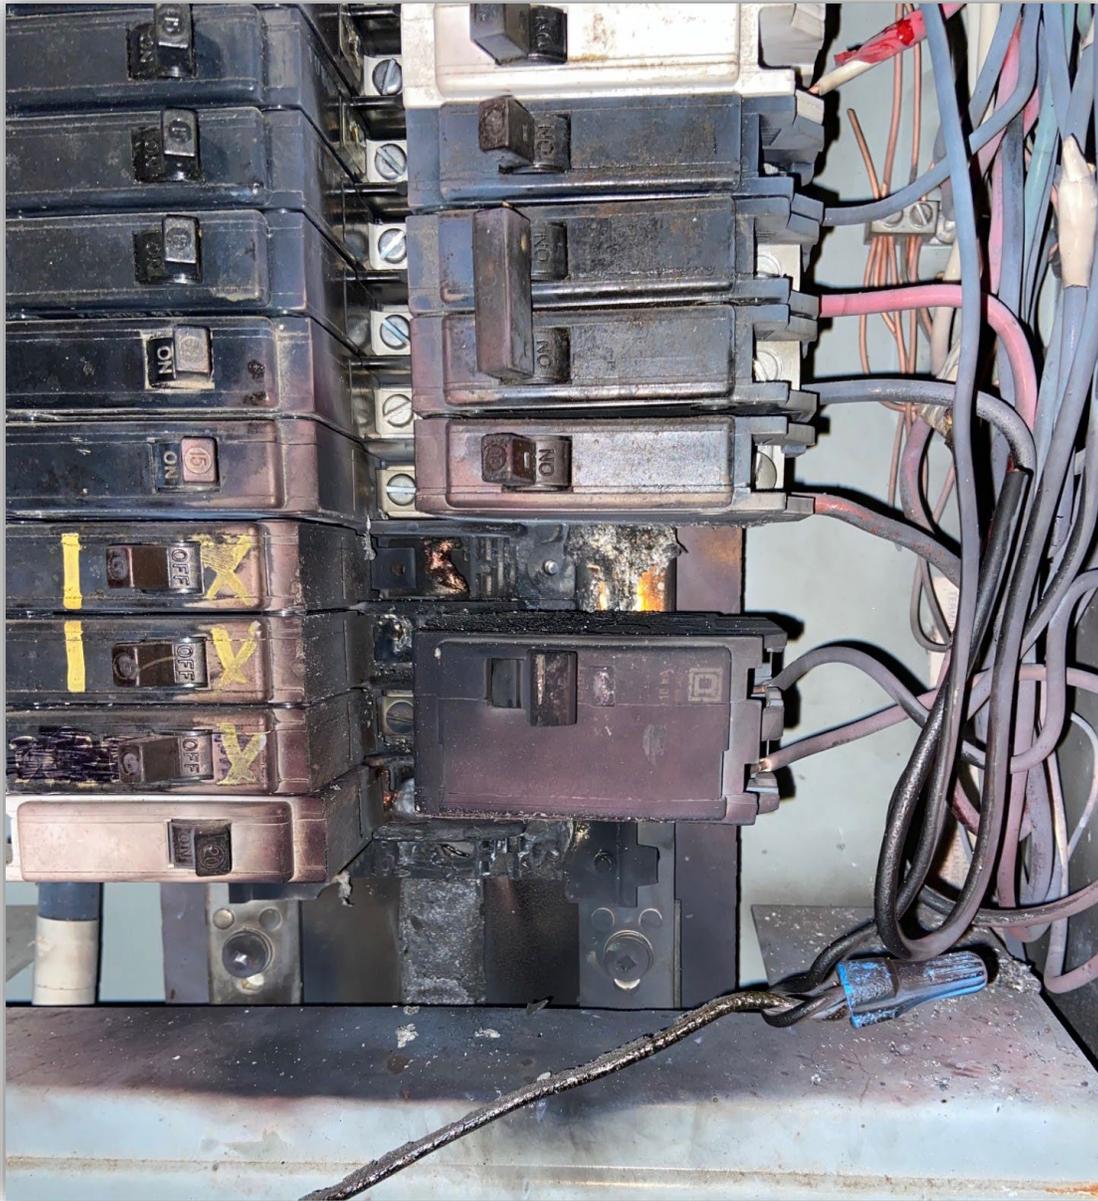
Image 1 – Panel showing damage from the short circuit.

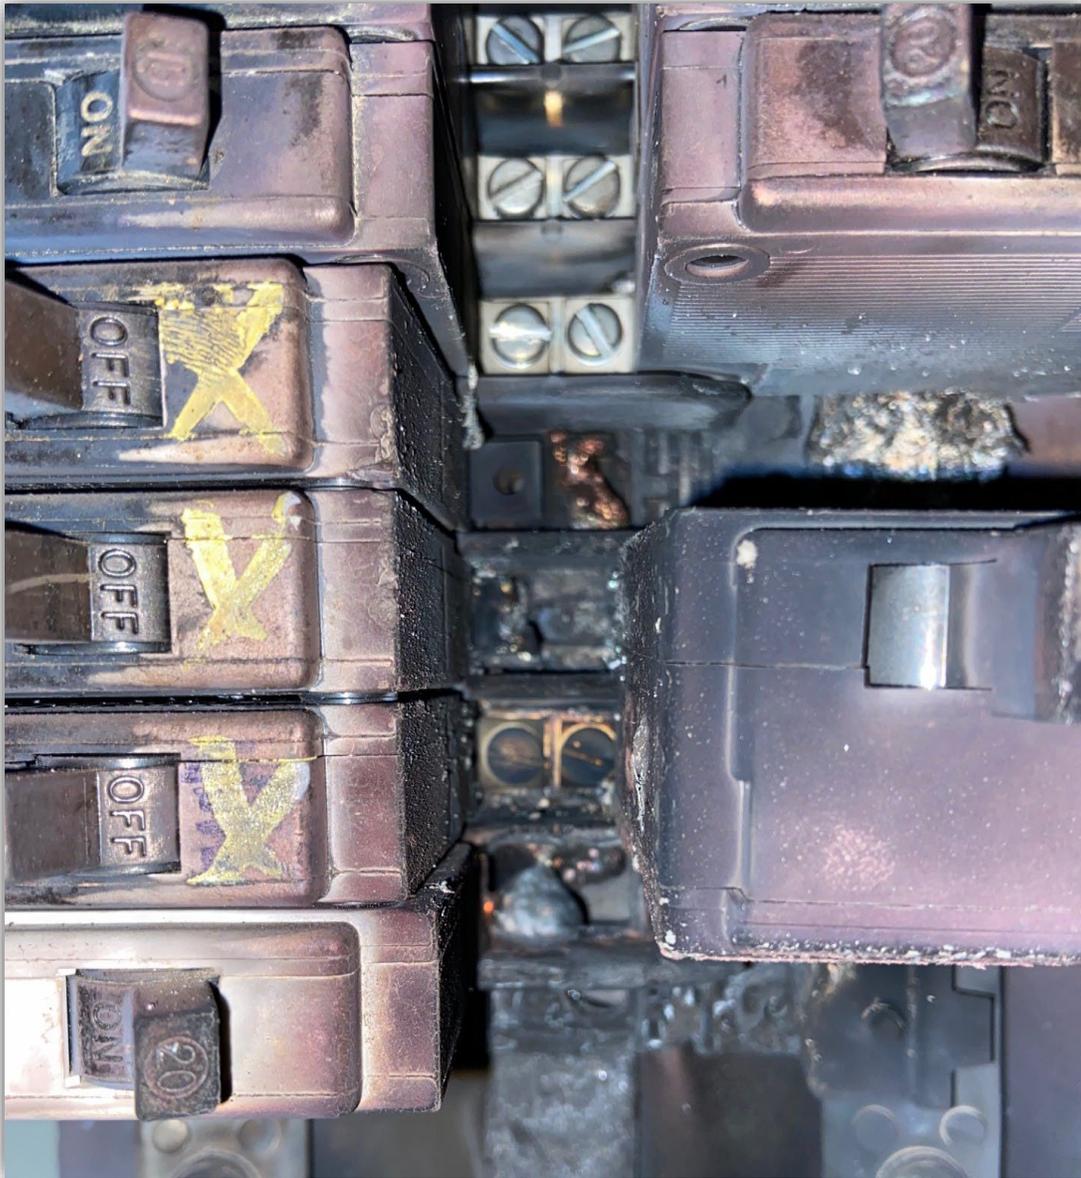
Image 2 – Closeup of the panel showing damage from the short circuit.

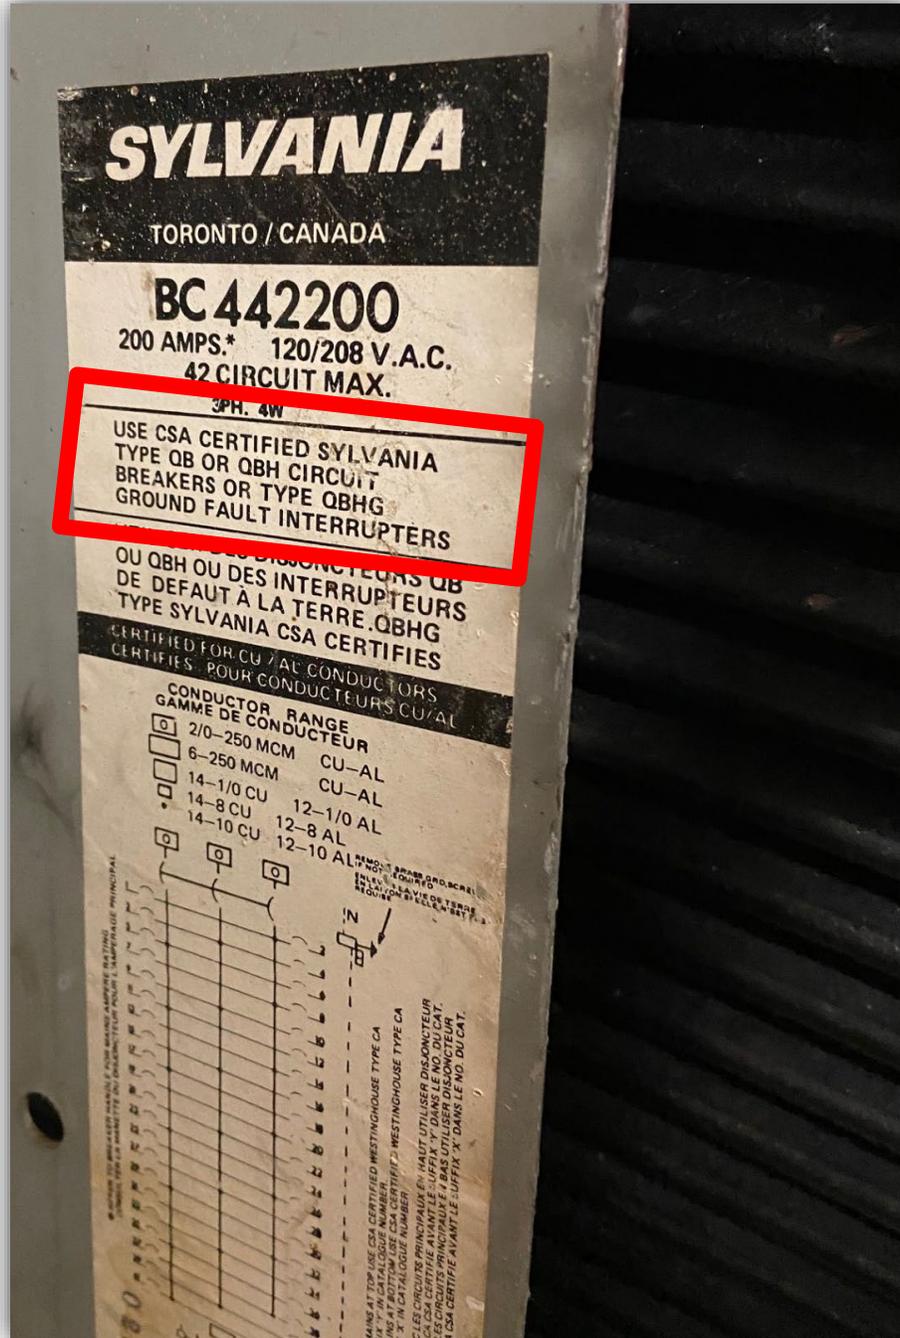
Image 3 – Panel schedule showing compatible breaker types.

Facts and evidence	<p>Witness statements</p> <ul style="list-style-type: none">• The worker used the schedule on the panel and incorrectly identified a “Square D” style breaker for the Sylvania panel• The worker had only just become a Journeyperson after passing the qualification exam earlier that month.• The work was being done without a permit and there was no FSR responsible for the work• The worker stated they did not de-energize the electrical panel before working on it because they did not want to inconvenience the restaurant by turning off the power.• The bolt on the breaker was incompatible with the panel.• When the bolt was being attempted to be installed with a screwdriver, the screwdriver slipped contacting energized parts of the panel creating a short circuit
Causes and contributing factors	<p>The cause of the incident was the electrical work being done without first de-energizing the panel as required by BC Electrical Code.</p> <p>Contributing factors to the incident include the inexperience of the worker and along with no Field Service Representative responsible for the work allowing the incorrect breaker to be selected and attempted to be installed.</p>

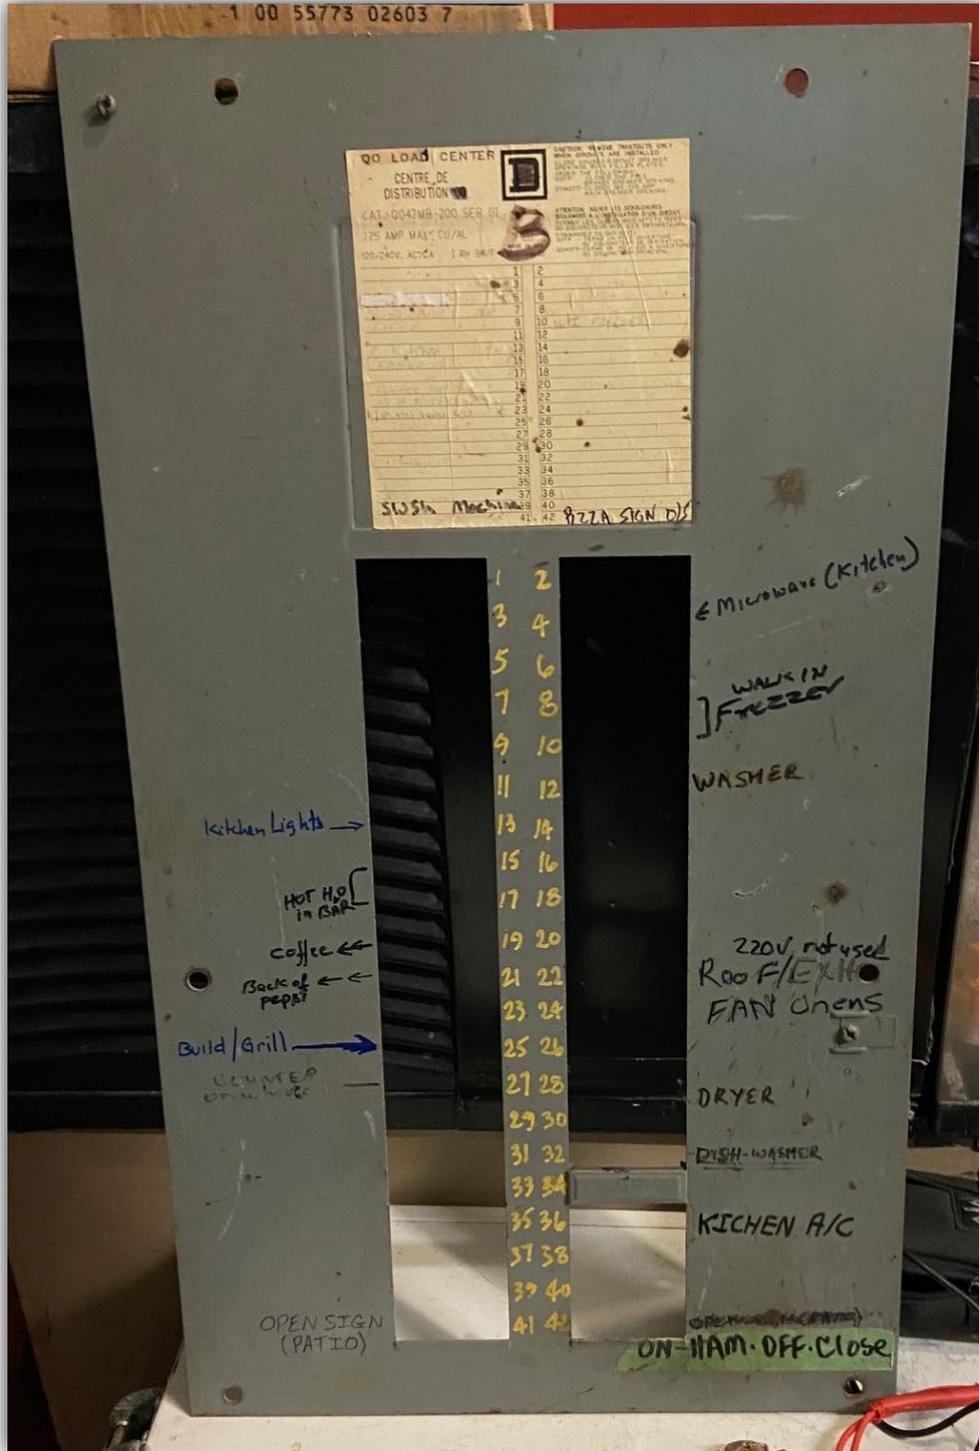
Image 4 – Panel cover showing a Square D schedule.

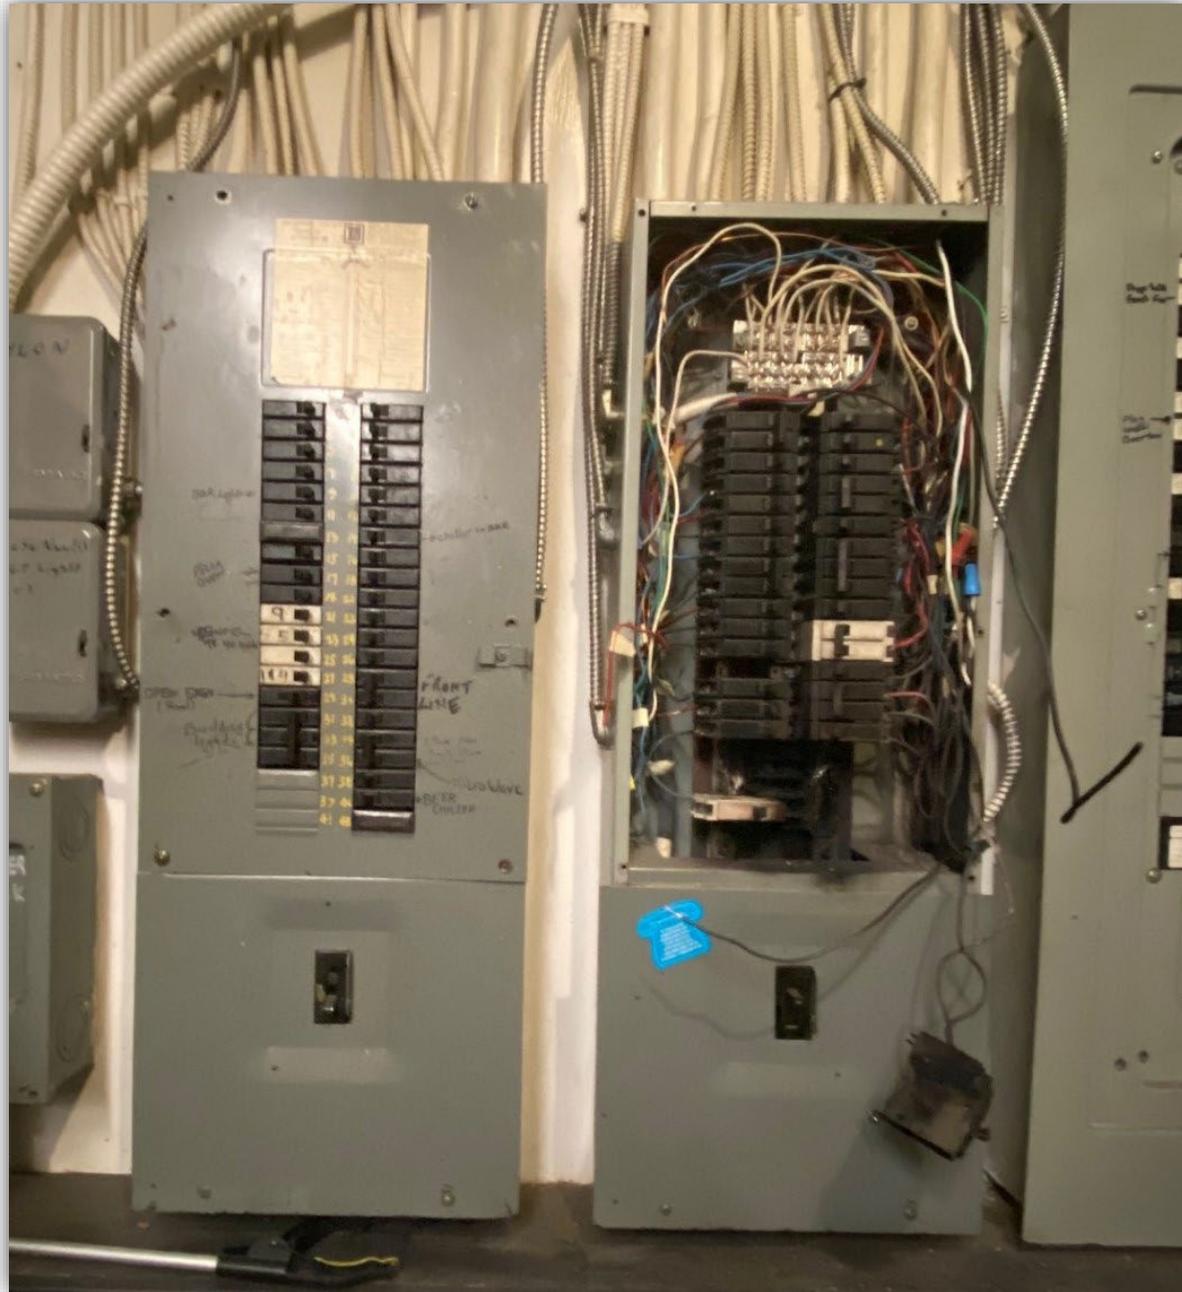
Image 5 – Two breaker panels next to each other.
