Incident Summary #II-1624613-2023 (#40659) (FINAL)

SUPPORTING INFORMATION	Incident Date	August 18, 2023	
	Location	Surrey	
	Regulated industry sector	Gas - Natural gas system	
	Impact	Qty injuries	1
		Injury description	One occupant reported experiencing nausea
		Injury rating	Minor
	Damage	Damage description	Carbon monoxide (CO) release from dislodged boiler venting system
		Damage rating	Moderate
Incident rating	Moderate		
Incident overview	The natural gas fired boiler's exhaust venting system was dislodged from a delayed ignition detonation. The boiler continued to run releasing CO into an interior space through the exhaust vent connection opening. One occupant reported feeling nausea, the CO alarm was going off repeatedly, the building was exited, and 911 was called.		
INVESTIGATION CONCLUSIONS	Site, system and components	<p>Site and system</p> <p>The residential home utilizes one natural gas Viessmann Vitodens 100 B1HA 26 hydronic boiler for water heating with a rated output of 87,000 BTU. The heating system includes the boiler, the hydronic water plumbing system, the gas system, and exhaust venting system.</p> <p>Boiler system</p> <ul style="list-style-type: none"> - The boi

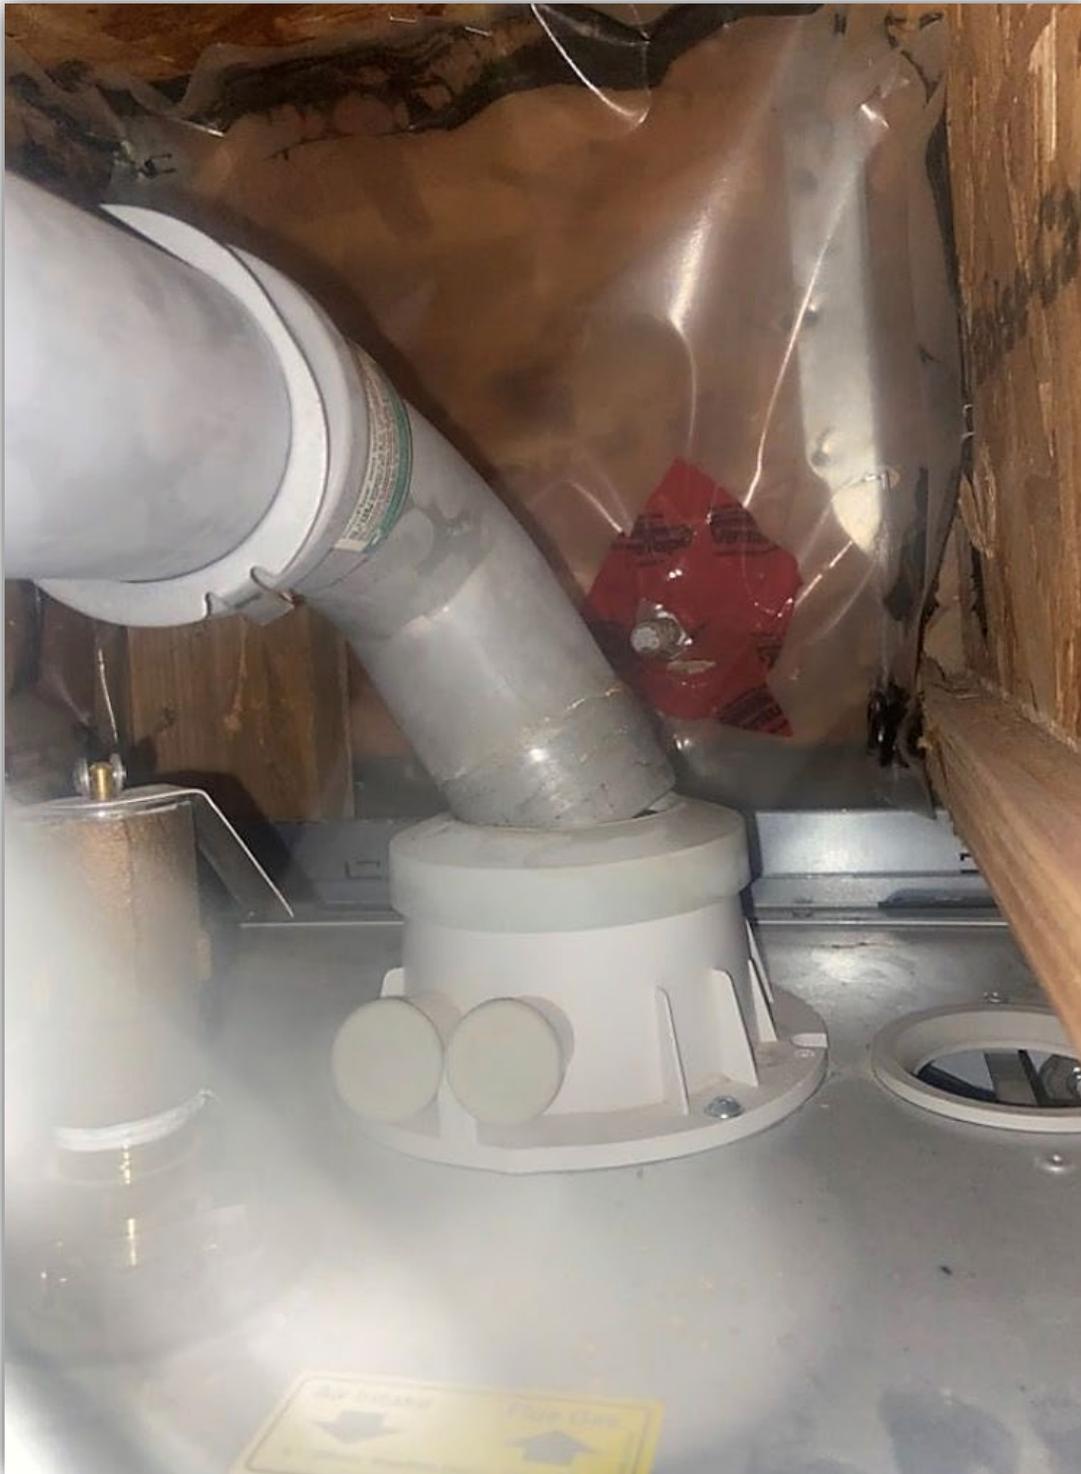
Image 1 – Dislodged vent.

<p>Failure scenario(s)</p>	<p>The hot water boiler was installed in the crawl space of a residential home in 2017-2018. The venting system connects to the top of the boiler in a rubber boot or gasket that uses friction to keep the vent in place. The venting system had wrapped metal strapping in place as a securing means leaving the vent vulnerable to upward motion. The boiler continued in operation over the next five-to-six-year period. It was stated that maintenance was performed on the boiler 1-2 years before the August 2023 incident. The boiler was found to have a fouled heat exchanger, a degraded ignitor rod, and a clogged condensate drain. These conditions contributed to the boiler experiencing delayed ignition detonation. The detonation blew the partially supported vent out of the friction fit connector on the top of the boiler (Image 1). With the venting system dislodged, the boiler continued to run emitting products of combustion and CO into interior spaces. The CO alarm in the house was triggered, an occupant was nauseous, and the occupants exited. The homeowner called 911 and the fire department attended. The gas utility attended the site a half hour after the fire department arrived and even with the doors having been left open in the house by fire crews there was still roughly 60-70PPM (parts per million) of CO in the crawl space and a low CO reading in the home. The gas utility technician noticed a strong aldehyde and sulphur smell inside the home while moving towards the crawl</p>

<p>Causes and contributing factors</p>	<p>The vent was most likely dislodged by delayed ignition detonation leading to CO release into interior spaces. The venting system not having the required support may have contributed to the vent being able to move upwards and dislodging.</p> <p>Contributing factors to the detonation may have included the:</p> <ul style="list-style-type: none"> - Degraded arcing ignitor. - Heat exchanger filled with dirt and debris. - Clogged condensate drain. <p>A contributing factor to the CO release into interior spaces was the ability of the boiler to run with a dislodged vent.</p>

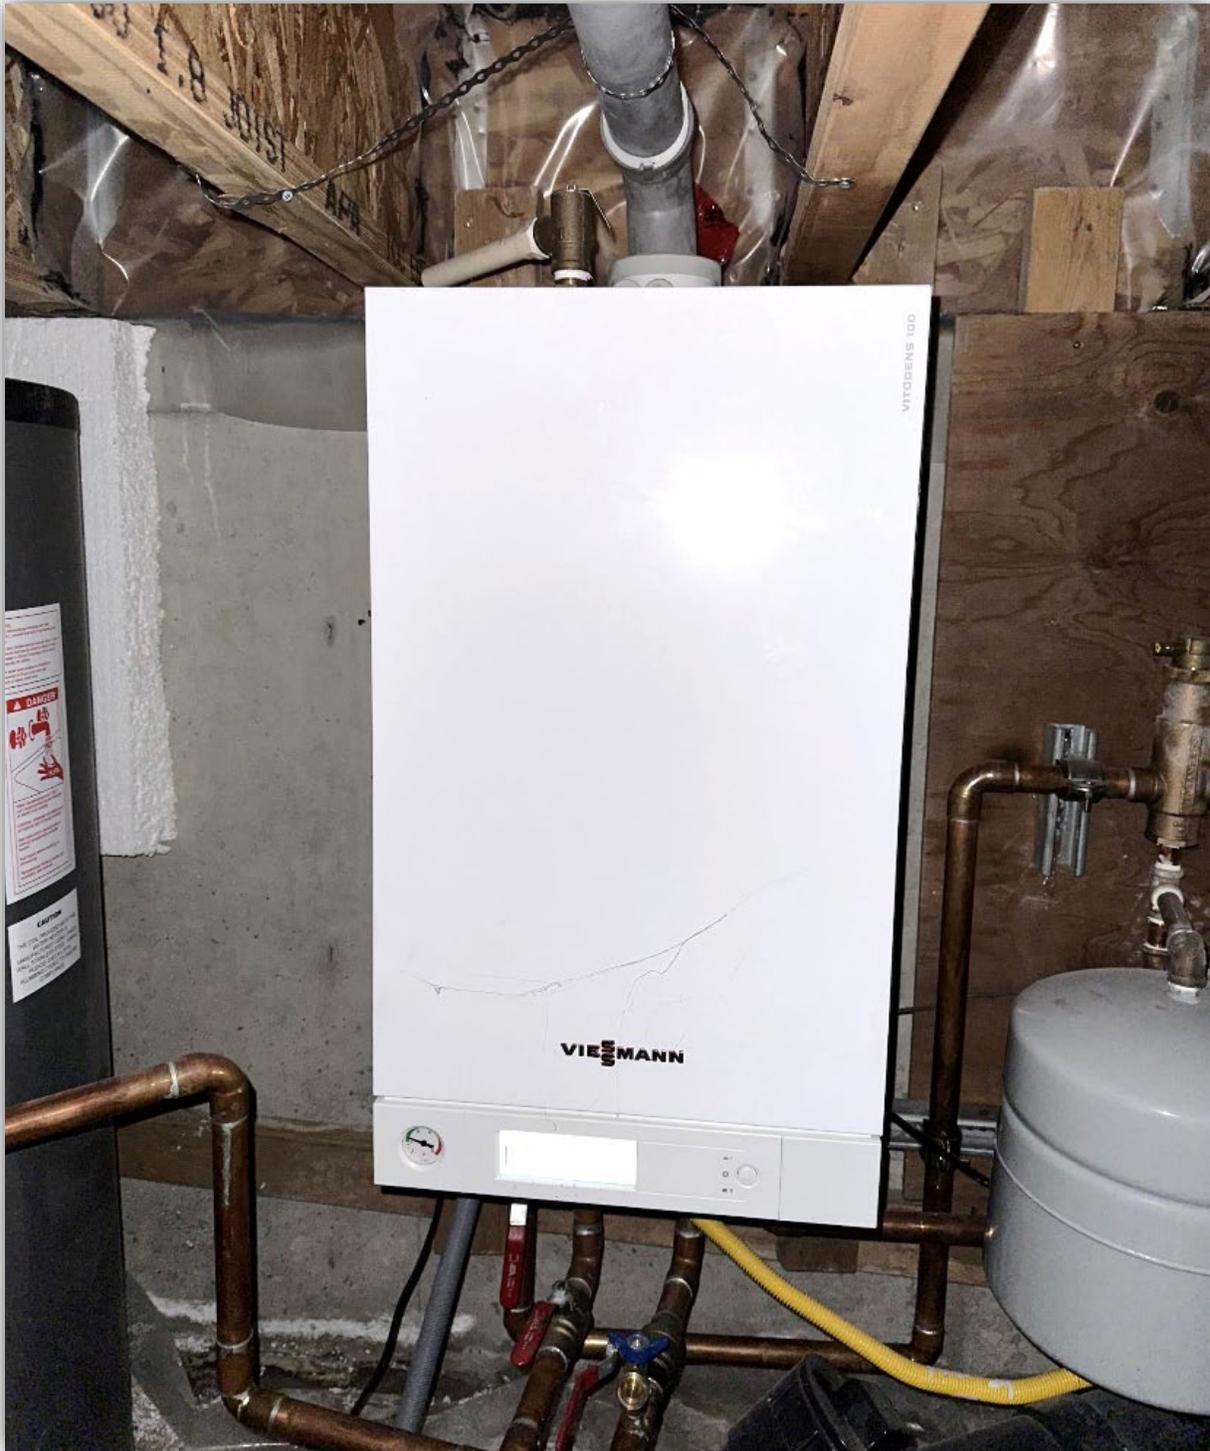
Image 2 – Boiler after servicing.

<p>space. The boiler was shut down and red tagged. During servicing the day after the incident, the boiler had an F4 error in the controller (Image 5), which the boiler manual associates with ignition issues.</p>
<p>Facts and evidence</p>	<p>Repair gas fitter statements</p> <ul style="list-style-type: none"> - The boiler's venting gasket [boot] was worn out and needed replacing. - Ignitor was worn at the end. - Condensation was not going down properly. - Heat exchanger was filled with dirt and debris. - Boiler had an F4 error. <p>Utility gas technician statements</p> <ul style="list-style-type: none"> - The venting 90 was popped of the top of the boiler. - Was told by an occupant that the CO alarm had been reset over a period of a couple days as they thought it was faulty. - Upon walking in the house, could smell aldehydes quite a bit, down the landing it smelled sulphury. - Read 60-70 PPM on their gas detector in the crawl space, 30 minutes after the fire crews had arrived and started airing the place out. - In the house there was a low reading of CO at that time. - Shut power and gas off. <p>Fire fighter</p> <ul style="list-style-type: none"> - Fire crew CO monitor activated when close to the crawl space. - One occupant reported feeling nauseous. <p>Homeowner statements</p> <ul style="list-style-type: none"> - Heard the CO alarm keep ringing and ringing for 10-15 minutes, so called 911. - Occupants' younger child was nauseous when the incident occurred. - The boiler had been serviced 1-2 years before the incident by a gas fitter, but the owner couldn't recall the name of the gas fitter. - That maintenance service reportedly included general inspection, cleaning the heat exchanger, and changing the ignitor. - Boiler was installed when the house was built in 2017-2018.

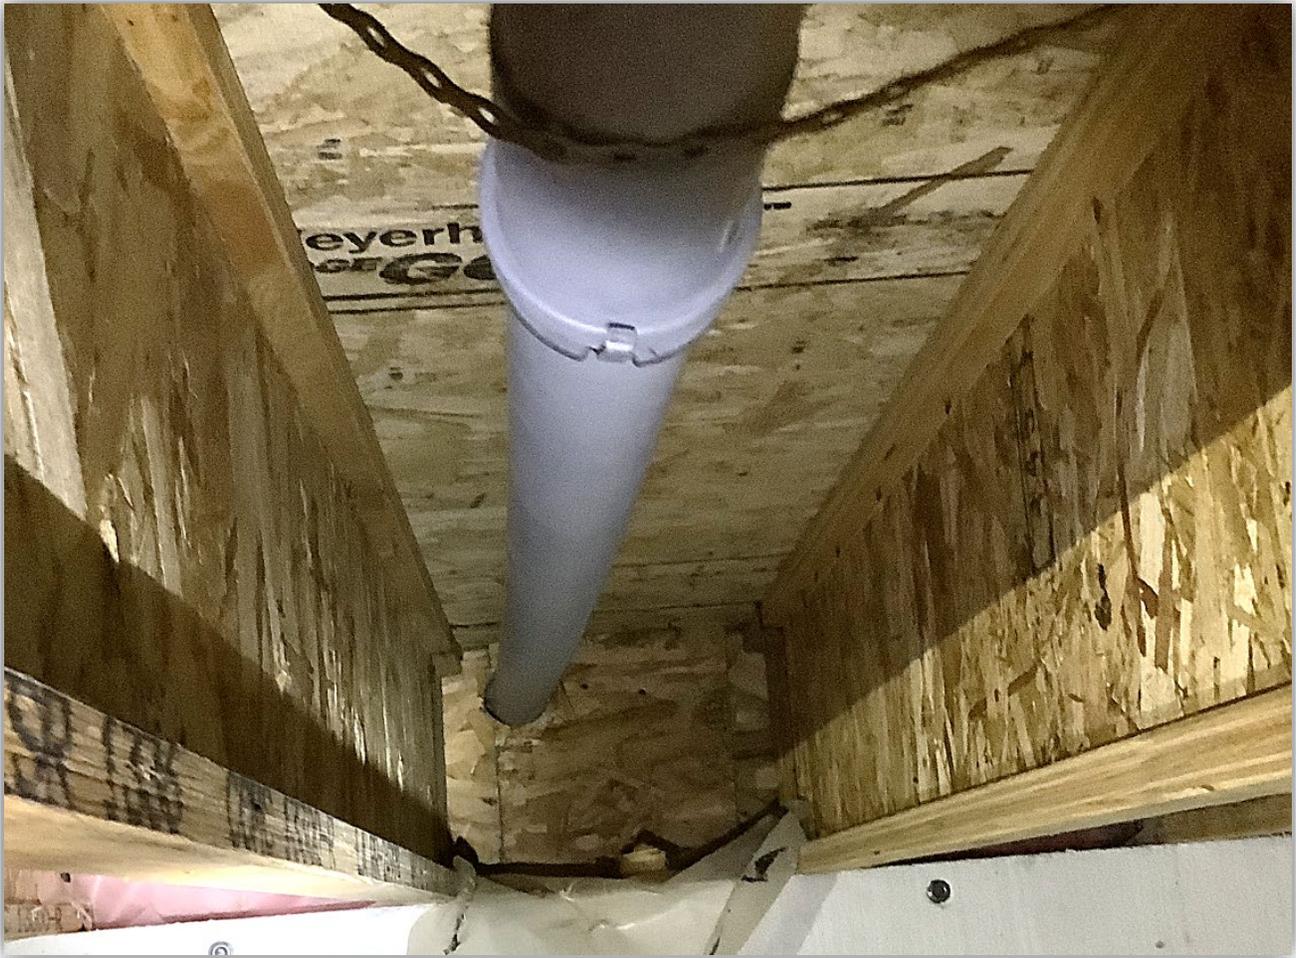
Image 3 – Exhaust venting to exterior.

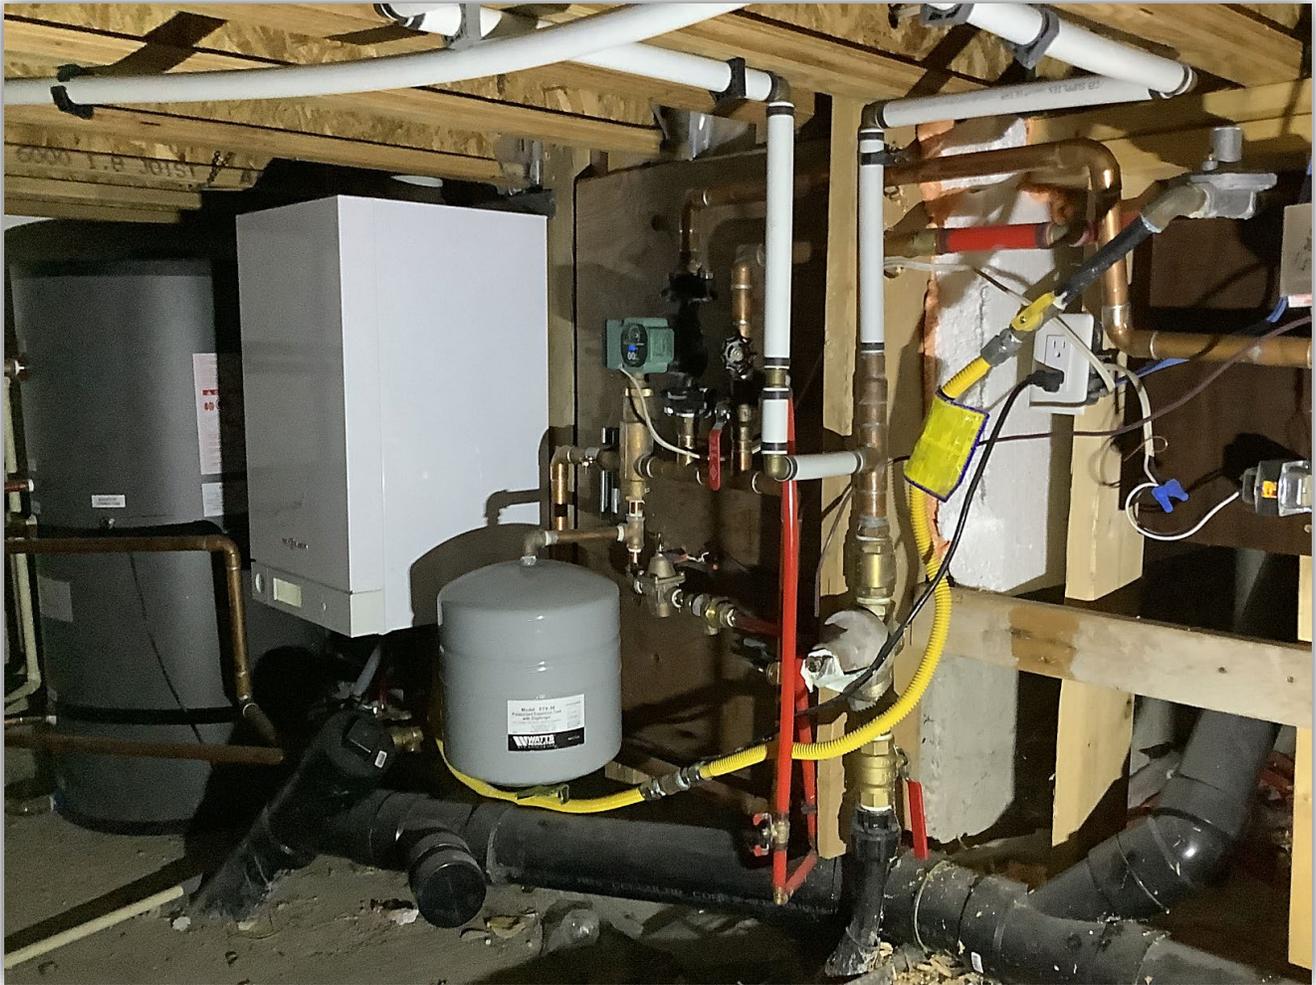
Image 4 – Boiler overall system.
