Incident Summary #II-848335-2019 (#15152) (FINAL) Revised June 9, 2020.

SUPPORTING INFORMATION	Incident Date	April 6, 2019	
	Location	Windermere, BC	
	Regulated industry sector	Electrical - Low voltage electrical system (30V to 750V)	
	Impact	Qty injuries	0
		Injury description	None.
		Injury rating	Moderate
	Damage	Damage description	Electrical unit heater destroyed by fire. Structure and property within damaged by fire.
		Damage rating	Moderate
	Incident rating	Moderate	
Incident overview	A fire began in a detached garage in Windermere, BC. An electrical unit heater was found at the center of the fire damage.		
INVESTIGATION CONCLUSIONS	Site, system and components	The unit heater was installed in the detached garage as the sole source of heat in the space. The purpose of the heater was to prevent fluids stored in the garage from freezing.	
	Failure scenario(s)	The electric heater involved in the fire was determined to have been connected to a power supply at the time of the fire event. It was suspected that the heater may have malfunctioned.

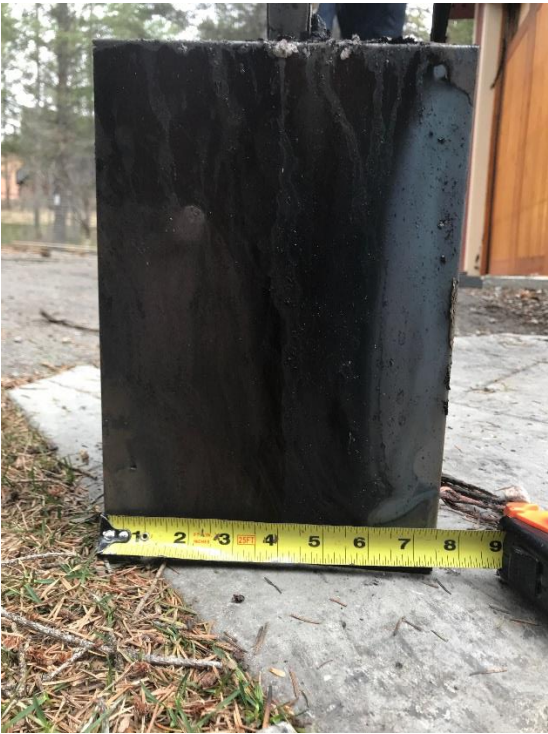
Figure 2: Unit heater depth

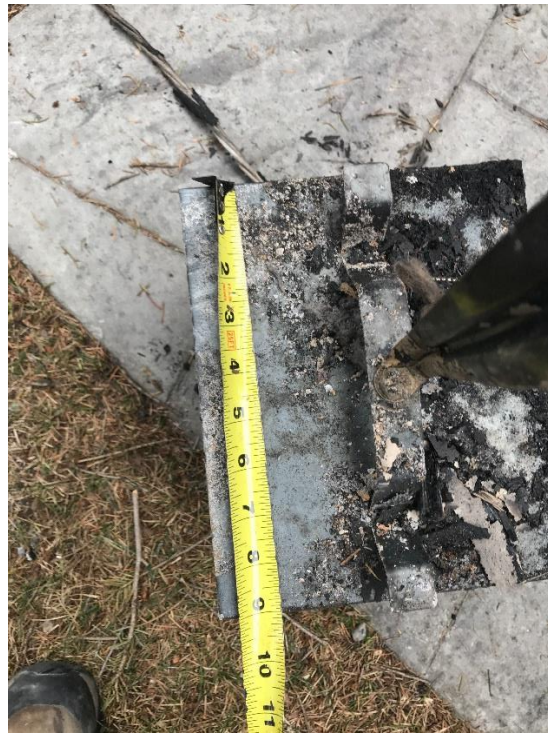
Figure 4: Unit Heater width

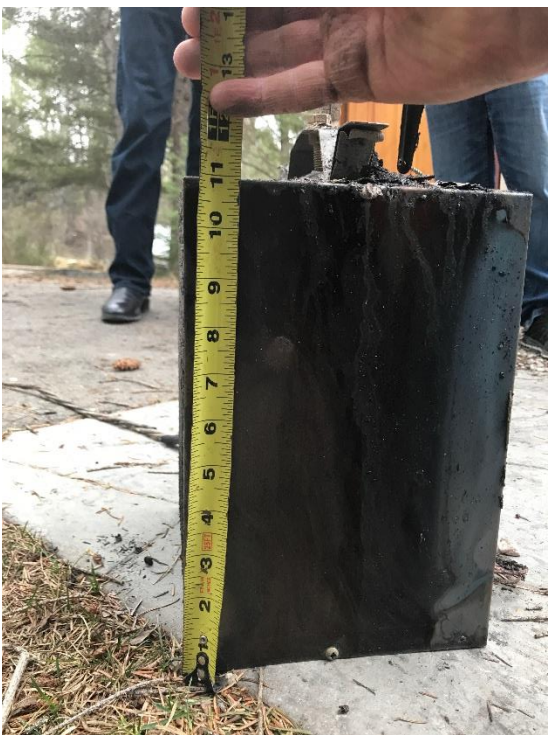
Figure 3: Unit heater height

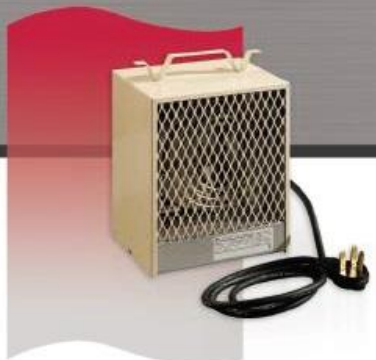
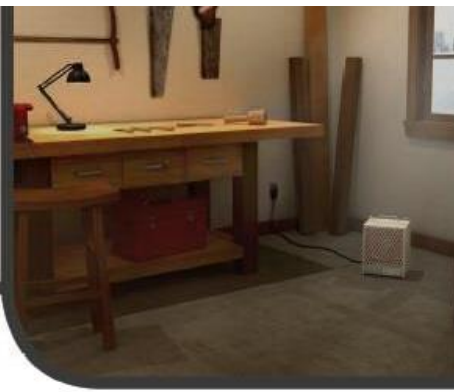
OCH Portable Heater

Grounded 3-Pronged Outlet

NEMA 6-20R
20A, 250VAC

NEMA 6-30R
30A, 250VAC

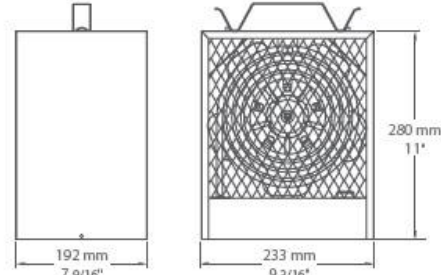
Figure 5: Product catalog listing for recalled unit heater.

known to be defective, and as such, have been subject a product recall by the manufacturer.
Causes and contributing factors	Given the degree of damage to the unit heater, location of the heater near the center of the most fire damaged area and the lack of other plausible ignition sources nearby it is likely that the heater was the source of ignition for the fire. The dimensions of the heater closely matched a recalled regulated product known to be associated with increased fire risk, it is possible that the fire was caused by a failure of a faulty heating element within the heater.
