## Incident Summary Report II-644301-2018 (Incident ID 5305) (Final)

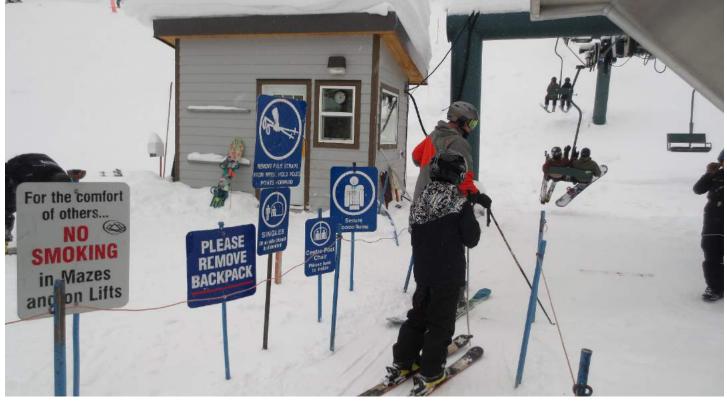
## **Lower lift line**

Failure scenario(s)	Passenger failed to load chair in the correct seated position. The safety restraining device was left in the up position. This condition lead to the passenger slipping and eventually falling to the ground. The load station attendant failed to notice the inadequate loading of the two boys. Lift attendant stopped the chair for another passenger at load station and at that time was informed of a passenger hanging from chair lift three towers uphill. The passenger could not hold on, resulting of him falling to the ground.
	Facts and evidence	Statements taken by duty holder: -Passenger indicated that he did not get seated correctly in the chairPassengers on chair behind indicated that the boy did not lower restraining device -Lift operator recognized that both children loaded chair half-on, but saw passengers squirm onto the seatCompanion on the chair indicated that the boy was hanging on since Tower 1

Causes and contributing factors	It is very likely that the passenger did not load the chair in the proper seated positon at the loading station and did not lower the restraining device once he was seated.
