Incident Summary #II-983834-2020 (#16699) (FINAL)

Incident Date	February 21, 2020
SUPPORTING INFORMATION		, and the second
	Location	Duncan
	Regulated industry sector	Elevating Devices – B44 Passenger Hydraulic
	Qty injuries	1
	Injury description	Bruising of two fingers
	Injury rating	Minor
	Damage be description Damage rating	Not Applicable
	Damage rating	None
	Incident rating	Minor
	Incident overview	An elevator door closed on a young child's hand, the door was re-opened by the parent pressing the door open button, releasing the child's hand.
INVESTIGATION CONCLUSIONS	Site, system and components	A passenger elevator in an apartment building. The elevator has an automatic door that is powered by a motor and controller (<i>door operator</i>) located on the roof of the elevator car. The doors located at each landing are opened and closed by the elevator <i>door operator</i> when the elevator is stopped at a landing. A timer is set inside the main elevator controller to determine how long the door stays open (<i>dwell time</i>). A light screen safety device is installed on the elevator door. This safety device consists of a light transmitting bar on the leading edge of the elevator

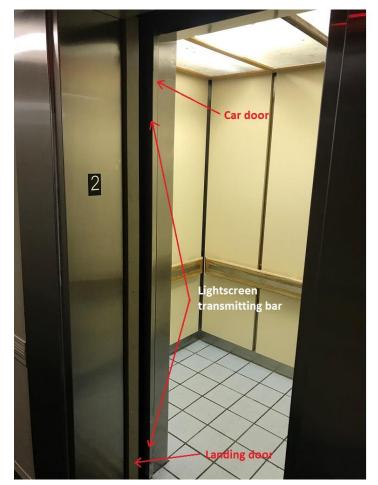
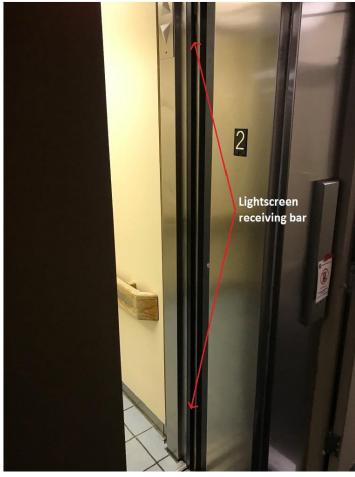
Photo 1 – Elevator entrance with details.

Failure scenario(s)	The elevator lost its programmed timers for <i>dwell time</i> and <i>nudging time</i> . The elevator door opened and immediately started closing in nudging mode, closing a child's hand in the door.
	Facts and evidence	Code requirements for maximum door closing force in normal operation is 30lbf. Code requirements for maximum kinetic force of door closing in nudging mode is 3.5 joules.

Incident Summary #II-983834-2020 (#16699) (FINAL)		
	Narrative of events based on interview with the responding mechanic:	
	 The elevator had lost its programming for <i>dwell time</i> and <i>nudging time</i>, leaving both timers set to zero. The door would open and immediately start closing. If an object was blocking the door the buzzer would sound and the door would immediately go into nudging mode. Nudging mode operated at the same speed as the normal closing speed. The mechanic reset the <i>dwell time</i> and <i>nudging time</i> before shutting the unit down. 	
	Evidence observed during on-site investigation:	
	 Nudging mode operated at the same speed as the normal closing speed – 45ft/min (approximately 3 joules kinetic force). Meets code requirements. Door close force, under normal operation, was 25lbf. Meets code requirements. Mechanic reduced closing speed of the door in nudging mode from 45 ft/min to 18 ft/min to provide additional safety. Electronic contacts of door lock and car gate functioning correctly. Maintenance records indicated that mandatory maintenance was being performed at scheduled intervals.

Narrative of events based on phone conversation with parent who witnessed incident:	
	 Parent and child called elevator on second floor of building. Car arrived and child entered the elevator as soon as doors opened. Doors opened fully and started closing immediately. Child turned and reached towards parent located outside the elevator as the door was closing. Door closed on child's hand. Parent pressed the hall call button on second landing multiple times. Door re-opened and child's hand was released. Door started to close again, parent held door open. Child was afraid to exit the elevator so parent entered the elevator. Elevator drove down to the bottom landing, doors opened and immediately started closing. Person located at bottom landing held the elevator door open so parent and child could exit. 	
Causes and	The elevator losing its <i>dwell time</i> and <i>nudging time</i> , causing the door to close almost immediately in nudging mode, was likely the main contributing factor.

contributing factors	The door closing at normal speed during nudging mode was possibly a contributing

factor.
