Incident Summary #II-1986500-2025 (#59015) (FINAL)

Failure scenario(s)

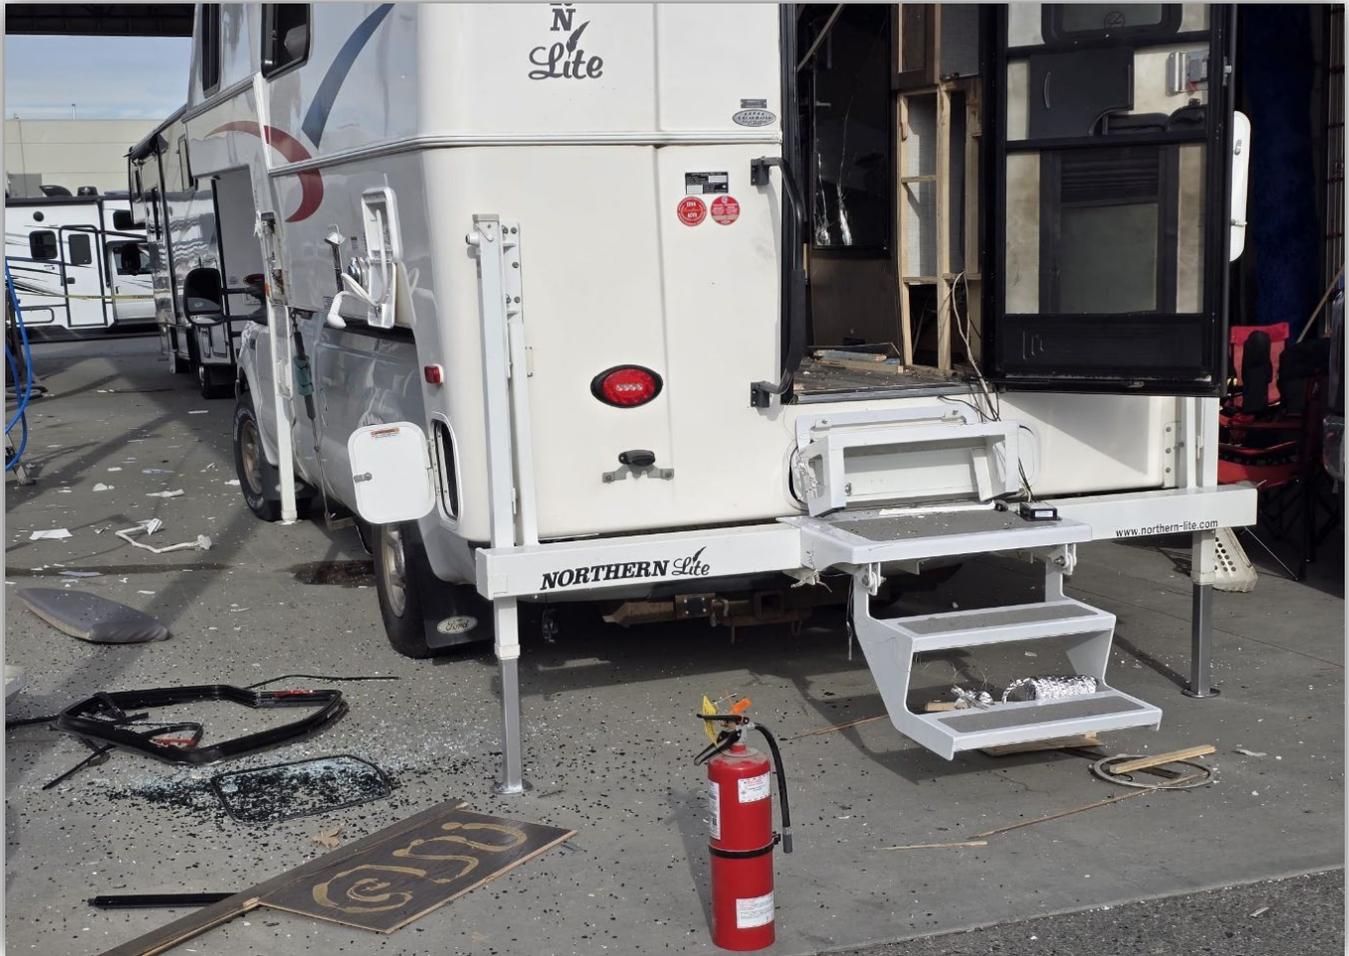
Image 1 - Camper with debris on the ground after explosion (provided by Canda Dream).

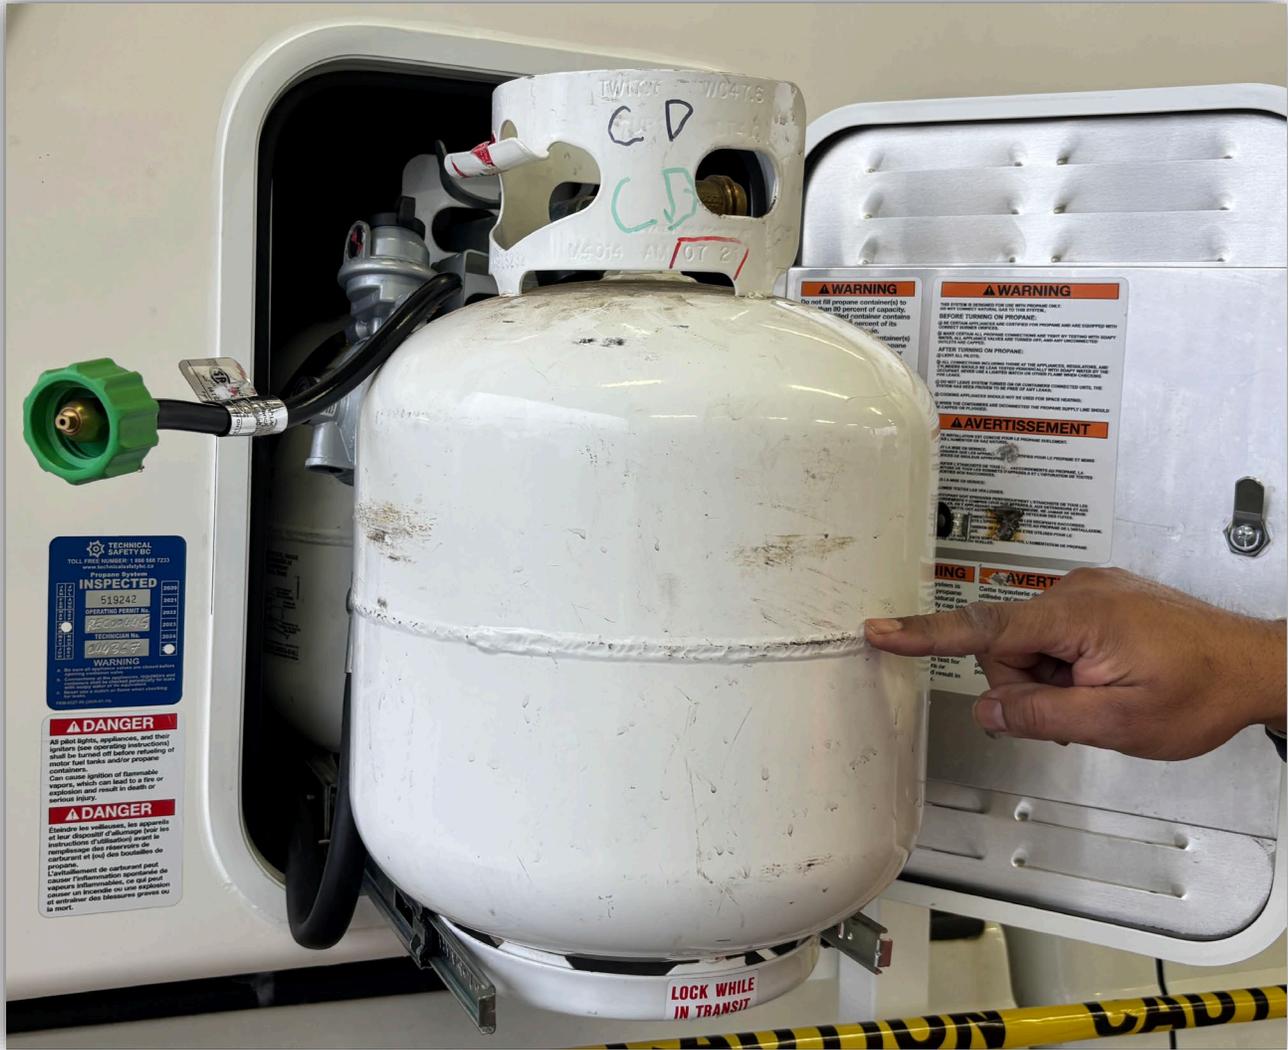
Should a rapid emptying of a propane tank happen, an intense evaporation chilling effect and gas expansion will occur. The escaping liquid propane will pull heat from the surrounding environment and frost, and condensation may occur ([Image 2](#)).

- The two propane tanks that fueled the camper were hooked up, with one bottle open, leading up to the incident ([Image 4](#)).
- It was half full after the incident. There was frost halfway down the bottle, indicating a consistent, outflow or leak leading up to the incident ([Image 2](#)).
- It was recorded as full the day before.

Image 2 - A frost line was seen at this level after the leak.

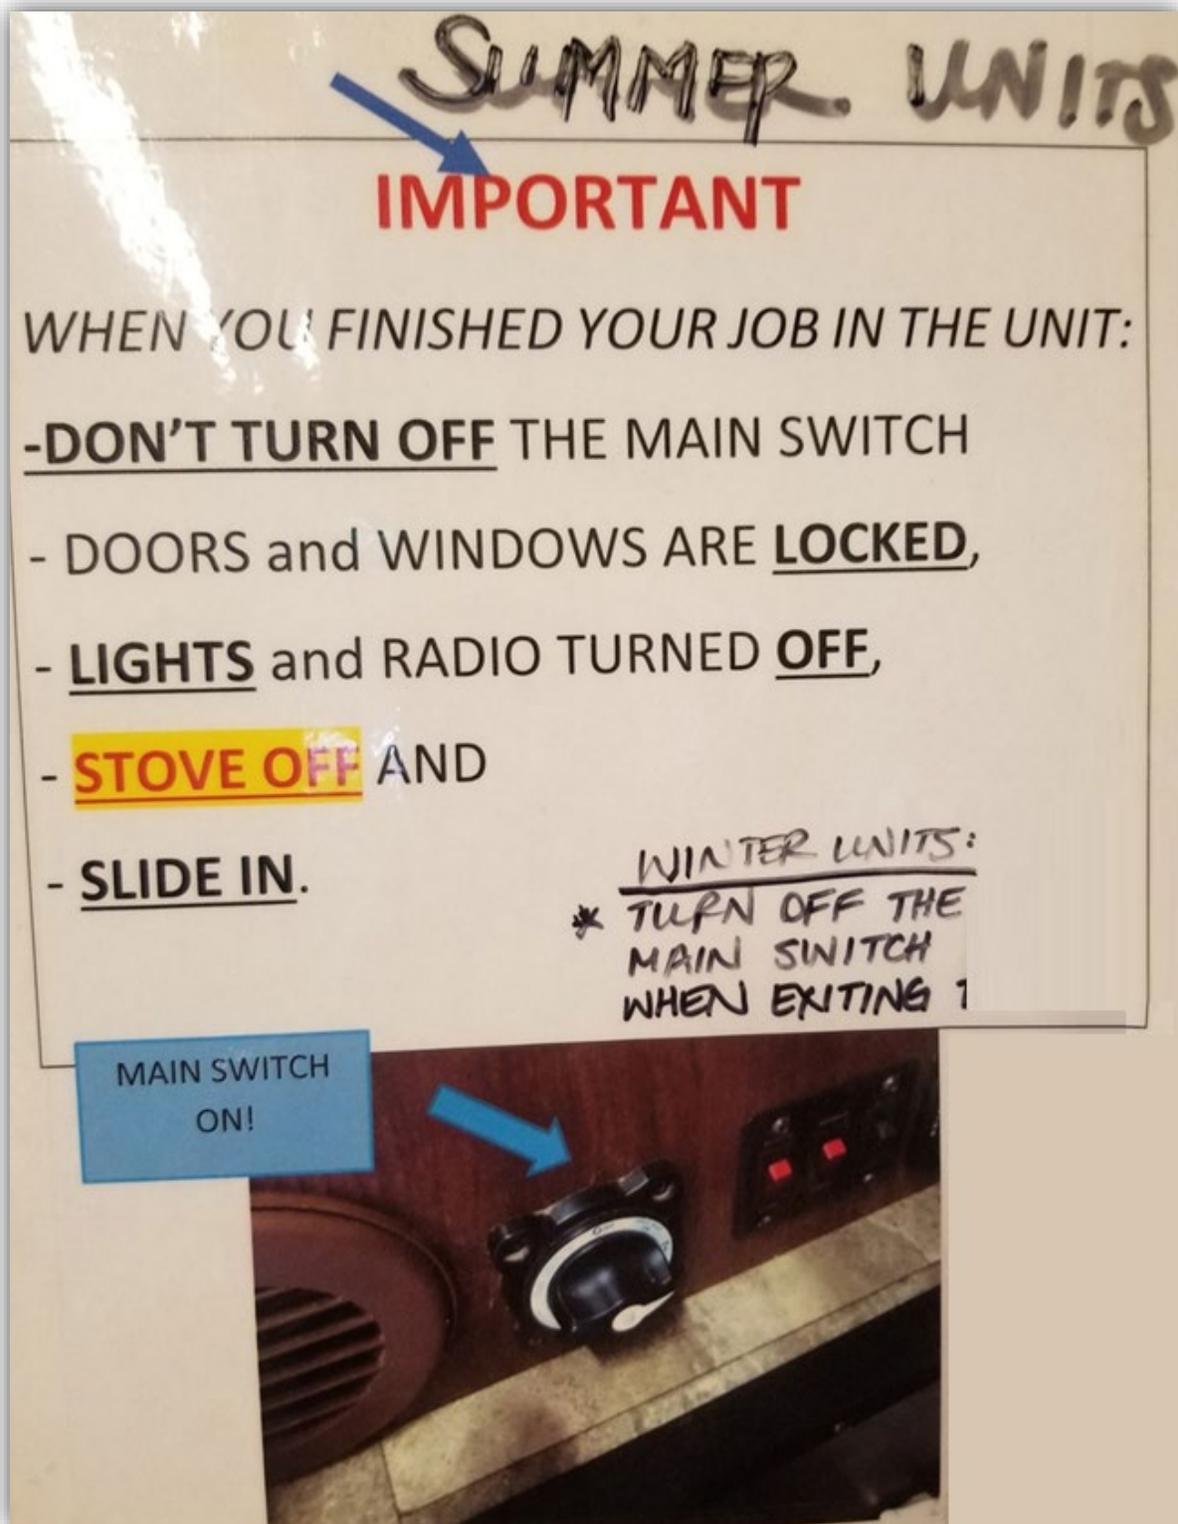
Posted instructions for cleaners indicated that before leaving, lights should be off and "Stove turned off" ([Image 3](#)).

Image 3 – Instructions for employees (Provided by Canada Dream).

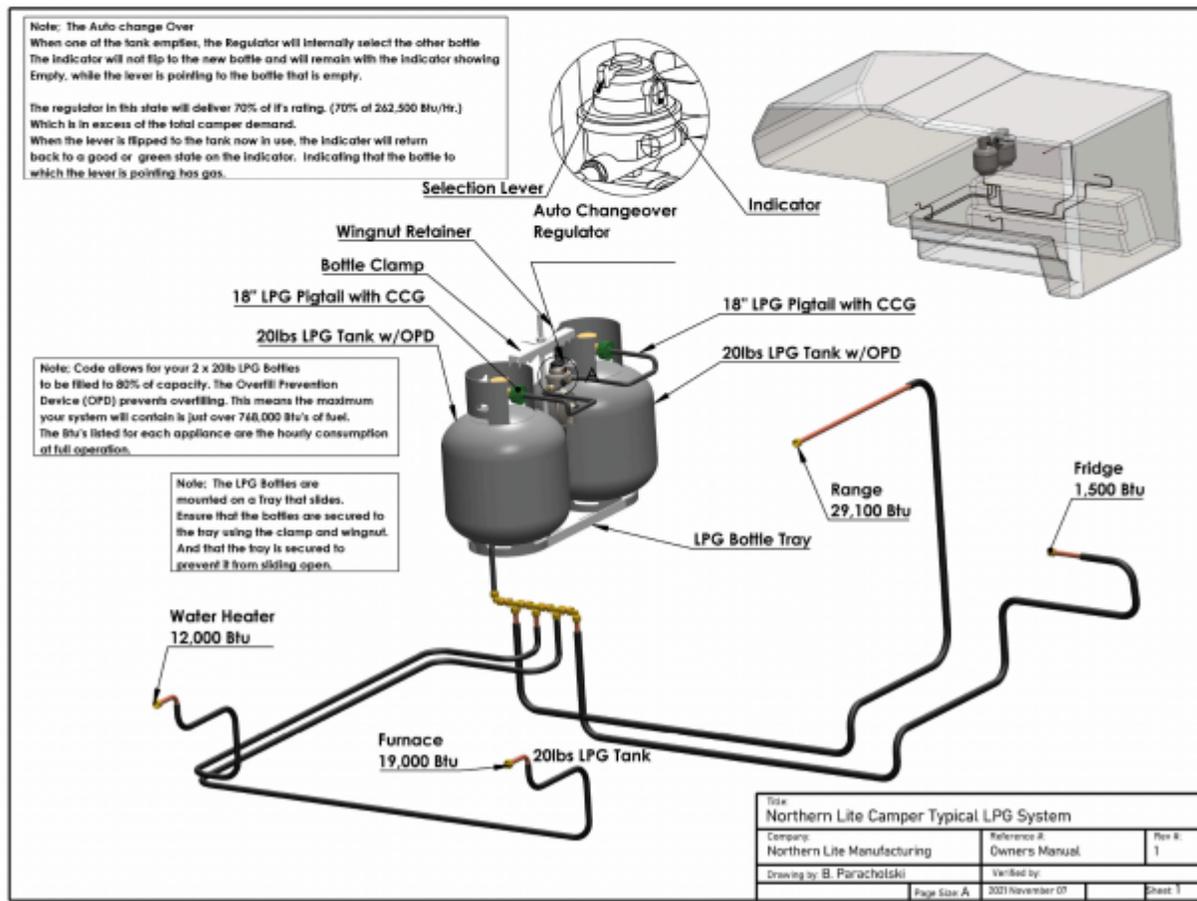
Image 4 - Propane system from the Northern Lites Manufacturers Owner's Manual.

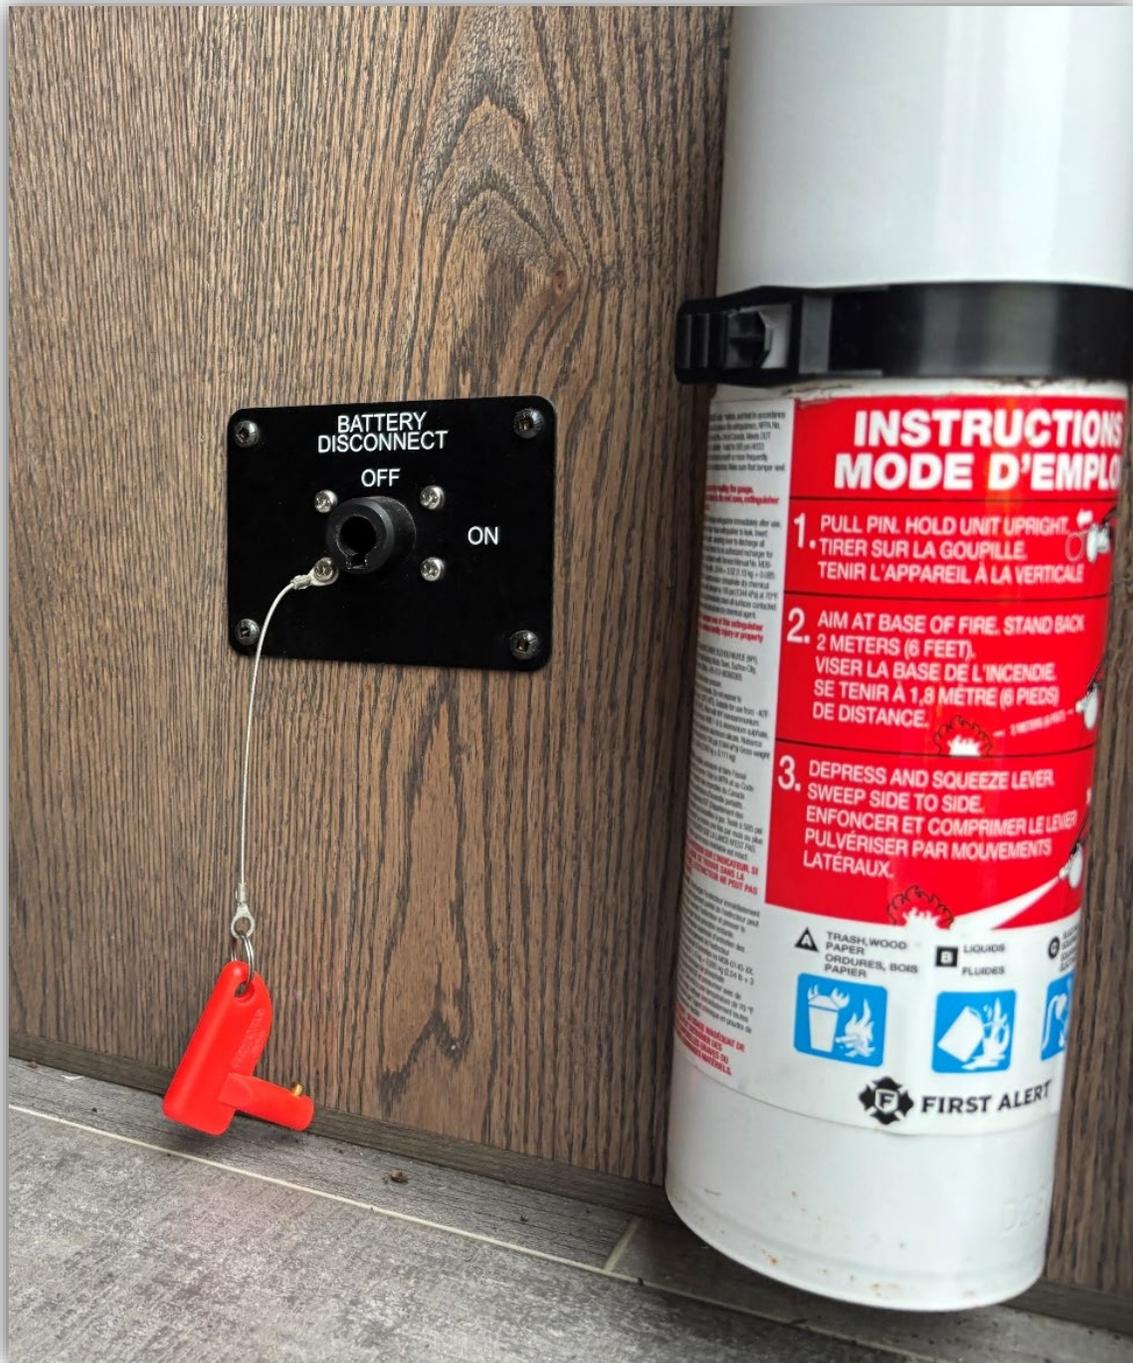
Potentially if the RV is plugged into the 120V system all appliances requiring 120V can be used in the camper unit similar to a home. A 12V inverter can power other appliances requiring that amount of energy. Battery disconnect switch ([Image 6](#)) can turn off the power supply for the unit when power is not required.

The stove’s gas valve knob was observed in the on position and turned off, and windows were being opened for ventilation. During this process, the master switch was re-engaged to restore power for lighting ([Image 6](#)). This likely introduced an ignition source. The gas ignited, causing an explosion and damage ([Image 7](#), [Image 8](#), and [Image 9](#)).

Analysis of the incident power switch compared to one in an exemplar camper revealed the direction of the subject switch was likely positioned neither fully "on" nor "off."

Image 6 – Inside camper where battery switch is located (reachable from inside and outside camper door).

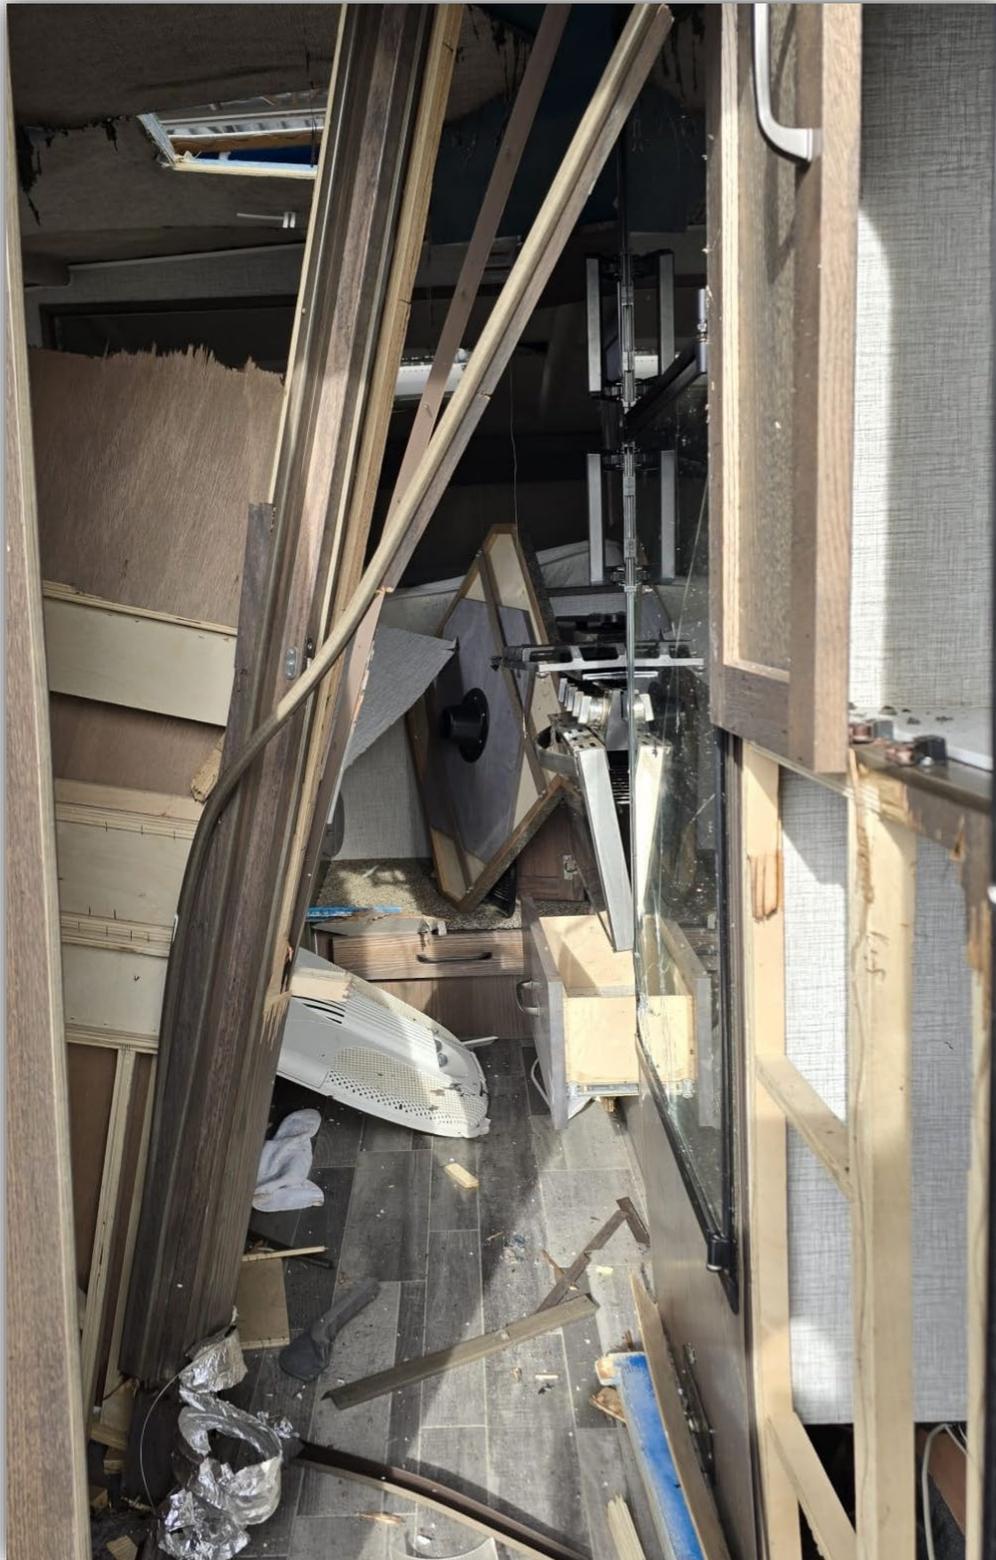
The gas valve knobs are positioned facing forward, creating a potential hazard during activities conducted in the confined space surrounding the stove. Tasks such as mattress replacement ([Image 5](#)) may result in inadvertent contact with the knobs. Even minor pressure combined with rotational movement can unintentionally engage the valve, releasing propane when the stove is not in use, but propane is left on.

Image 7 – Damage after explosion. Limited walkway where the stove is visible. The mattress can be seen at the back.

- The stove knob was likely inadvertently turned on the night before when moving a mattress resulting in the release of propane.
- Despite written posted instructions staff did not check stove was off before leaving.
- A stove design which placed the knobs in a high traffic area and allows for easy depression and inadvertent activation.
- Wiring of the propane gas alarm through the battery disconnect, with no battery backup which deactivated the propane gas alarm when the master switch was turned off.
- The decision by staff to enter the camper after smelling a strong smell of propane, despite being trained not to do so.

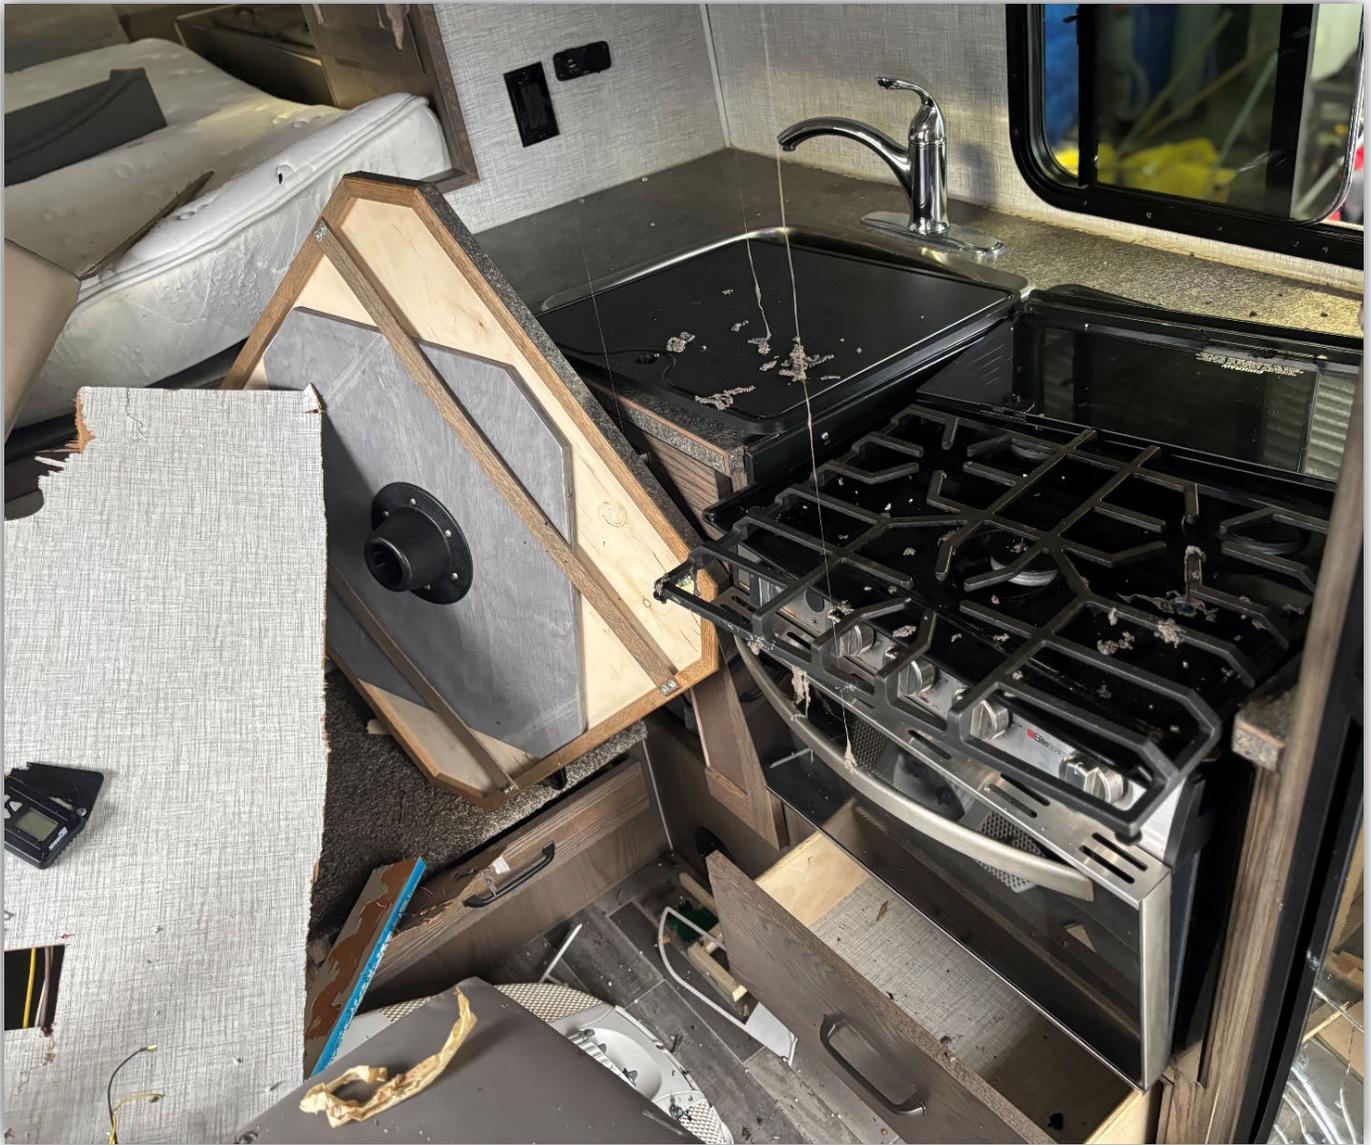
Image 8 – Damage and debris. Stove knob positioning is visible under the stove grate.

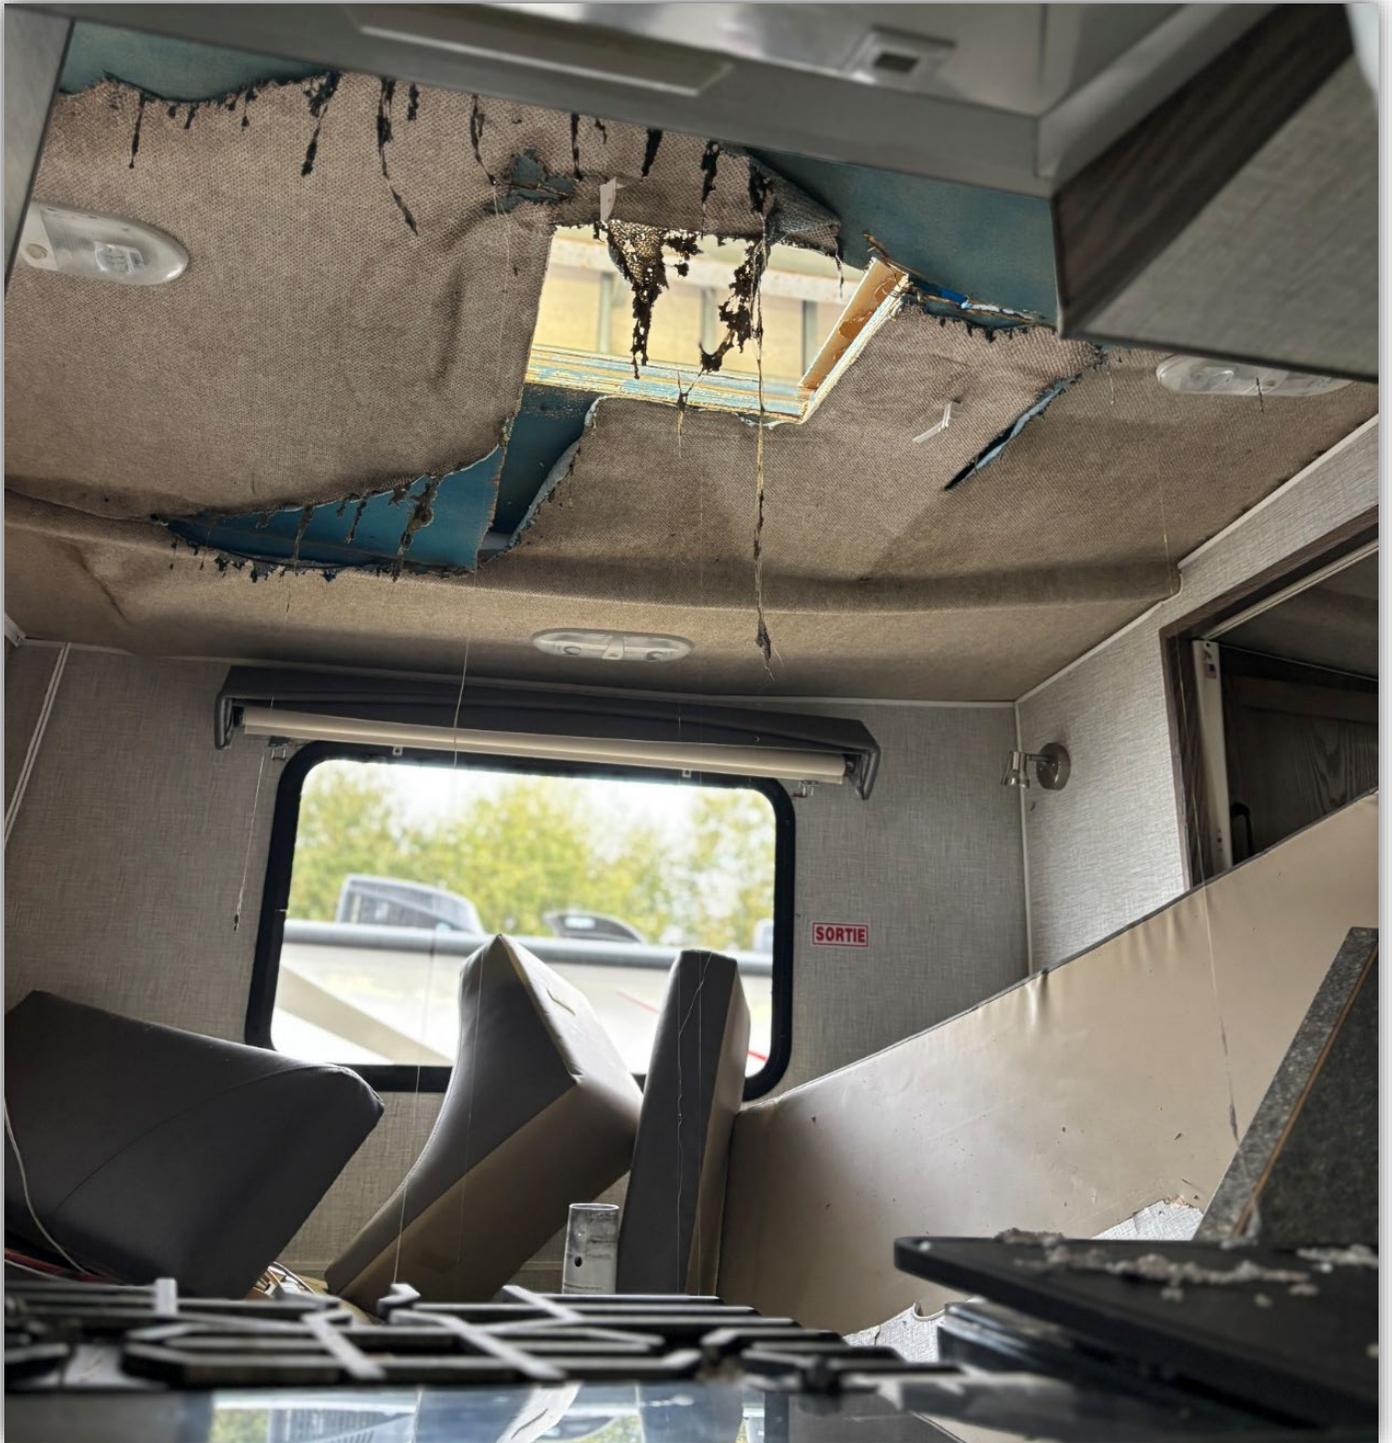
Image 9 – Damage to ceiling.
