## Incident Summary (Reference # 7296-II 690544-2018) (Final)

| | Regulated industry sector | | Gas Propane System | |
| Incident overview | | There was an explosion within the mechanical room of a day lodge, which resulted in property, building and the air handling unit itself being damaged. | | |

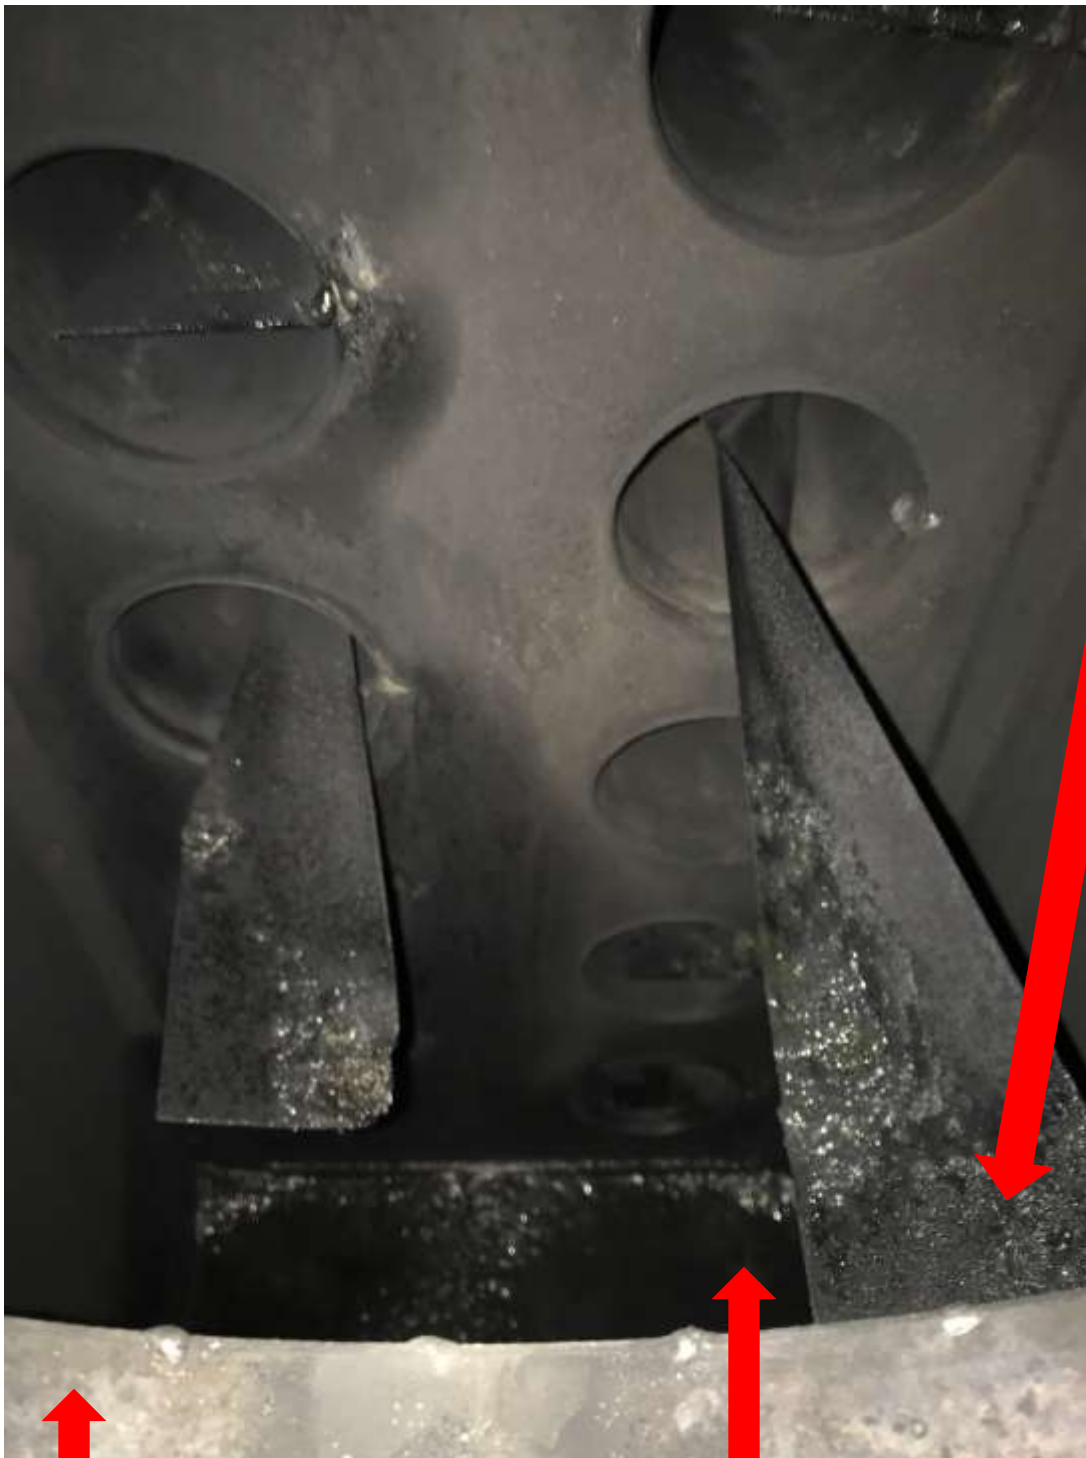
Baffle dislodged and  
pushed towards the flue  
collar

Bottom of the flue collar

Carbon buildup indicating poor combustion

- There was a lot of soot in and around the air handling unit itself indicating poor combustion (incorrect mixture of gas and air which makes a flame that craters in part excessive soot) within the air handling unit.
- The outer portion of the burner tube was discolored due to heat exposure proving a flame was present where a flame was not designed to be.
- When taking the burner apart the insulated wire from the flame sensor had been damaged. The insulation had been melted and the exposed wire was stuck to the grounded portion of the burner.

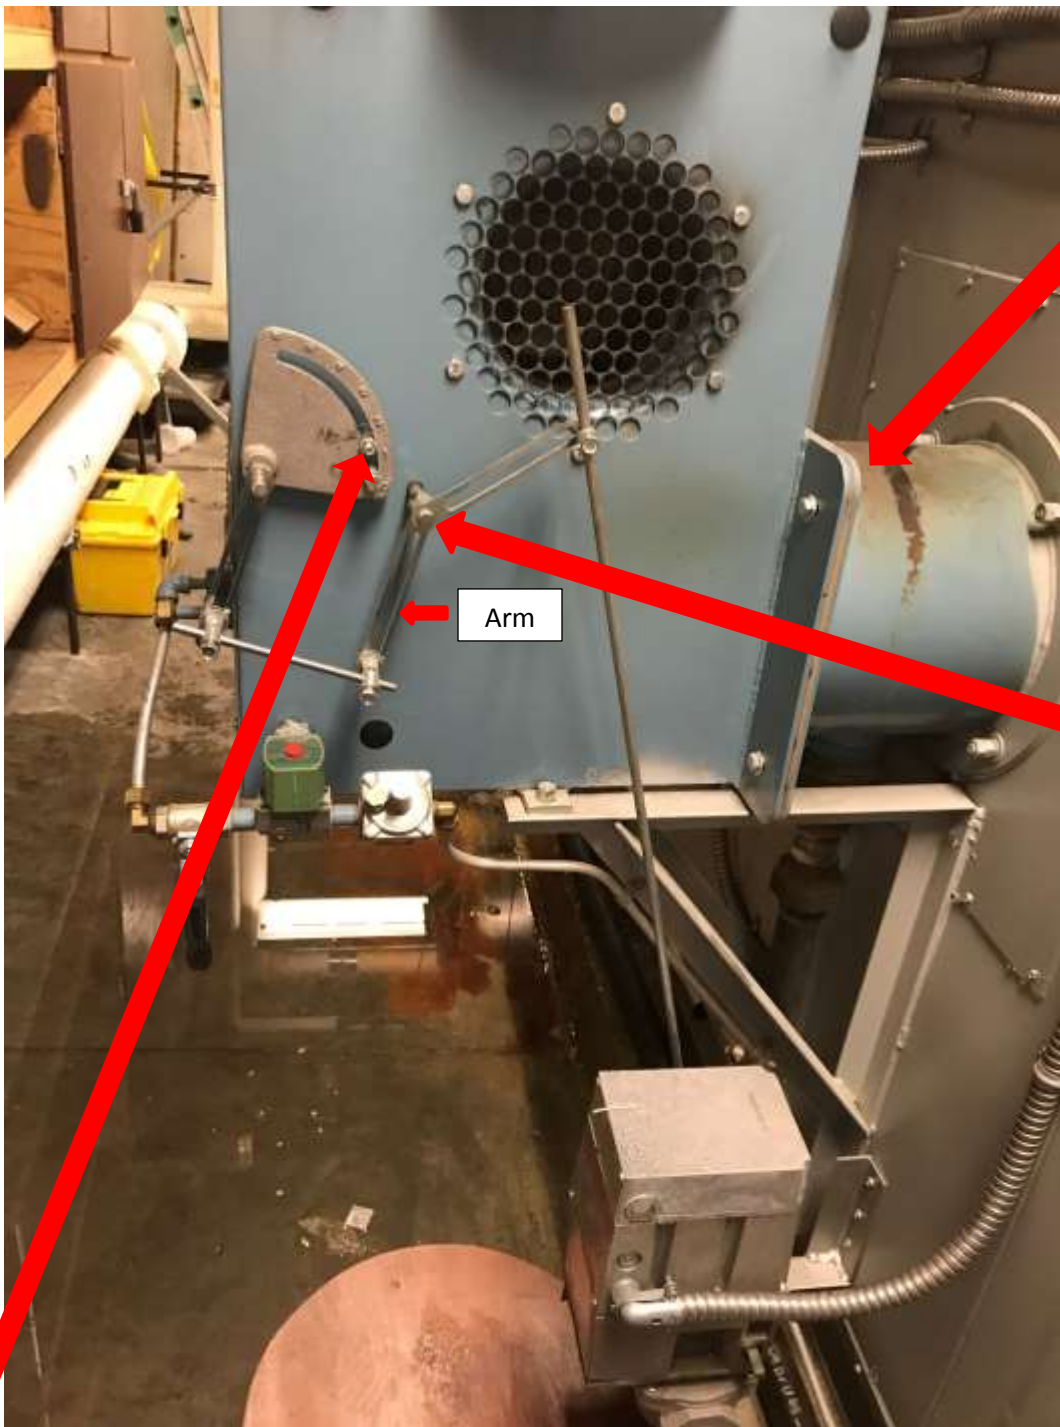
Discoloration on the outside of the burner indicating a flame was inside this portion of the burner which was not designed for a flame.

This Joint is loose reducing the movement of the arm to the air shutter causing incorrect gas air mixture ratio for good combustion and safe ignition

This nut impaired the free movement of the air shutter also increasing the incorrect gas air mixture ratio for good combustion and safe ignition

- Physically moved the linkage from the actuator to the air damper and found a connecting rods set screw was loose reducing the air dampers movement, also a nut was binding the air damper further impeding the free movement of the air damper there by reducing the air delivered for the correct gas and air mixture to achieve a stable clean flame.

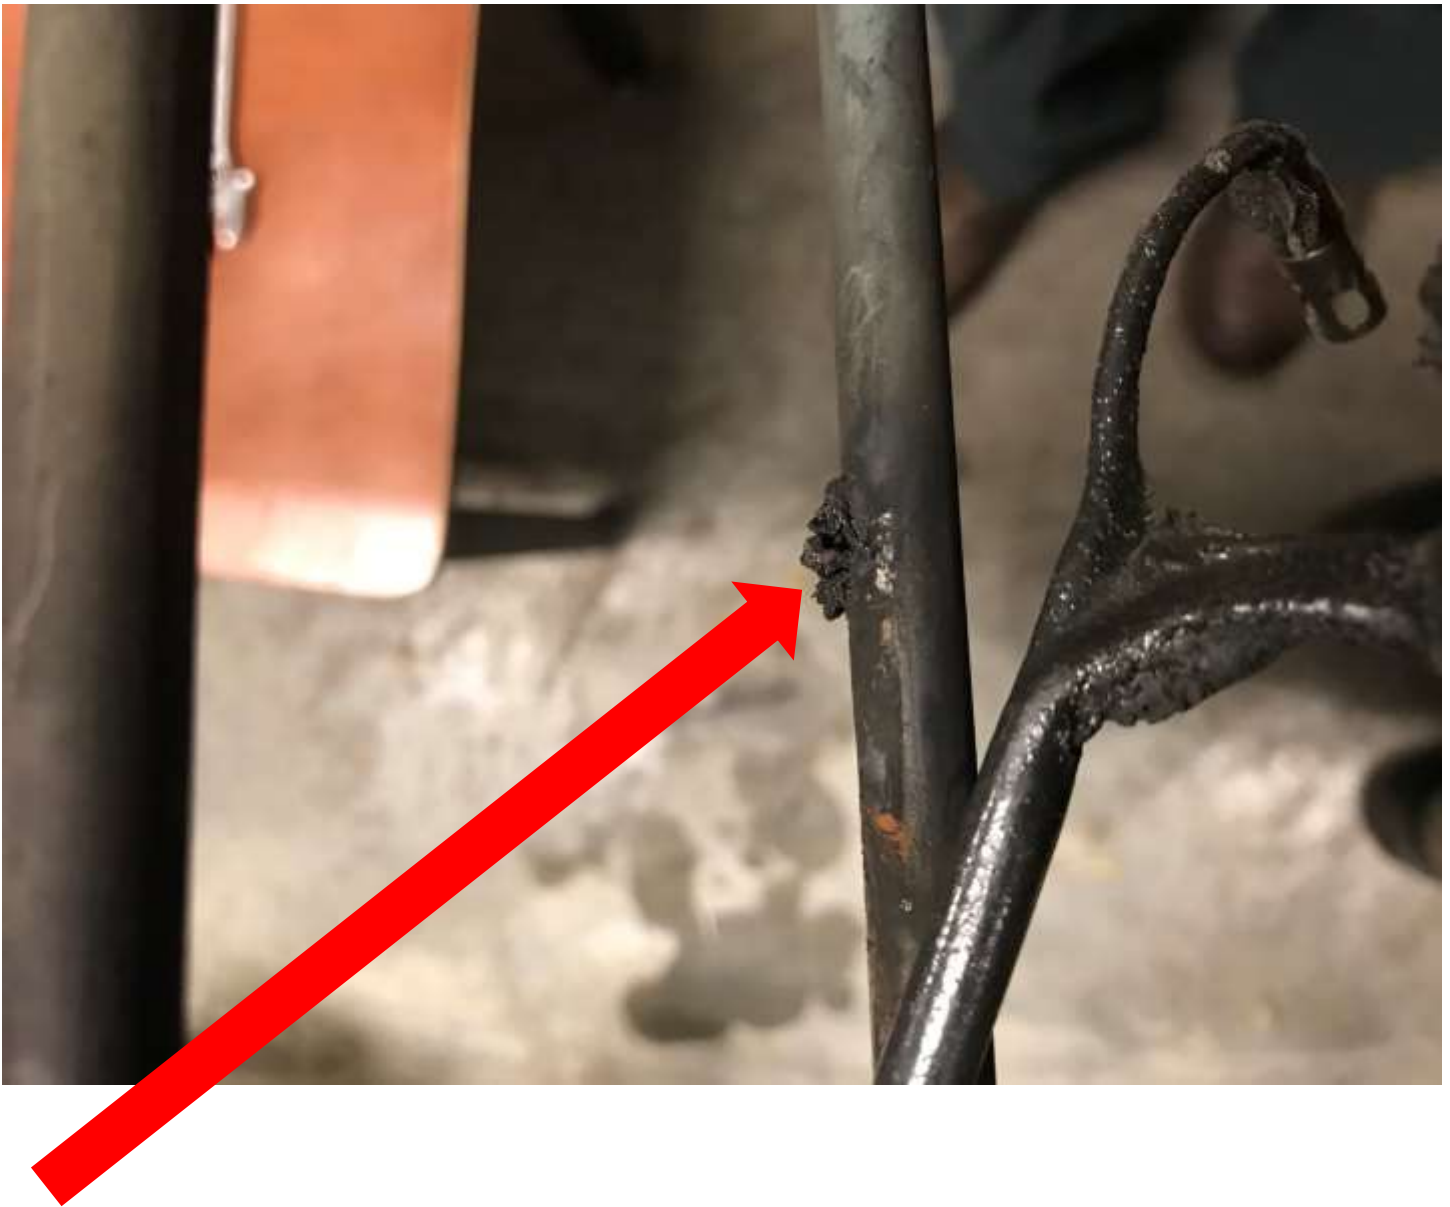
The residue shown here is where the sensor wire was attached to the support arm of the burner causing the ground fault with enough resistance to cause a false flame reading.

- On further observation of the defective sensor wire the proximity of the wire to the grounding surface allowed the controller to be fooled into sensing a flame where no flame was present.

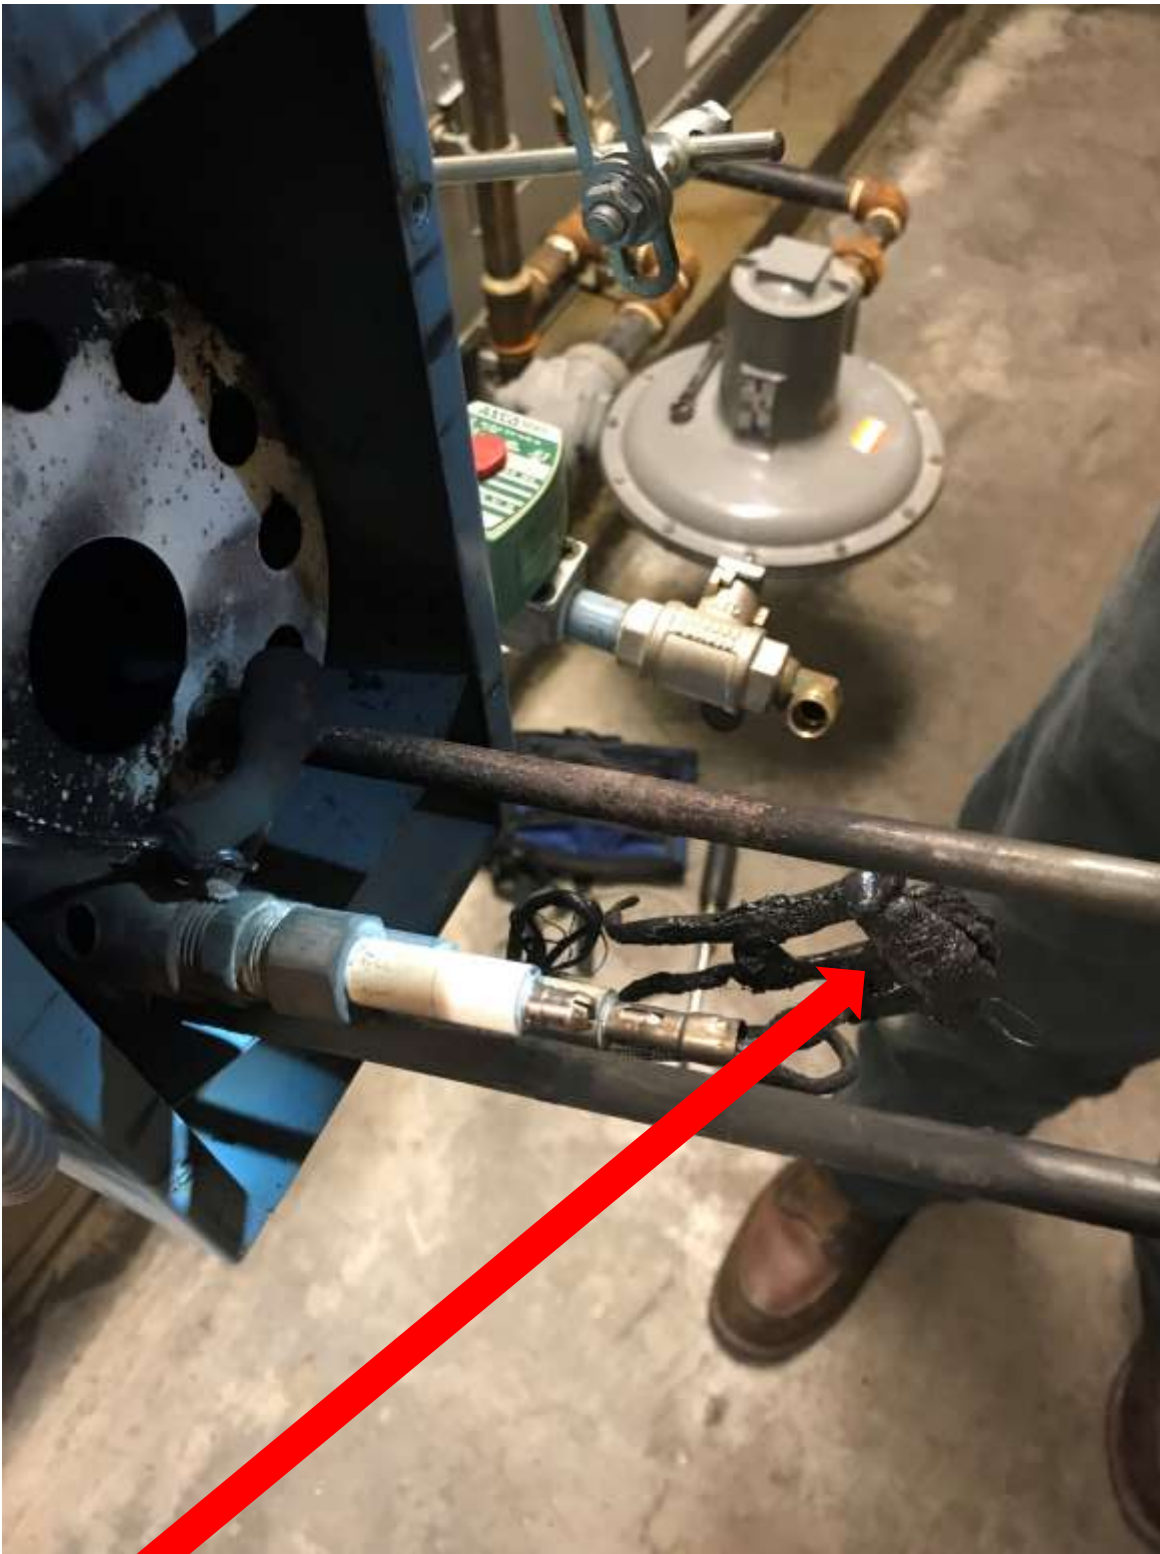
Burnt Electrical leads indicating flames present in an area where there should be no flames.

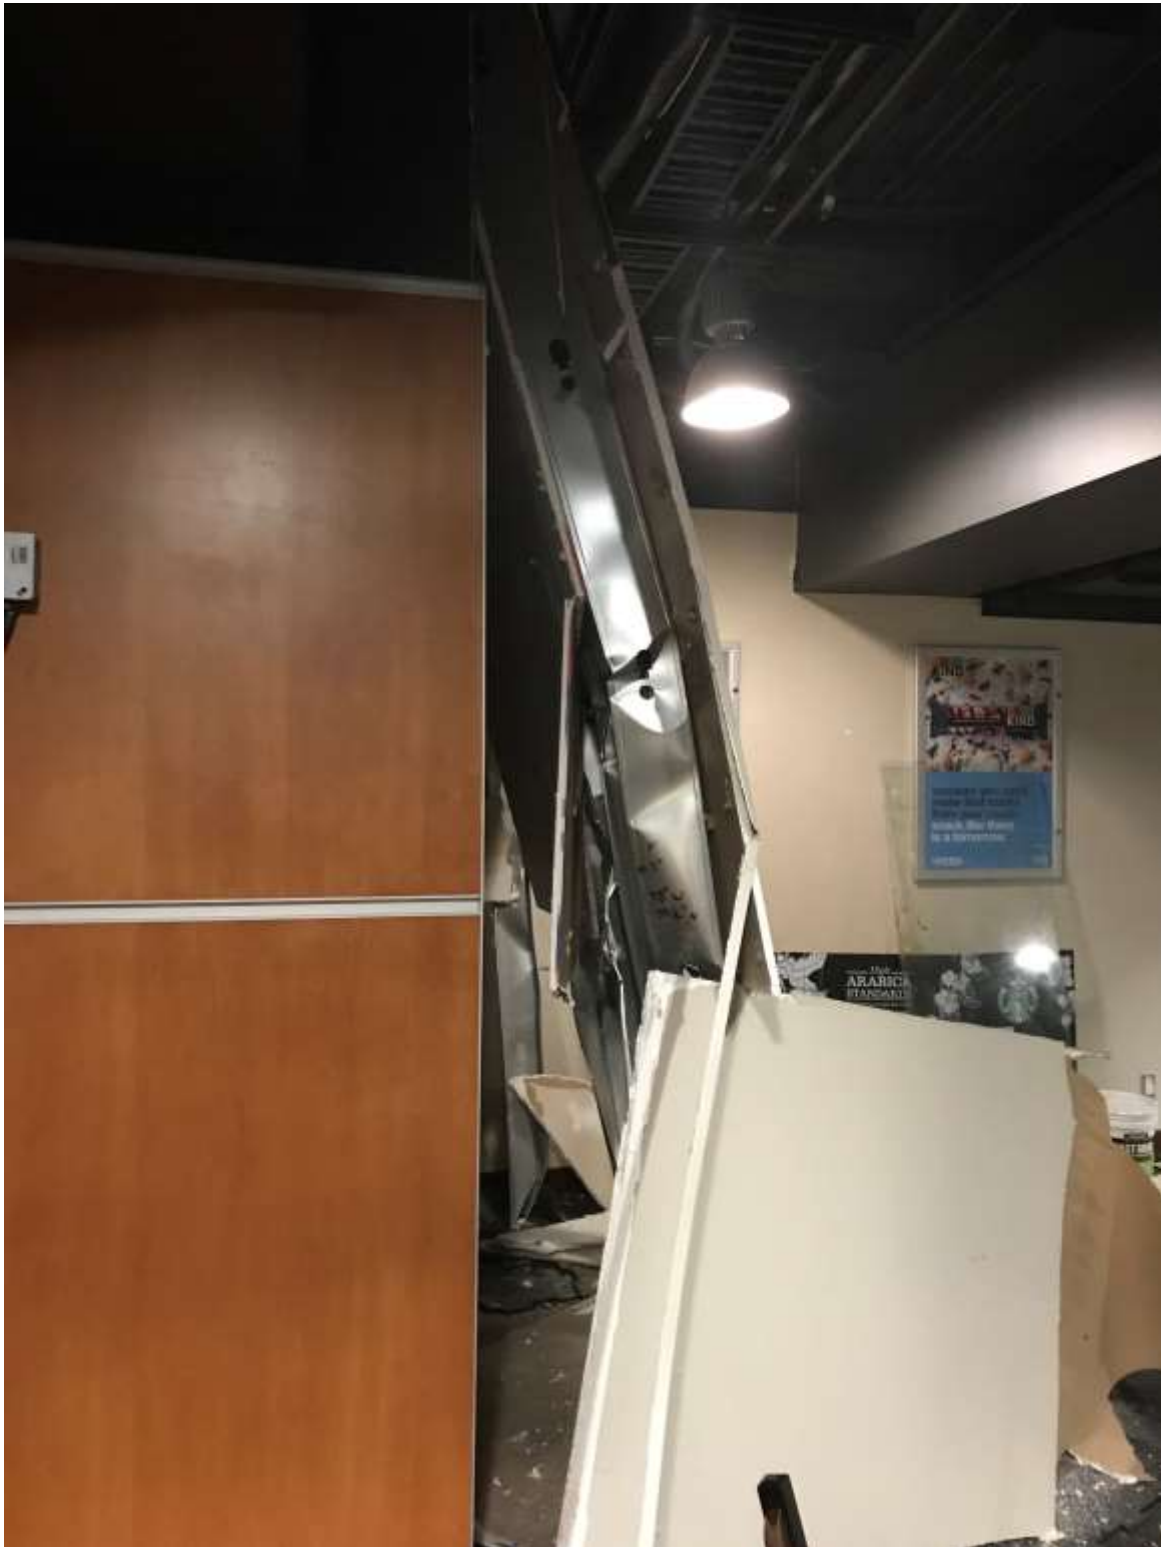
Damaged Internal Wall Side View

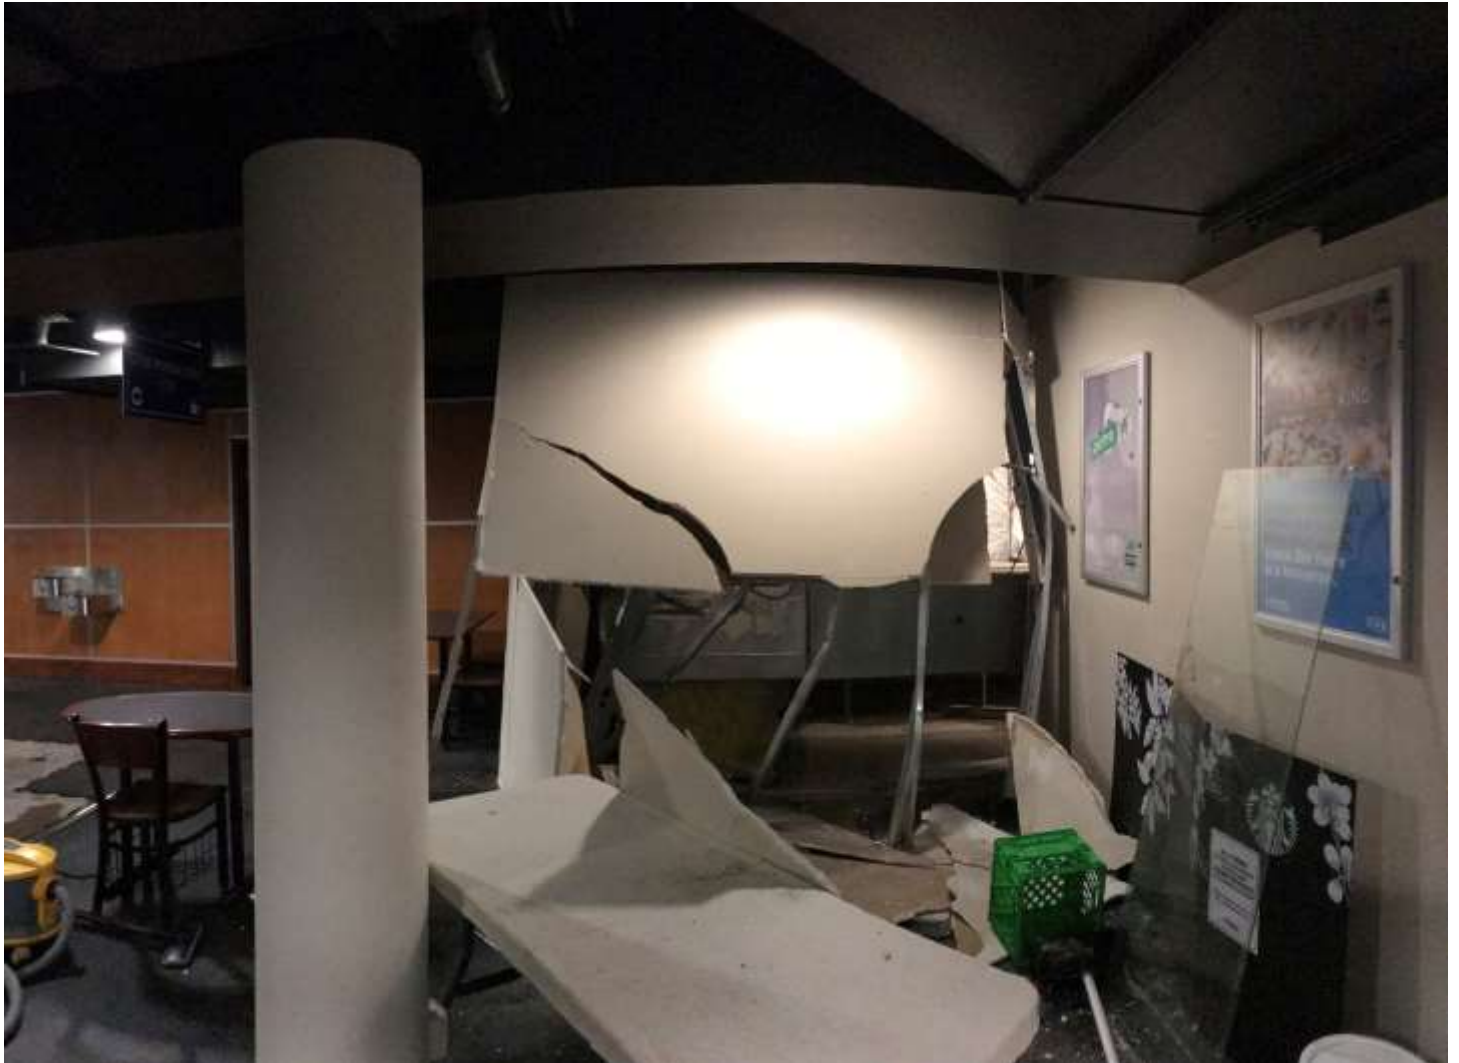
Damaged Internal Wall Front View

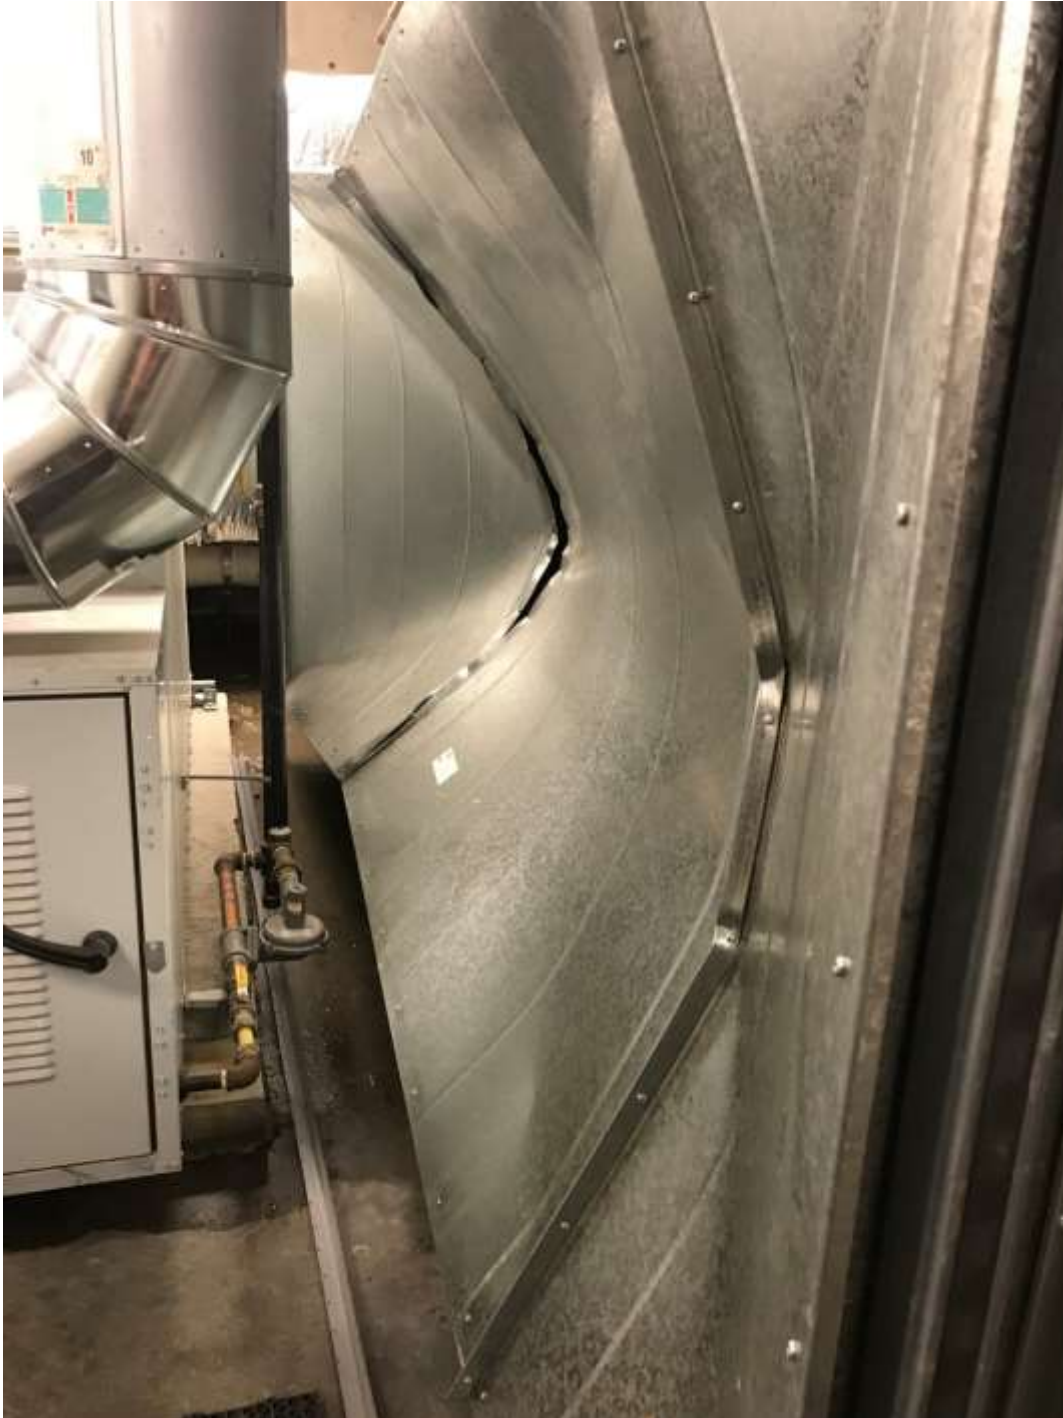
## Damaged Duct Work
