Incident Summary #II-1905302-2025 (#57438) (FINAL)

SUPPORTING INFORMATION	Incident Date		May 2, 2025
	Location		Victoria, BC
	Regulated industry sector		Gas - Natural gas system
	Injury	Qty injuries	0
		Injury description	N/A
		Injury rating	None
	Impact Damage	Damage description	A fire occurred burning a tree, bushes, the front window of a home, and the hydraulic hose casing of an excavator when a buried residential gas line was severed. Other Impacts: <ul style="list-style-type: none">Combined financial costs for some of the initial responders is reported at over \$25,000.Resources committed to the incident meant responses to any other emergencies were sent to mutual-aid partners to respond in the City of Victoria during that time.Gas utility company had one supervisor, eight employees, and two traffic control personnel responded to this incident.Street pavement was removed to cut off the gas supply upstream of the leak and subsequently needed to be repaired.Employees returned several times over two weeks.

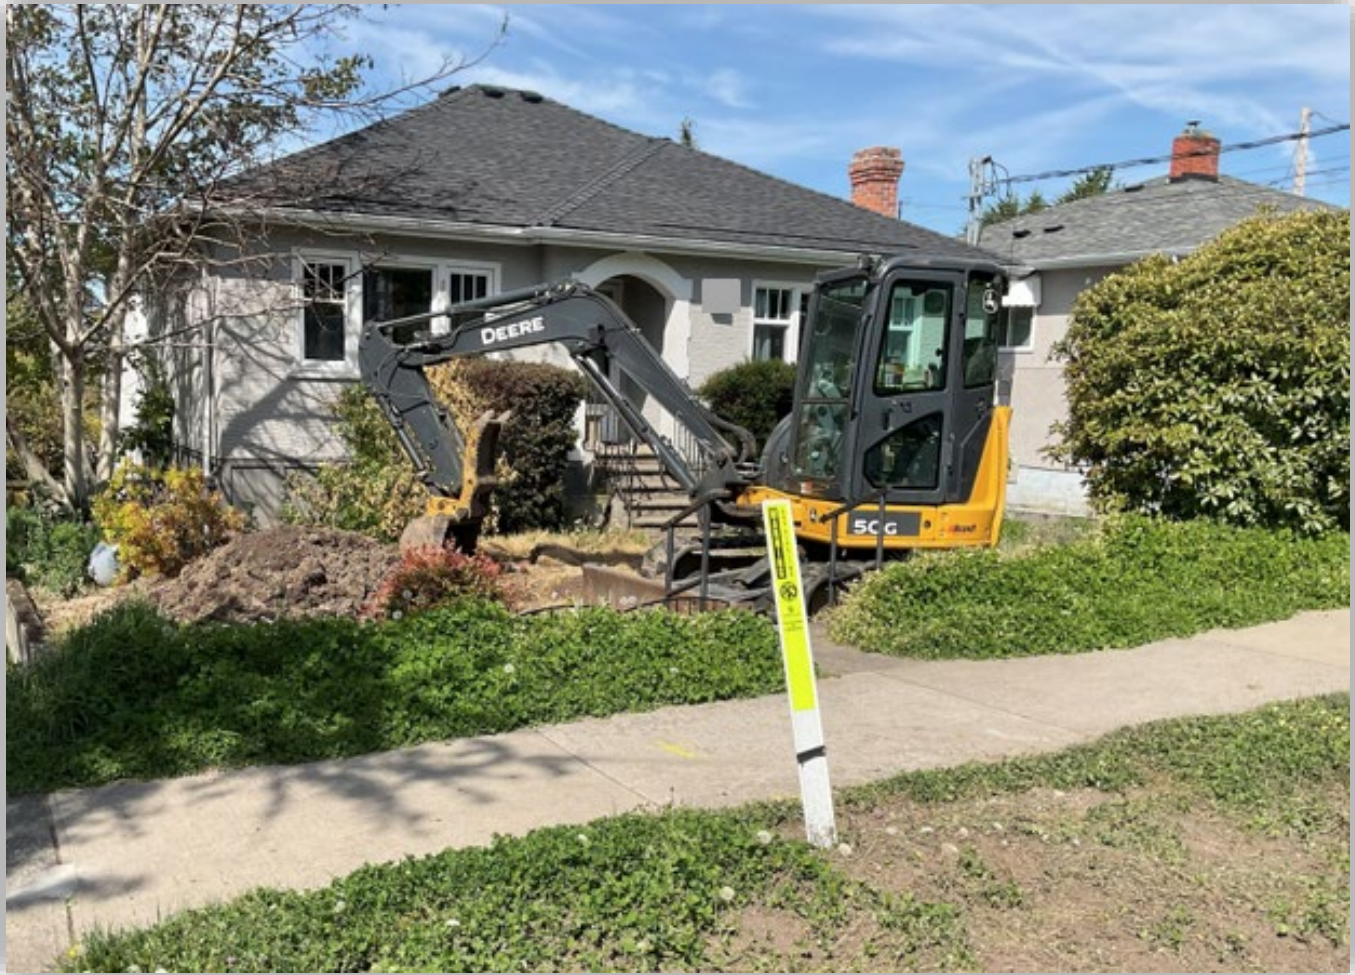
Image 1 – Excavator in the front yard of the home post incident.

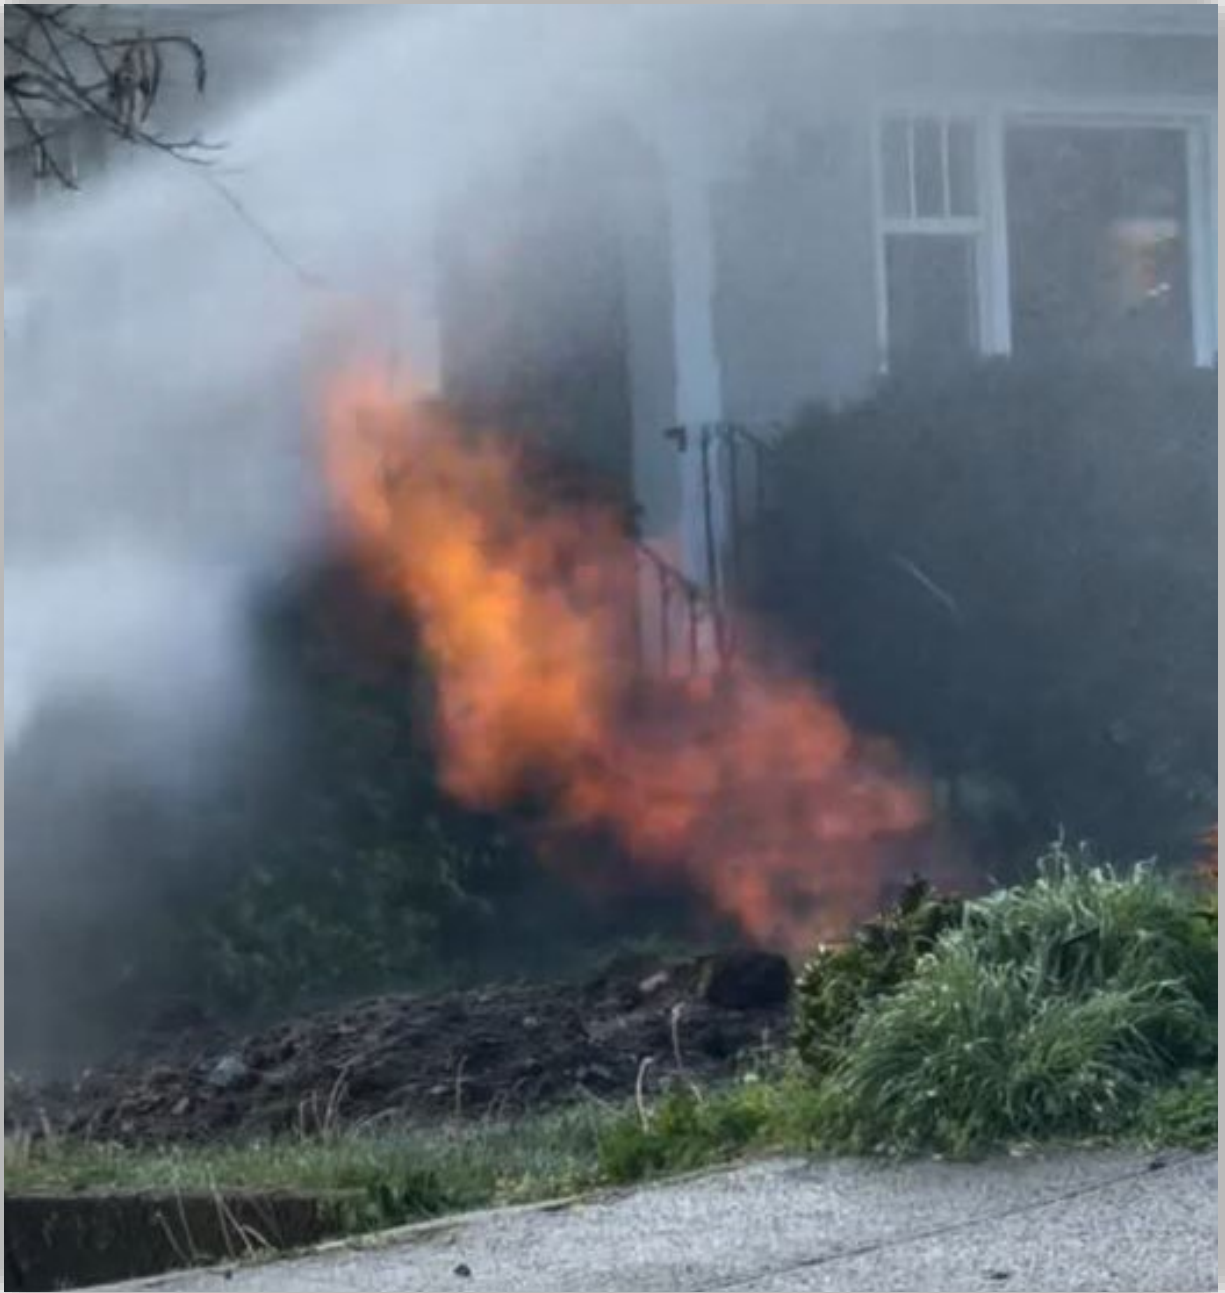
**Manners of excavation that are considered dangerous are not defined in the Regulation. See attached fire resulting from this incident ([Image 2](#)).*

Image 2 - Flames after gas line strike at the residential home.

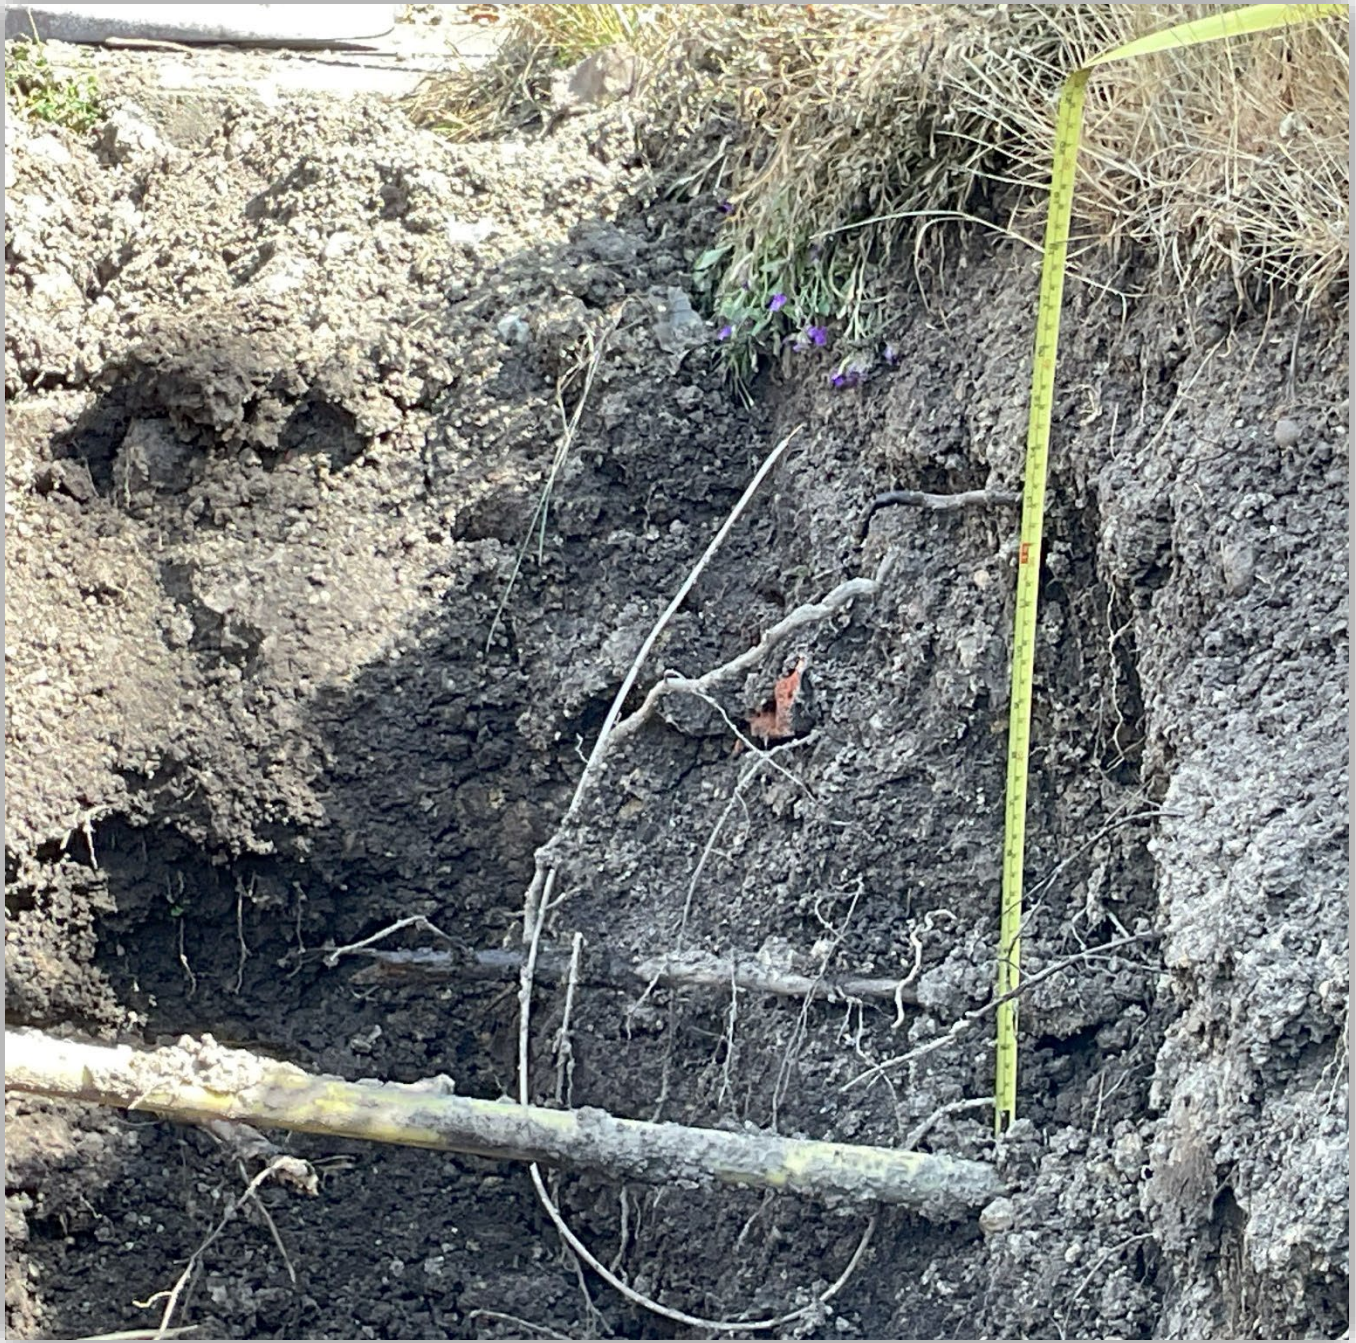
The Gas line at the location that was contacted was approximately 22 inches below grade ([Image 2](#)).

Image 3 - Gas line to surface to depth (22 inches) measured at location post gas line strike.

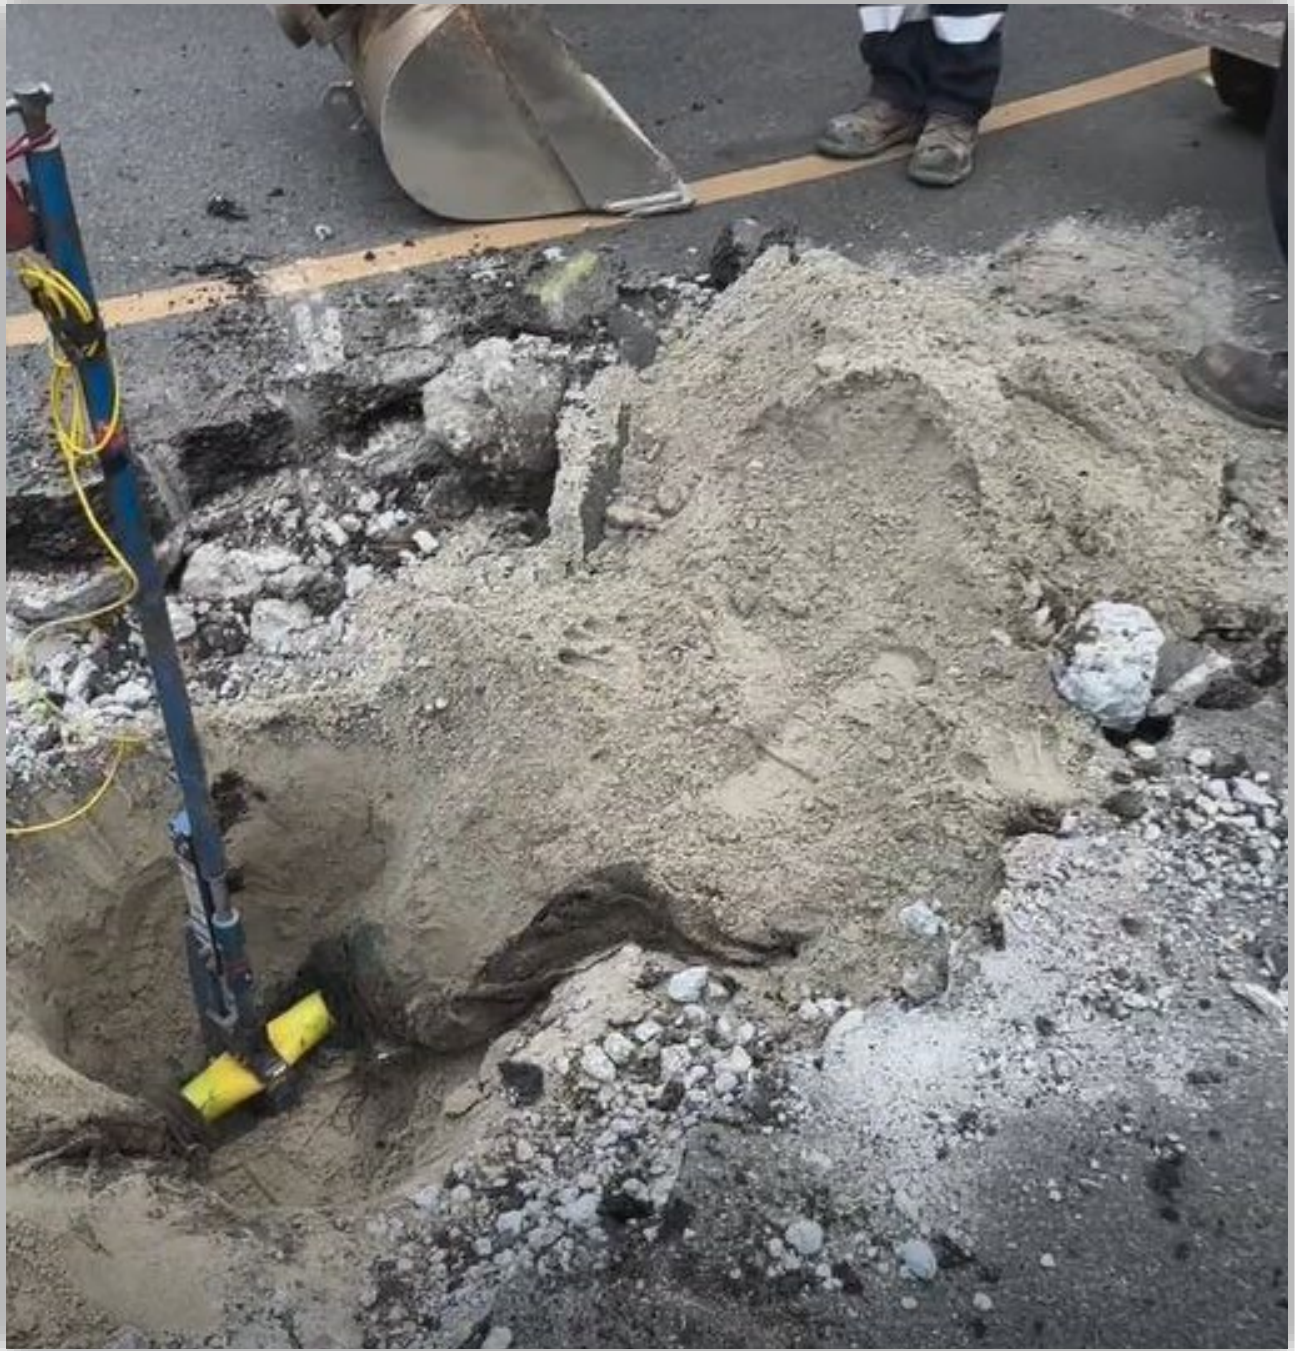
The gas line was capped at the street with service removed from the property.

Image 4 - Post incident gas line clamped off at street by Fortis.

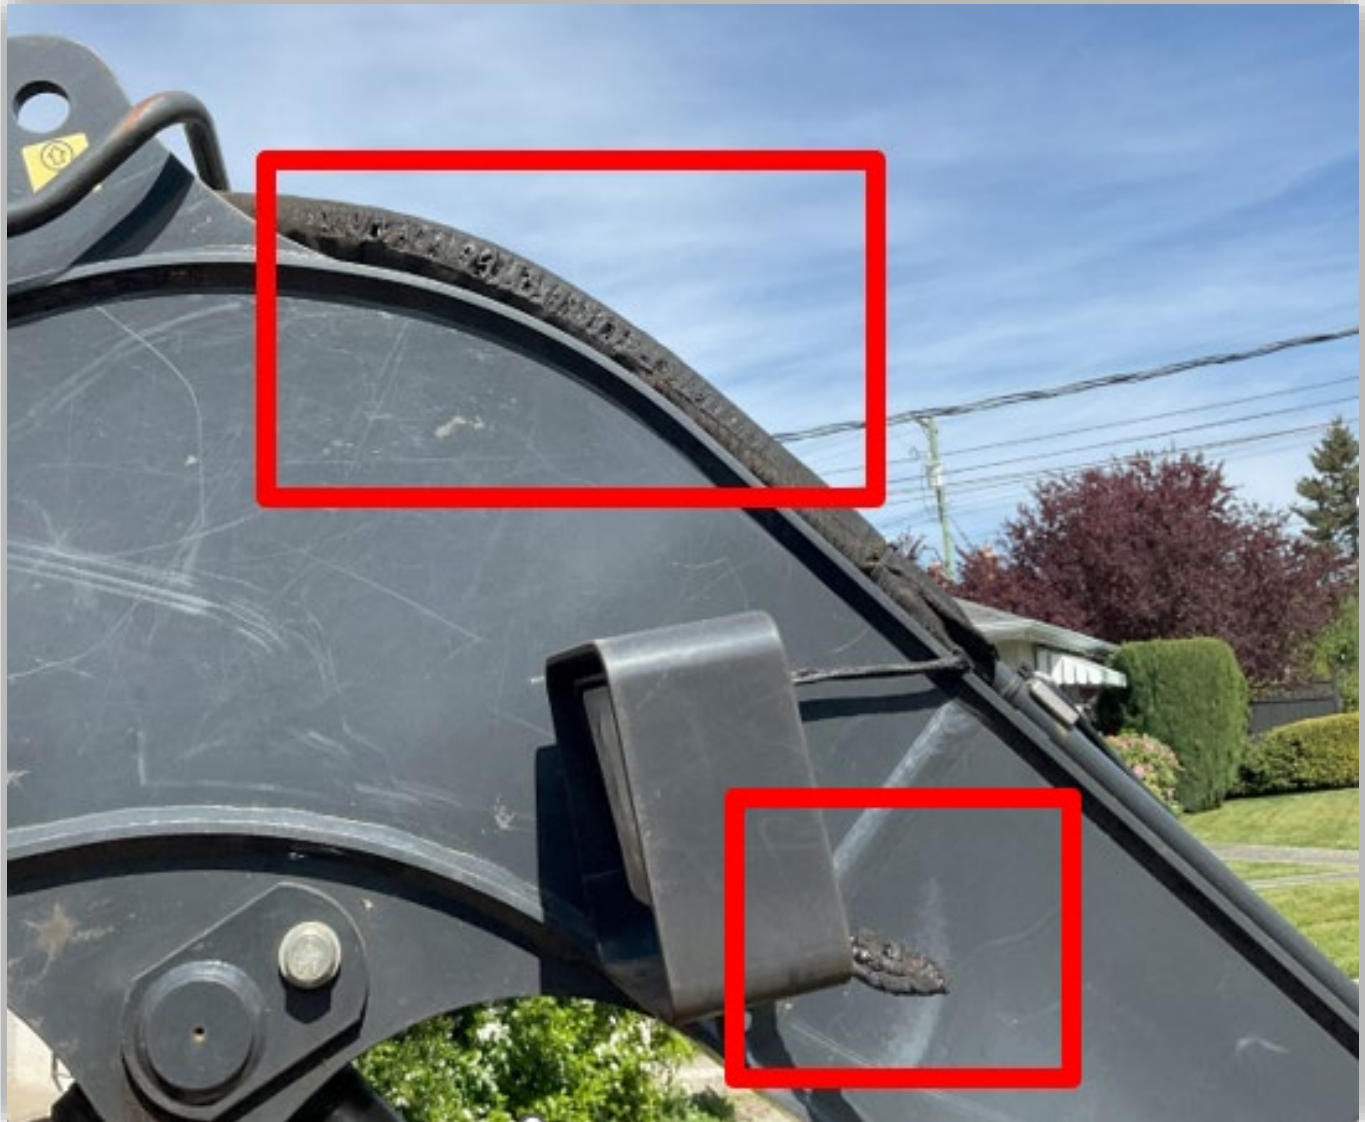
The owner stated they believed that the gas line was not in the area that they intended to use this excavator in, as they believed it ran on an angle from the second hole. After completing hand digging, they utilized the excavator and shortly after hit the underground gas line in the second hole near the street and gas escaped to the atmosphere. They jumped out of the excavator and ran to the tenant's front door to advise the tenant to leave the home immediately and at roughly the same time, the gas escaping ignited. The owner then ran back to the excavator and moved it from the area out of the flame to prevent further damage to his excavator ([Image 5](#)).

Damage that occurred by the fire was limited to a tree, bushes at the front of the home, the front window of the home and hydraulic hose casing located on the excavator.

Image 5 – Excavator arm showing hydraulic and electrical lines damage from the fire.
