## Incident Summary (#5619277)

| | Regulated industry sector | | | Natural Gas system |

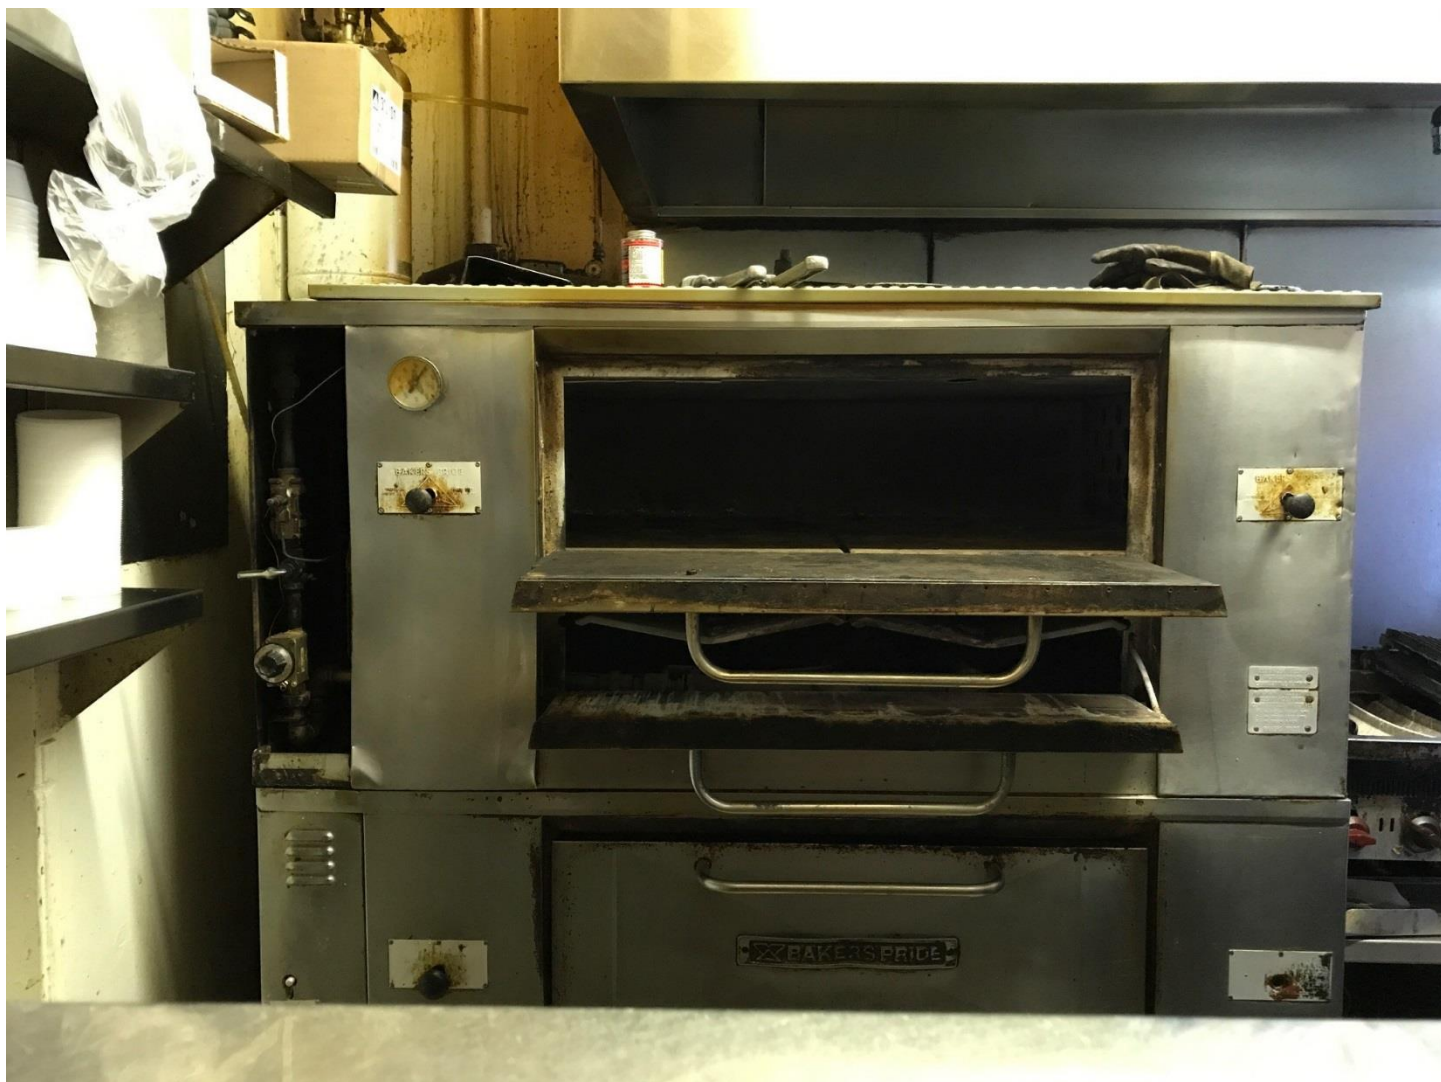
| | Facts and evidence | | | Upon testing it was determined that the gas valve had failed in the open position. The oven was tested and the scenario described above was replicated, indicating that the failed gas valve was indeed the cause of the incident. Upon removal the gas valve was found to be stuck in the open position, which would allow the flow of gas without a safety pilot flame. |
| | Causes and contributing factors | | | The likely cause of the fire/explosion is the failed oven gas valve which allowed an uncontrolled volume of gas to enter and accumulate in the oven combustion chamber which in turn ignited when the oven door was opened and the accumulated gas found a source of ignition. The age of the oven and gas valve likely contributed to the failure. |

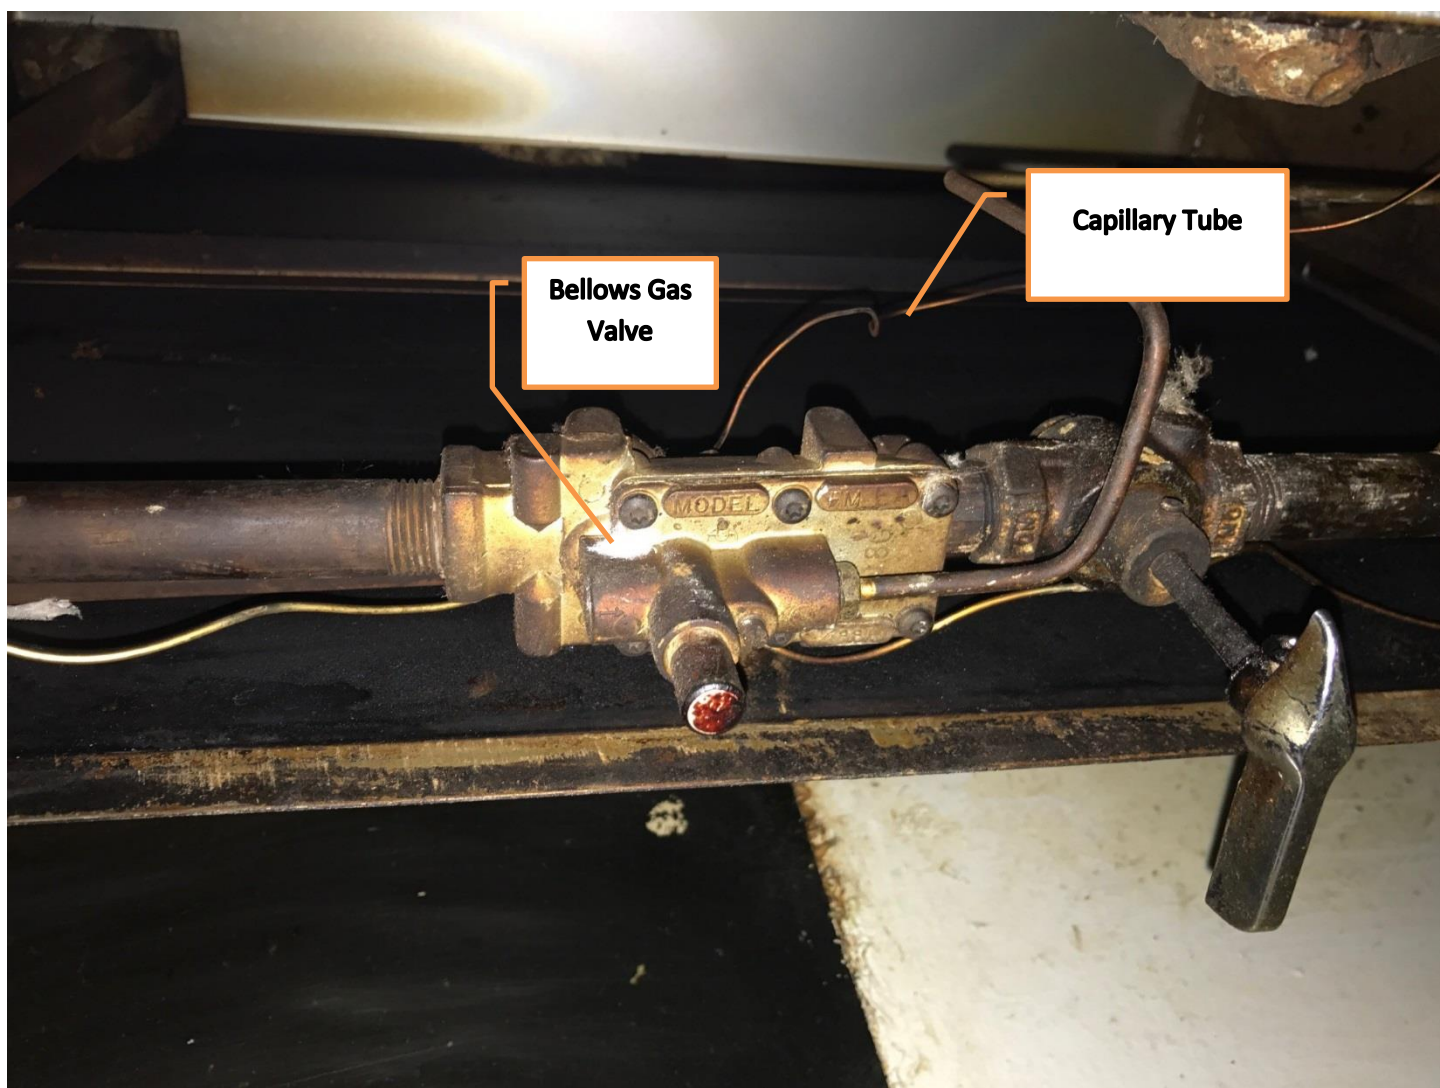
**Temperature Dial**

| INVESTIGATION CONCLUSIONS | Site, system and components | | | <p>In normal operation the gas valve will remain closed unless a standing pilot flame is detected and the oven temperature dial is engaged. Once the temperature dial is engaged, the gas will flow through the valve and ignite via the standing pilot flame and supply gas to the main burner. If the pilot flame is absent the gas valve will remain closed.</p> <p>The gas valve itself operates with a standing pilot flame that is sensed via a capillary tube that expands and contracts with heat. This type of gas valve is referred to as a bellows gas valve. When the capillary is heated via the pilot flame the medium expands, opening the gas valve. If the pilot flame extinguishes the medium within the capillary will contract and close the gas valve.</p> |
