## Incident Summary (Reference # 5611298)

| | Incident overview | | A gas valve serving a large hydronic boiler failed (stuck) in the open position, bypassing the systems electronic safety controls which caused an uncontrolled flow of gas to the boilers main burners. This condition allowed the boiler to overheat damaging the boiler supply and return piping system and boiler safety controls resulting in a release of steam and hot water into the boiler mechanical room. | |

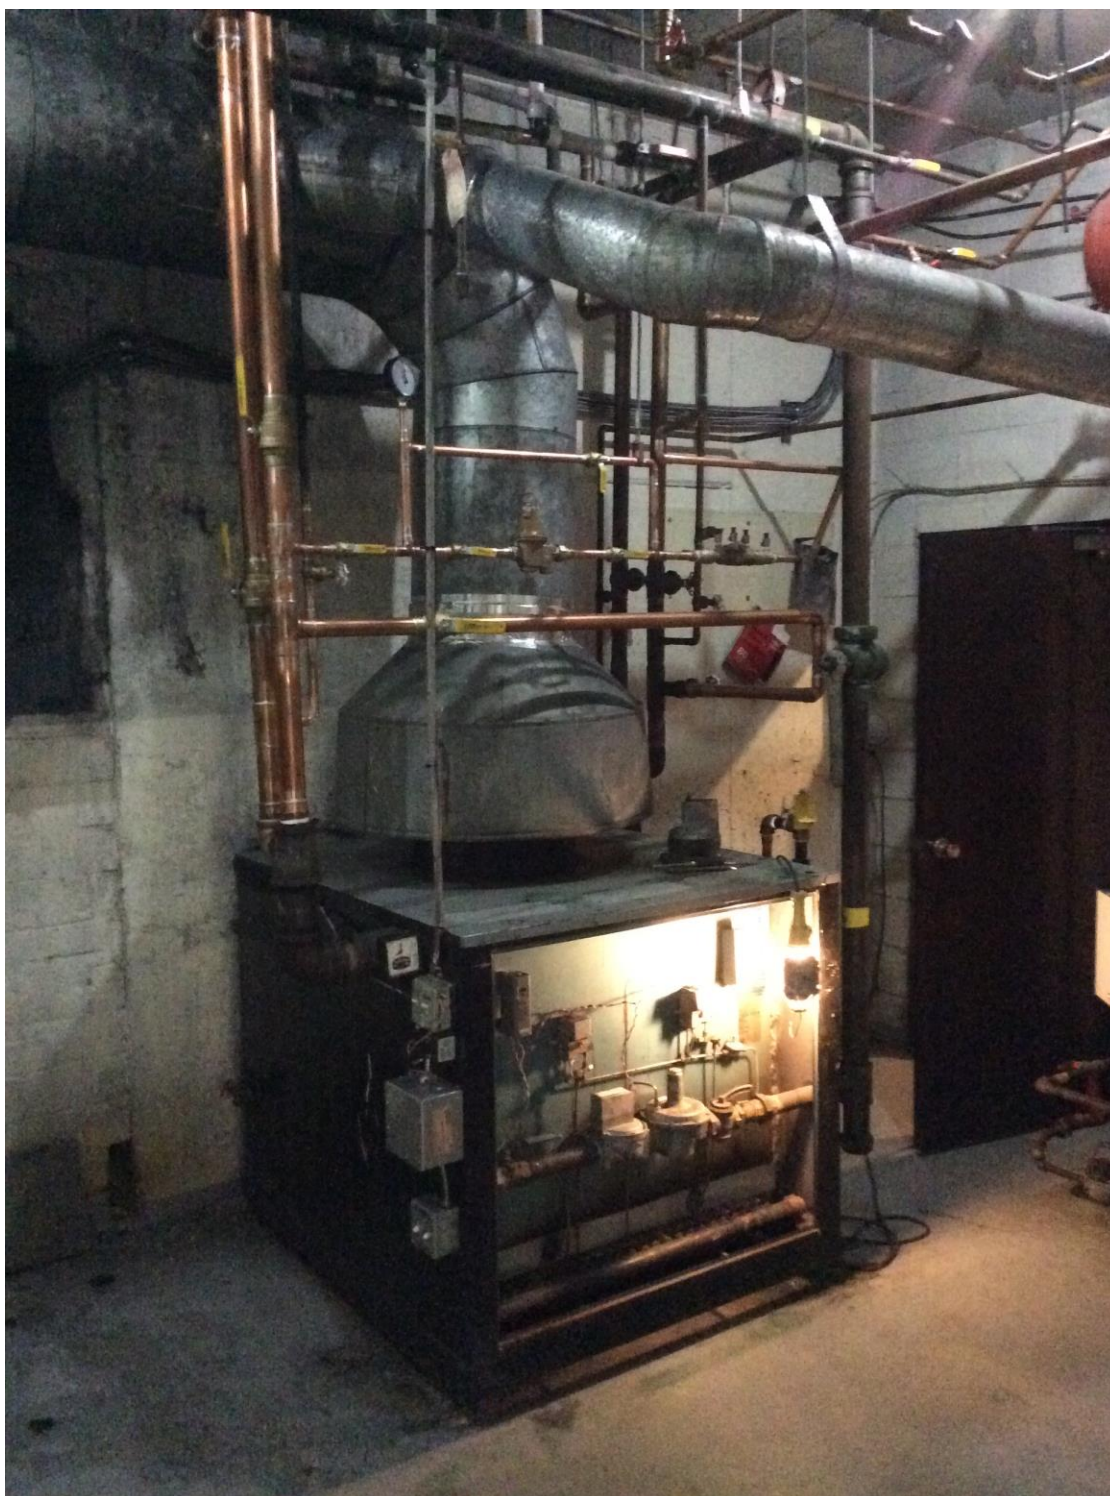
| re INVESTIGATION CONCLUSIONS | Site, system and components | | This boiler supplies the heating water to a multi-story residential buildings hydronic heating system. A circulating pump circulates water through the boiler, which is heated to the desired temperature (180 degrees F) and supplied to the heat emitters serving the buildings suites. The water temperature is controlled by a mechanical temperature sensor (aquastat) that controls power to the boilers single gas valve. The boiler utilizes a “standing pilot” type ignition system which maintains a small constant flame at all times in the combustion chamber, this flame is monitored by a thermocouple that will only allow gas to flow to the main burners if the standing pilot flame is present. | |

## Hydronic Heating Boiler

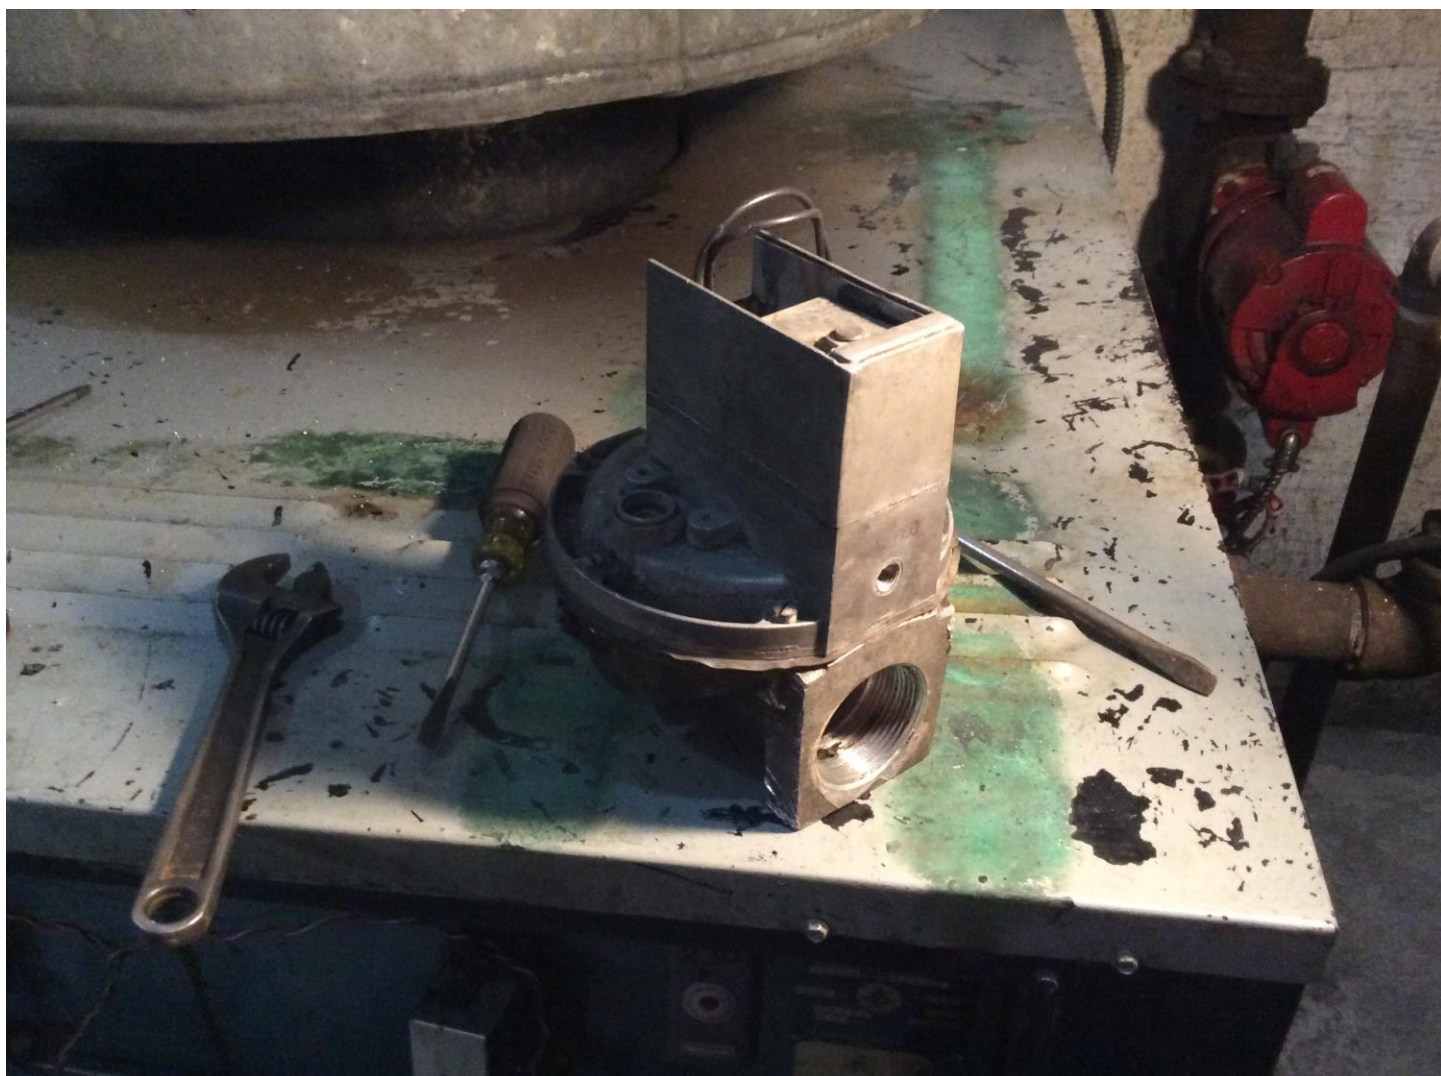
| | Facts and evidence | <ol style="list-style-type: none"> <li>1. The contractor who first attended the scene found that the boiler room was full of steam and the boiler was running. When he de-energized the boiler the unit continued to run even without electricity. In order to stop the flow of gas to the unit they had to close the manual gas shutoff valve.</li> <li>2. Upon removal and investigation of the failed gas valve it was found that the valve was stuck in the open position.</li> <li>3. After disassembling the valve it was found that the bleed port solenoid (plunger) shaft was stuck open and a buildup of fine metallic shavings were found within the solenoid.</li> </ol> |

## Diaphragm Gas Valve Stuck in the Open Position

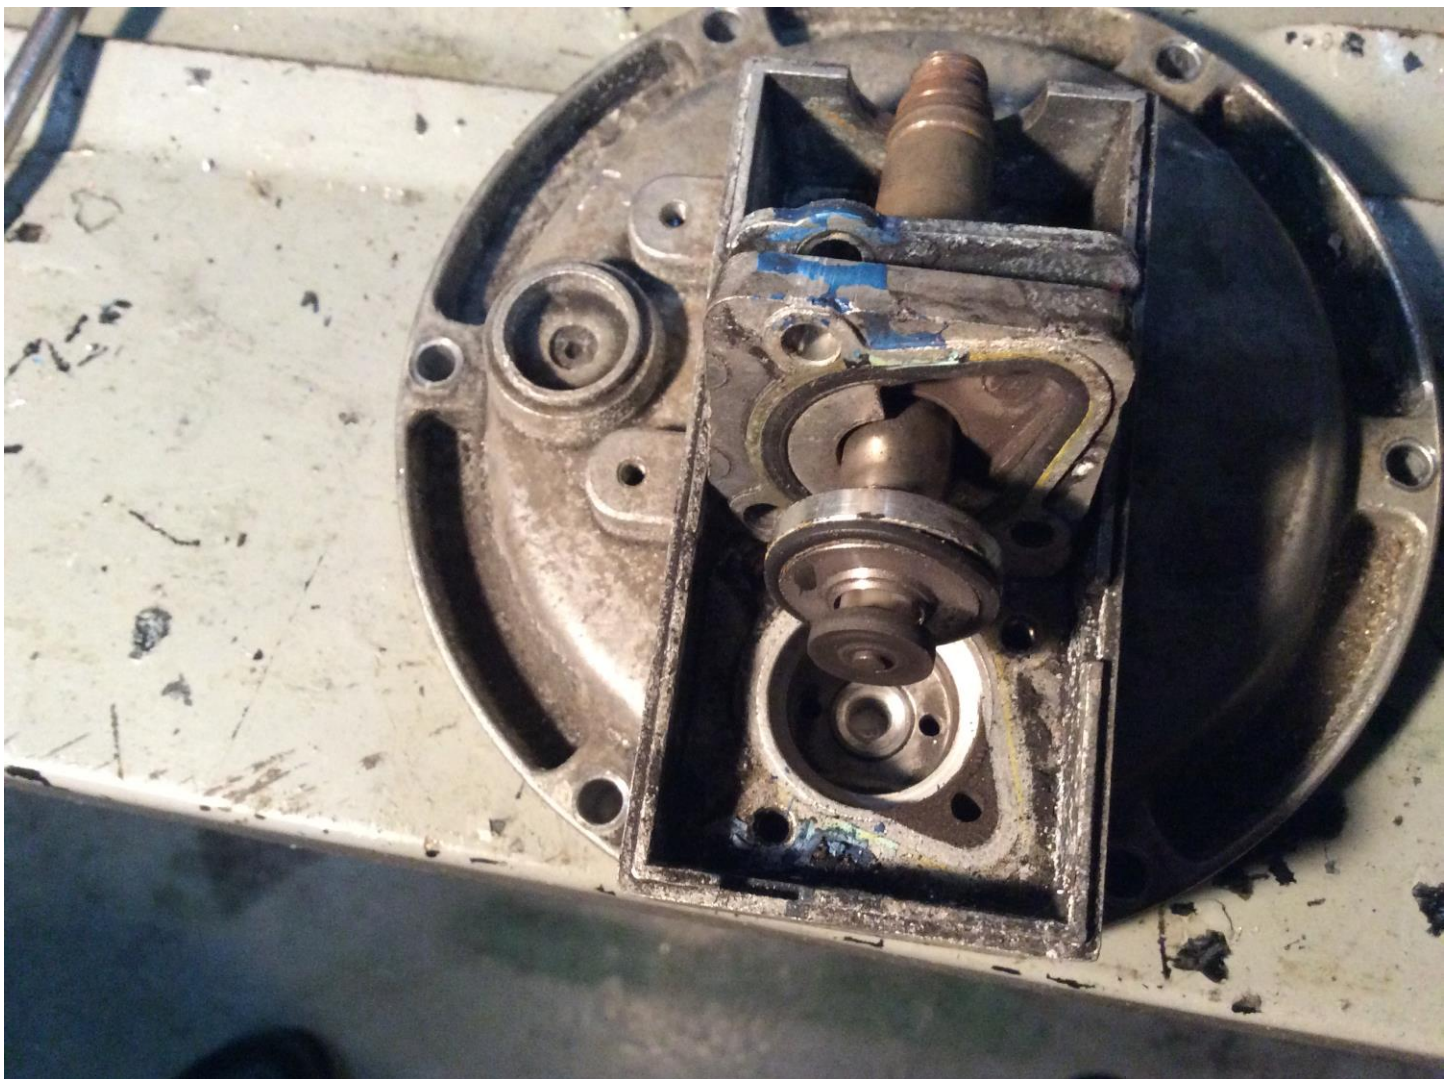
## Gas Valve Bleed Port Solenoid Disassembled
