## Incident Summary #II-1122963-2020 (#20292) (FINAL)

SUPPORTING INFORMATION	Incident Date		December 23, 2020	
	Location		Abbotsford	
	Regulated industry sector		Gas - Natural gas system	
	Impact	Injury	Qty injuries	0
			Injury description	N/A
			Injury rating	None
	Damage	Damage	Damage description	Major fire damage to a pigeon barn
			Damage rating	Major
	Incident rating		Major	
Incident overview		A gas fired water heater was turned on to circulate warm water through water lines in a barn to keep them from freezing during cold weather. Several hour later the barn was engulfed in flames.		
INVESTIGATION CONCLUSIONS	Site, system and components		This water heater burns natural gas that transfers heat to the water in the tank and then uses a pump to circulate this warm water throughout the barn to keep water lines from freezing. Areas where water heaters are installed and operating , need to remain free of heavy accumulations of dust , debris and other organic materials so that clean air can mix with natural gas to achieve a safe and controlled combustion process.

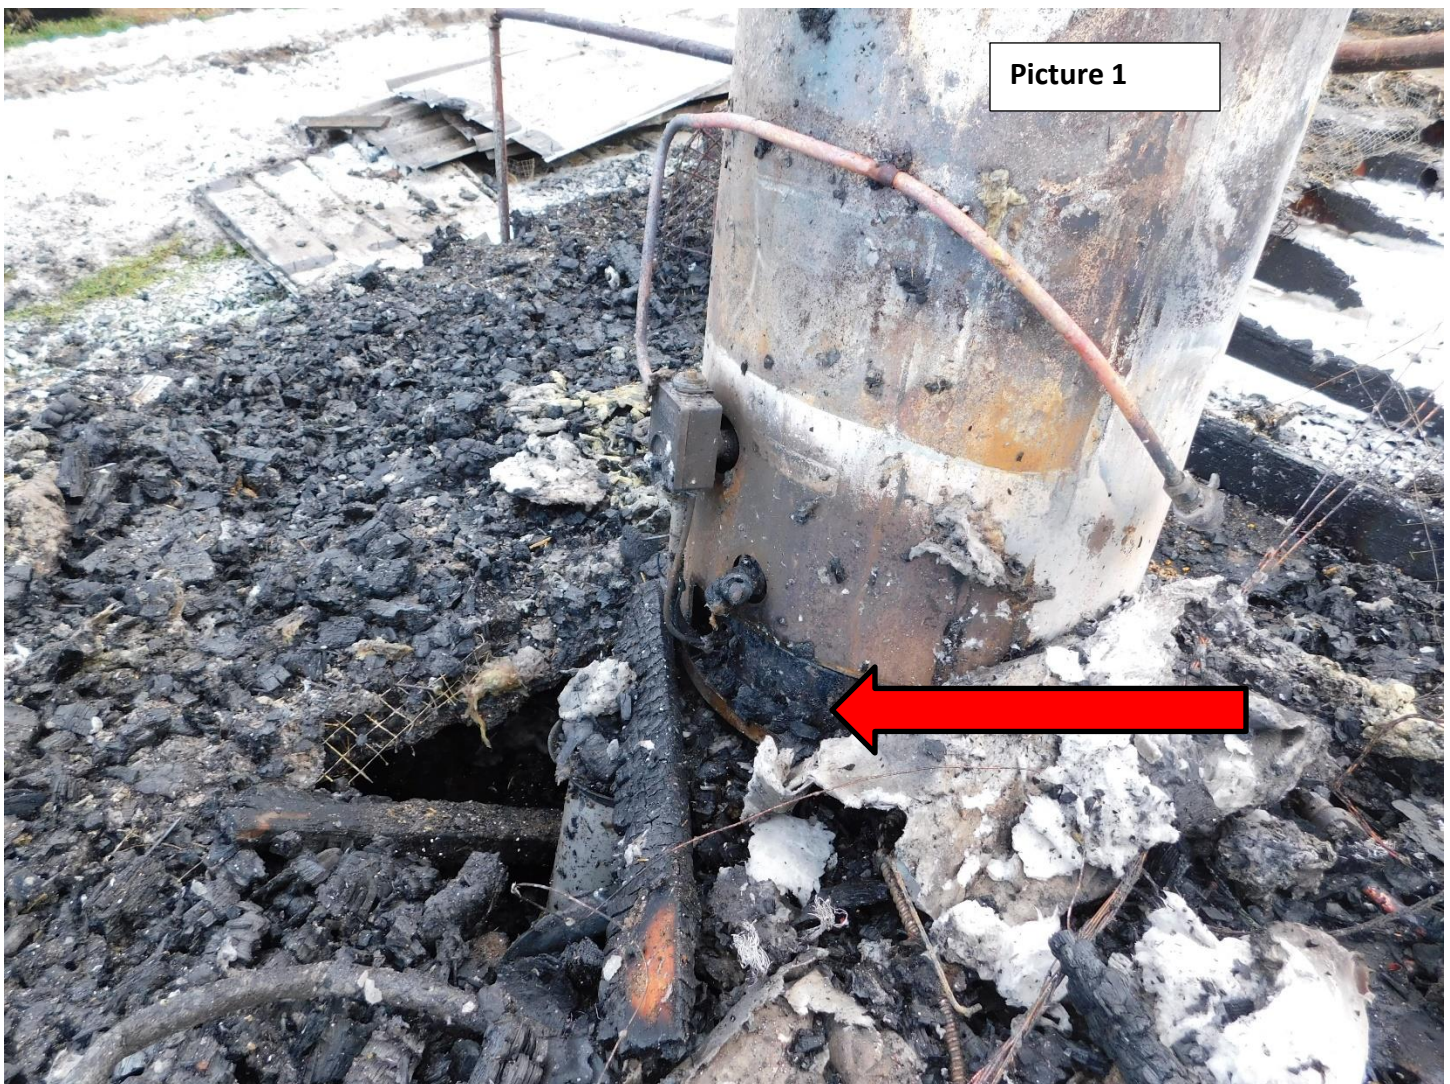
Water heater found in the barn that was destroyed. Burner compartment was closely examined and found to have a large accumulation of organic materials within. (Red arrow points toward burner compartment)

Failure scenario(s)		On December 22 <sup>nd</sup> 2020, the local area was experiencing snow and cold weather conditions. The owner went to the barn to turn on the water heater and begin circulating warm water throughout the barn around 4:30 PM . He did not notice anything unusual and left the water heater in operation. Early in the morning of Dec. 23 <sup>rd</sup> around 5 am, the fire was noticed and emergency services notified.	
	Facts and evidence		<p>-Owner reported that the water heater in the barn had not been turned on for approximately 1.5 months.</p> <p>-The fire department reported that the fire appeared to have started in the middle of the barn near the mechanical room and spread from there.</p> <p>-Private investigator reported the following:</p> <ul style="list-style-type: none"><li>-No evidence of electrical wiring issues or malfunction inside the barn.</li><li>-Hot water tank was closely examined and found to have large accumulations of burned organic materials inside the burner compartment. Likely nesting materials brought into the burner compartment by rodents. (see picture 1)</li><li>-Venting showed signs of heavy carbon deposits, suggesting an issue with the operation of the water heater or the burning of organic materials causing smoke deposits/ carbon inside the venting.</li><li>-Venting did not appear to have contacted combustible surfaces prior to the incident.</li><li>-No records to indicate if the water heater room or burner compartment had been cleaned or checked by anyone.</li></ul>

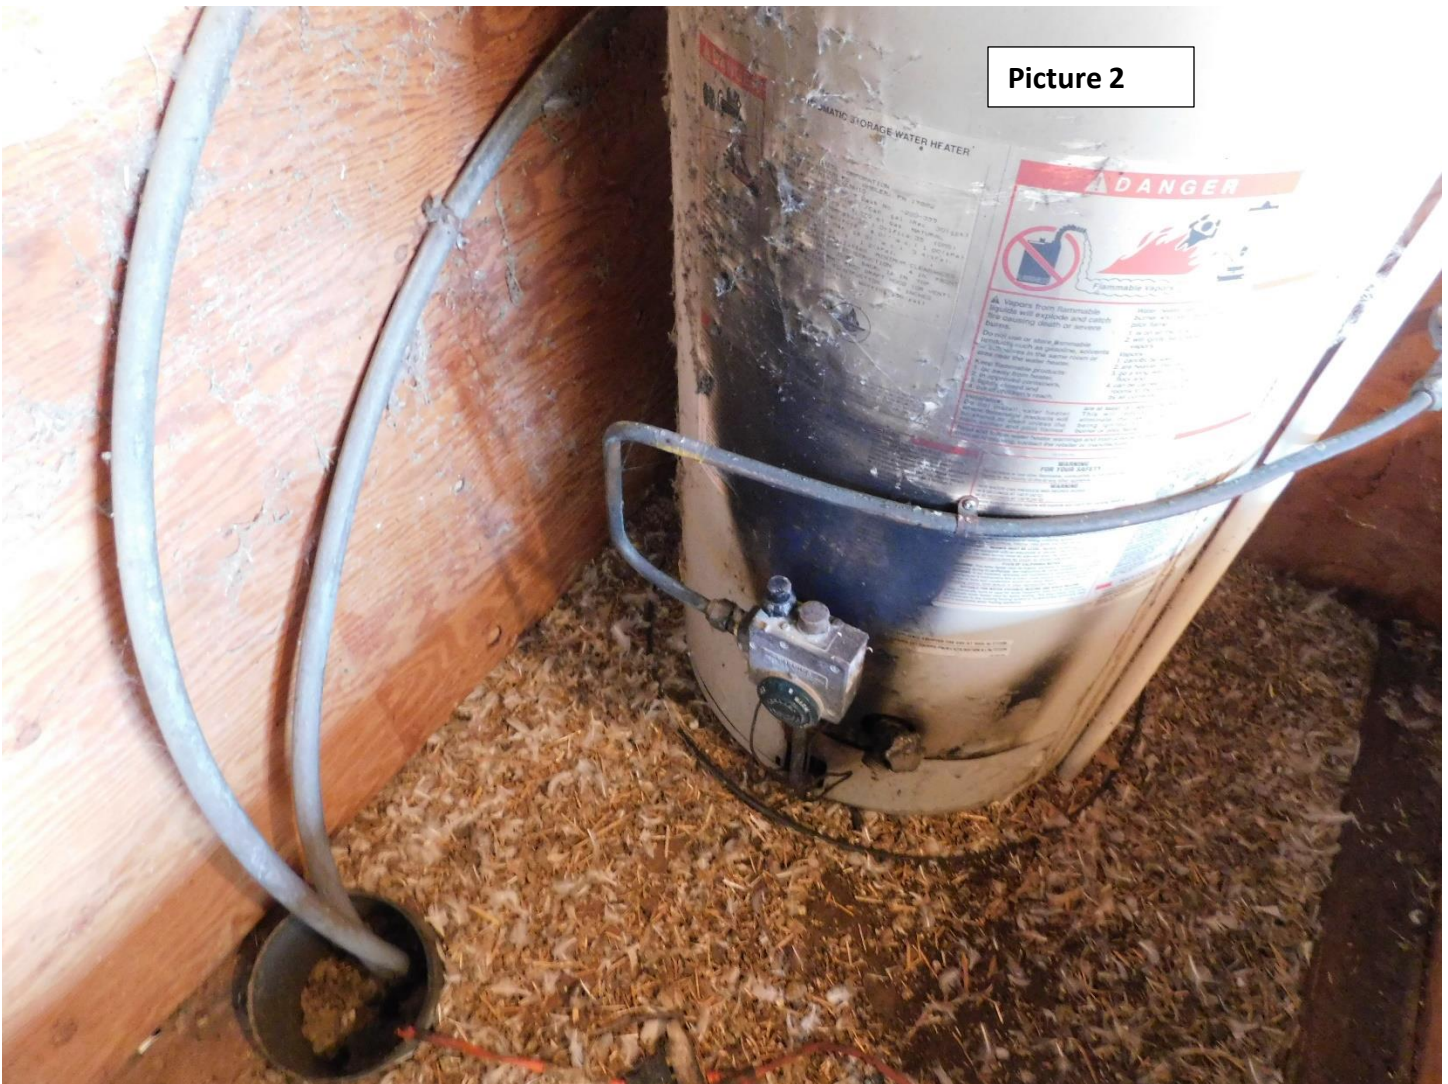
Picture 2

Water heater in second barn was examined. Combustible materials were found in very close proximity to the burner compartment. Black soot on the tank indicates an issue with this tank as well.

<p>-Another barn on the property has a similar water heater installed. It was noted that the area around the burner had accumulations of sawdust and debris. (see picture 2)</p> <p>-Installation/ operation manual states</p> <p>“The flow of combustion/ ventilation air <b>MUST NOT</b> be restricted. Make sure slots in jacket are open and unobstructed. Clear jacket slot openings of any dirt, dust, or other restrictions.”</p> <p>“At all times keep the water heater area clear and free from combustible materials, gasoline and other flammable vapours and liquids.”</p> <p>“Annually remove the inner door and main burner assembly to clean orifices and related parts of any dirt or other foreign material. Inspect the burner ports for obstructions or debris and clean with a wire brush as needed. Wire brush and/or vacuum clean the combustion chamber as needed to remove scale deposits and debris.</p>
<p><b>Causes and contributing factors</b></p>	<p>It's likely that the organic materials found inside the water heaters combustion chamber, caught fire sometime after the water heater was cycled on. Some of the combustible materials very near to the water heater likely came in contact and spread the fire to the rest of the structure.</p>
