Incident Summary #II-757768-2018 (#9165) (FINAL)

SUPPORTING INFORMATION	Incident Date		October 21, 2018	
	Location		Delta, BC	
	Regulated industry sector		Gas - Natural gas system	
	Impact	Injury	Qty injuries	1
			Injury description	2nd Degree burns to hands, and face
			Injury rating	Moderate
	Damage	Damage	Damage description	Localized burn patterns on propane-air mixer and melting of a plastic handle of a gas valve.
			Damage rating	Minor
	Incident rating		Moderate	
Incident overview		A gas fitter was burned when a flammable mixture of propane and air ignited on a piece of equipment they were working on.		
INVESTIGATION CONCLUSIONS	Site, system and components		<p>Fortis offers large industrial clients cheaper rates to have what is known as an “interruptible service”. This means that under peak demand times a customer can be asked to switch to a backup fuel source, decreasing the demand on the natural gas system, and saving more gas for residential and light commercial customers.</p> <p>One backup fuel option is propane, however propane has 2.5 times the calorific value (Energy released from burning a measured amount of fuel) of natural gas. To ensure that appliances do not fire

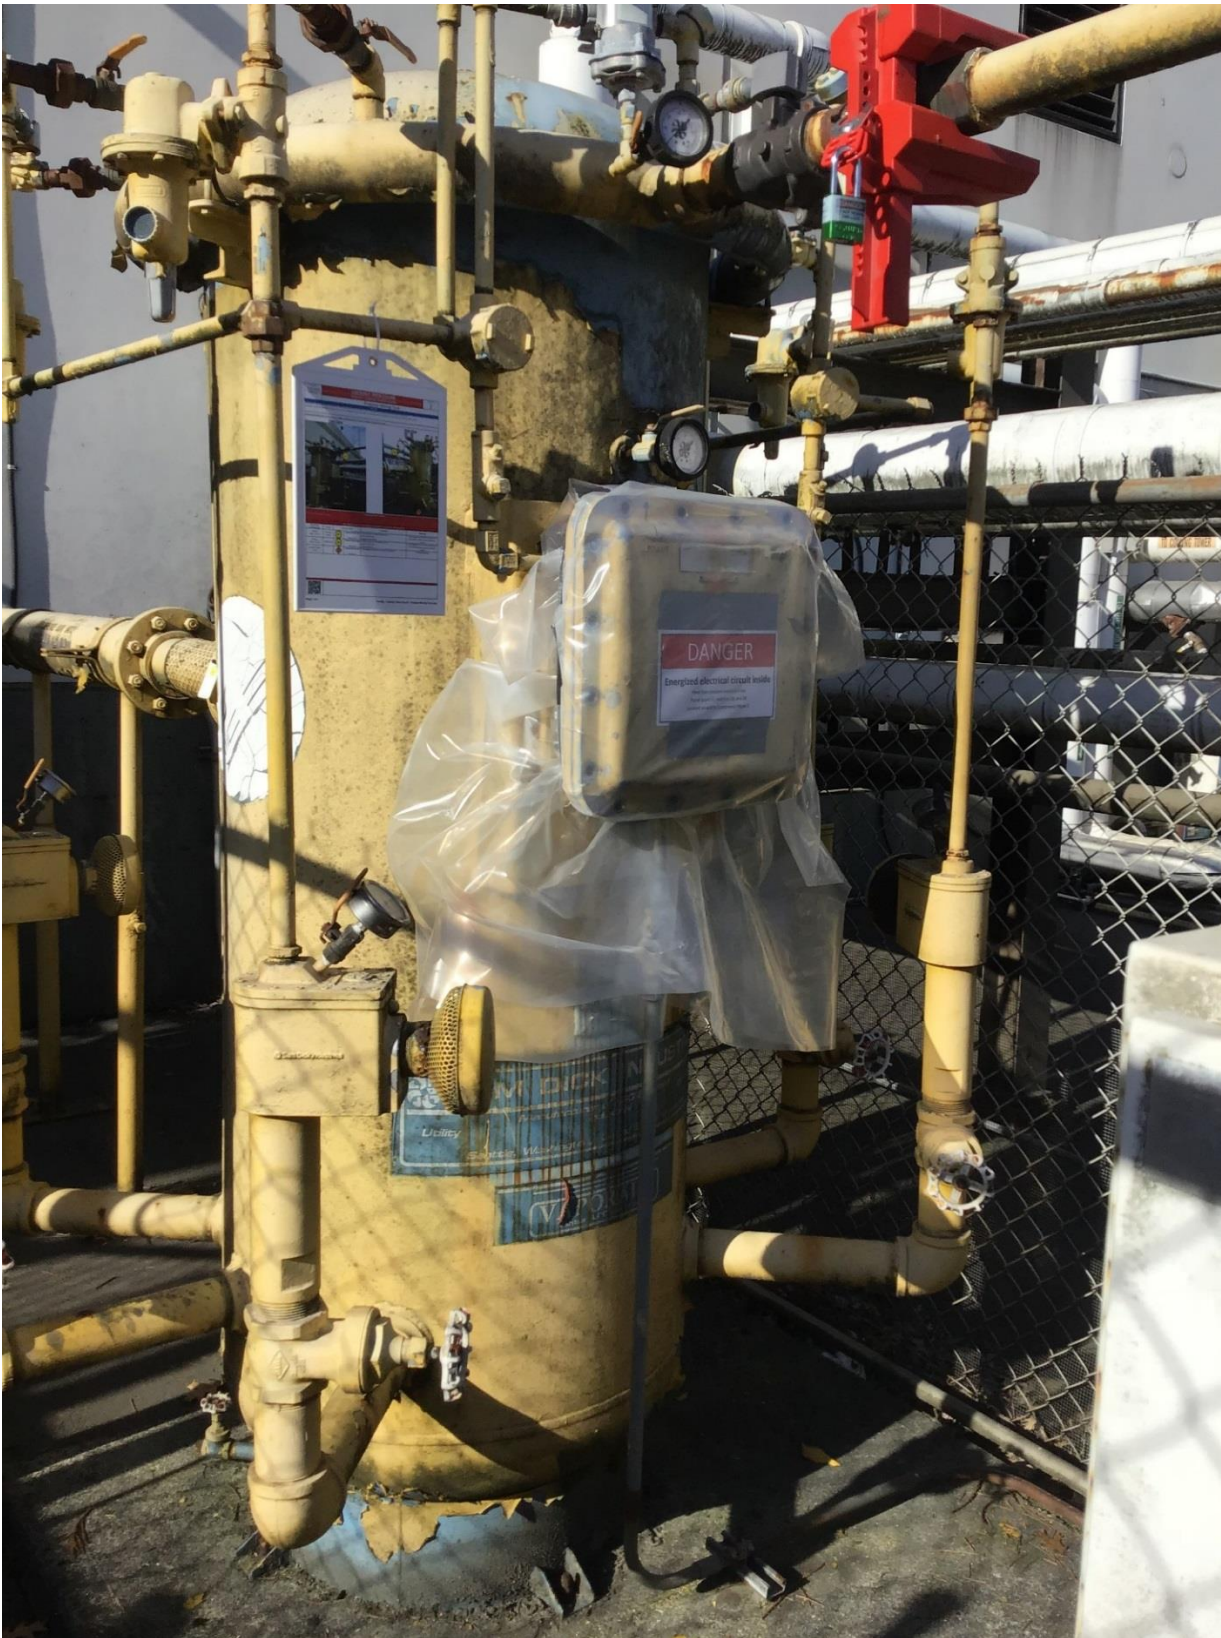
Figure 1. Propane air mixer on day of investigation.

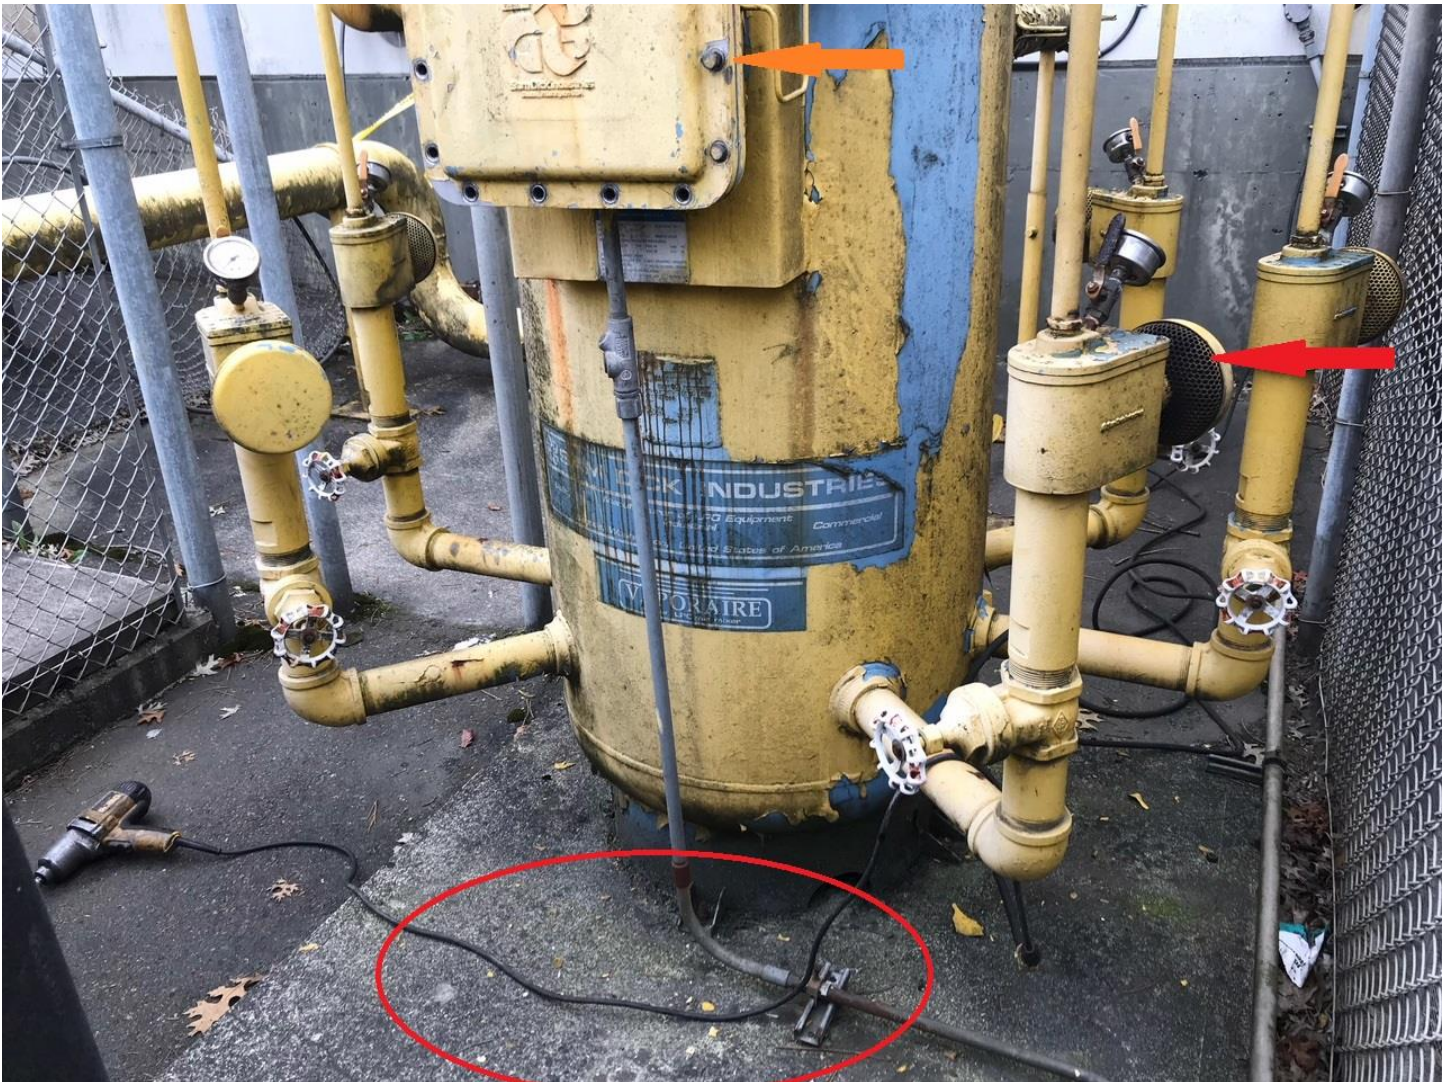
Failure scenario(s)		One of the mixing guns for the propane-air mixer developed a leak. When the gas fitter went to work on the appliance, an electric impact gun was used to open a service panel on the mixer. This impact gun generated a spark and ignited a flammable mixture of propane and air, which subsequently caused a fireball and burned the gas fitter.	
	Facts and evidence		<p>The gas fitter was working on the appliance the day before and recalls checking for leaks on the appliance before beginning work that day. However on the day of the incident the gas fitter told me they did not check for leaks.</p> <p>The gas fitter returned the following day to fix an unrelated issue that was causing the mixer to lock out on an error.</p>

<p>An interview with a plant service worker, who was supervising the gas fitter, stated that “the gas fitter went to take a bolt off, and all of a sudden there was a big fireball” so they “ran as fast as they could to turn the propane off to the mixer”</p> <p>Localized burn patterns, and melting of a plastic valve handle were found on one of the mixer’s air receivers, indicating that this was the mixing gun that was leaking, and subsequently caused the incident.</p> <p>When asked when the last time was that this system had been put into use, I was told by plant staff that “it probably hadn’t been used in 5-10 years”</p> <p>After the incident the gas contractor attempted to find parts to repair the leak on the mixing gun check valve seal, but the manufacturer refused to supply repair parts. The manufacturer stated that the appliance was deemed to be “past its service life and needed to be replaced”</p> <p>No other propane leaks were identified on the unit or surrounding area, and there were no other flammable materials in the area.</p>

Figure 2. Scene on the day of the incident. The red circle indicates where the gas fitter was standing. The orange arrow indicates the bolt that the gas fitter was undoing. And the red arrow indicates the leaking mixing gun (Note blackened handle and screen)

<p>Causes and contributing factors</p>	<p>Based on the evidence found on site, it is likely that a failed seal within the mixing gun check valve caused the leak which ignited.</p> <p>It is likely that the age of the equipment, and operation past its expected service life contributed to this incident.</p> <p>A second contributing factor was likely, the gas fitter’s failure to check for leaks on the day of the incident before beginning work on the mixer.</p> <p>A third contributing factor was likely, the type of tool used to open the access cover on the mixer. Electrical tools are considered a potential source of ignition, which should be avoided in potentially flammable environments, unless certified for usage in such environments.</p>

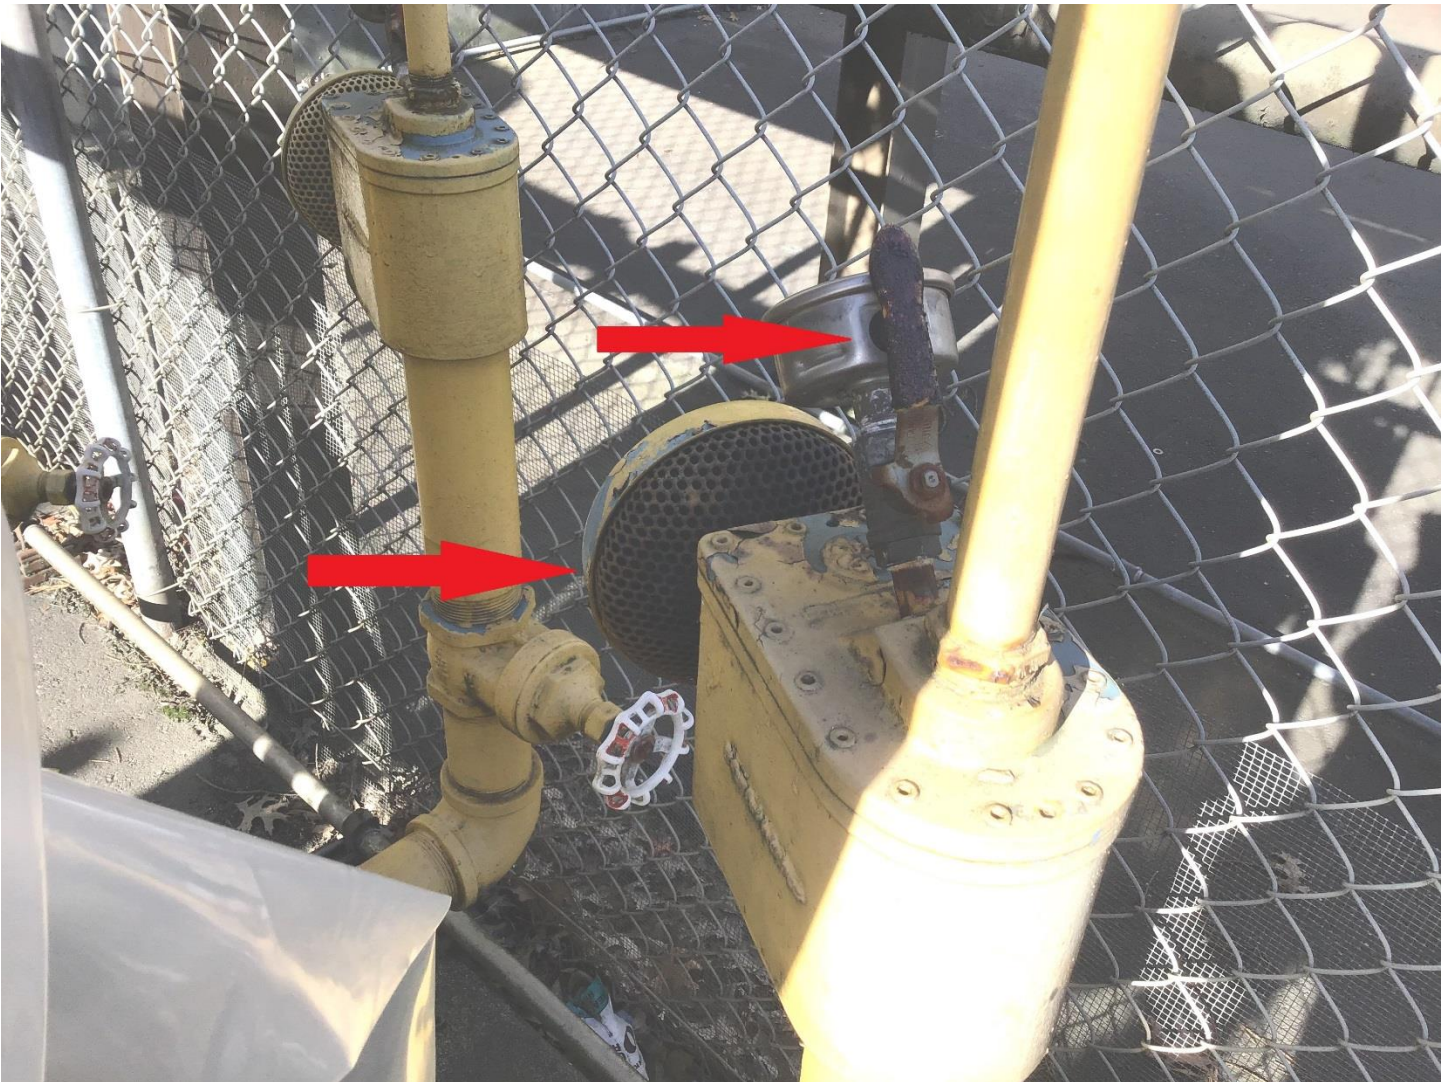
Figure 3. Close-up of leaking mixer, again note the burned handle and blackened receiver screen.
