Incident Summary #II-1800449-2024 (#54690) (FINAL)

SUPPORTING INFORMATION	Incident Date	November 24, 2024
	Location	Victoria, BC
	Regulated industry sector	Elevating devices - Escalator or moving walkway
	Qty injuries	1
	Impact Injury Injury description	A member of the public fell down an escalator and experienced head trauma. <i>*Cause of death (COD) is not determined by Technical Safety BC. The BC Coroners service conducts their own investigation to determine COD.*</i>
	Impact Injury Injury rating	Fatal
	Damage Damage description	N/A
	Damage Damage rating	None
Incident rating		Severe
Incident overview		A member of the public who was using their walker to assist with their mobility had been shopping for groceries when they entered the top of an escalator moving downwards. This escalator is located outside a retail-grocer at a multilevel mall during a busy holiday shopping week. The escalator was in a constant standard-motion, steadily lowering downwards as intended. The person holding the walker handles fell head forward as the walker lowered with the escalator and fell onto and around the walker and its contents. As a result, they sustained a serious head injury and a few days l

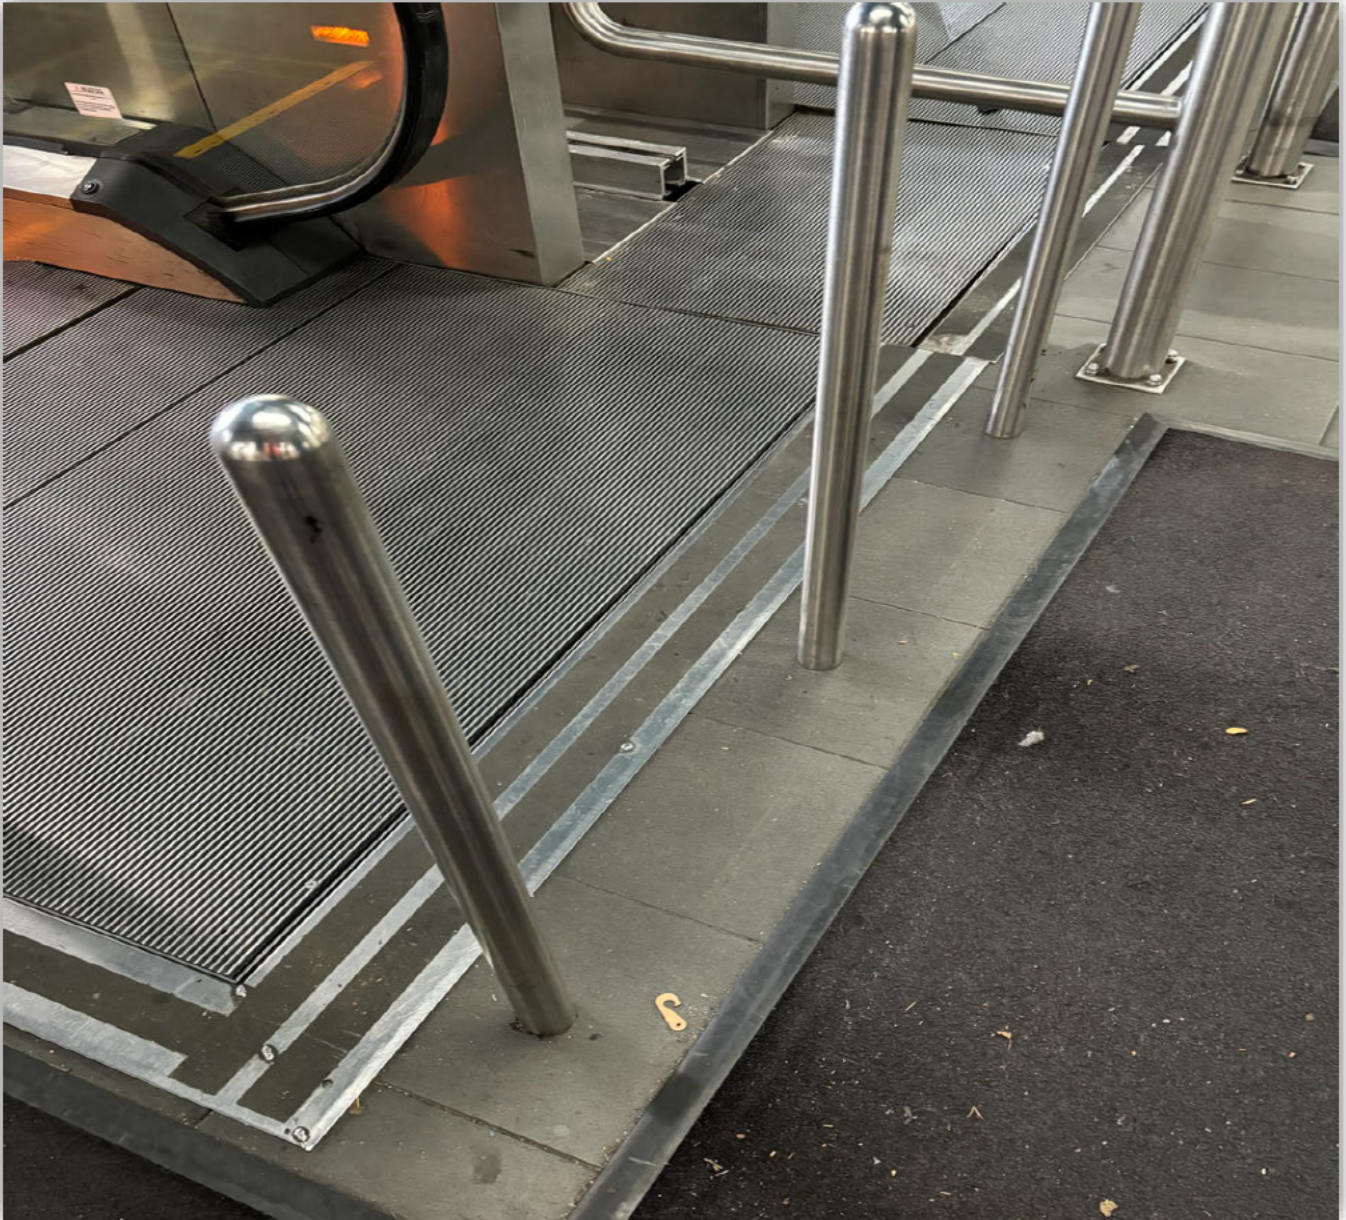
Image 1 – Bollards to prevent carts on escalator.

Bollards (posts) ([Image 1](#))

Metal posts were placed near the entrance of the escalator to help with guiding foot-traffic on and off and ideally these safety barriers are to prevent and block people from bringing bulky items like wheelchairs, shopping carts and prams onto the escalator.

Safety bollards which are the posts to prevent carts from entering escalators at top and bottom were installed in-front of the escalators preventing large items from being moved onto the escalator for transport but gaps to walk through in this case allowed a person to navigate mobility walker size cart through them.

Some locations install different barriers or bollards at the entrances and landing zones to their escalators to discourage passengers from riding the escalator with items such as carts, buggies, strollers or luggage. This is done to help prevent property damage or injuries. There are no current requirements in the CSA B44 code for such barriers or bollards.

Video shows the shopper walking with his mobility walker in the direction of the elevator. Then walks past it with the mobility walker towards escalator, passing signage and warnings ([Image 4](#)) and navigates through an opening behind a row of safety bollards ([Image 1](#)) and enters the downward moving escalator ([Image 5](#)).

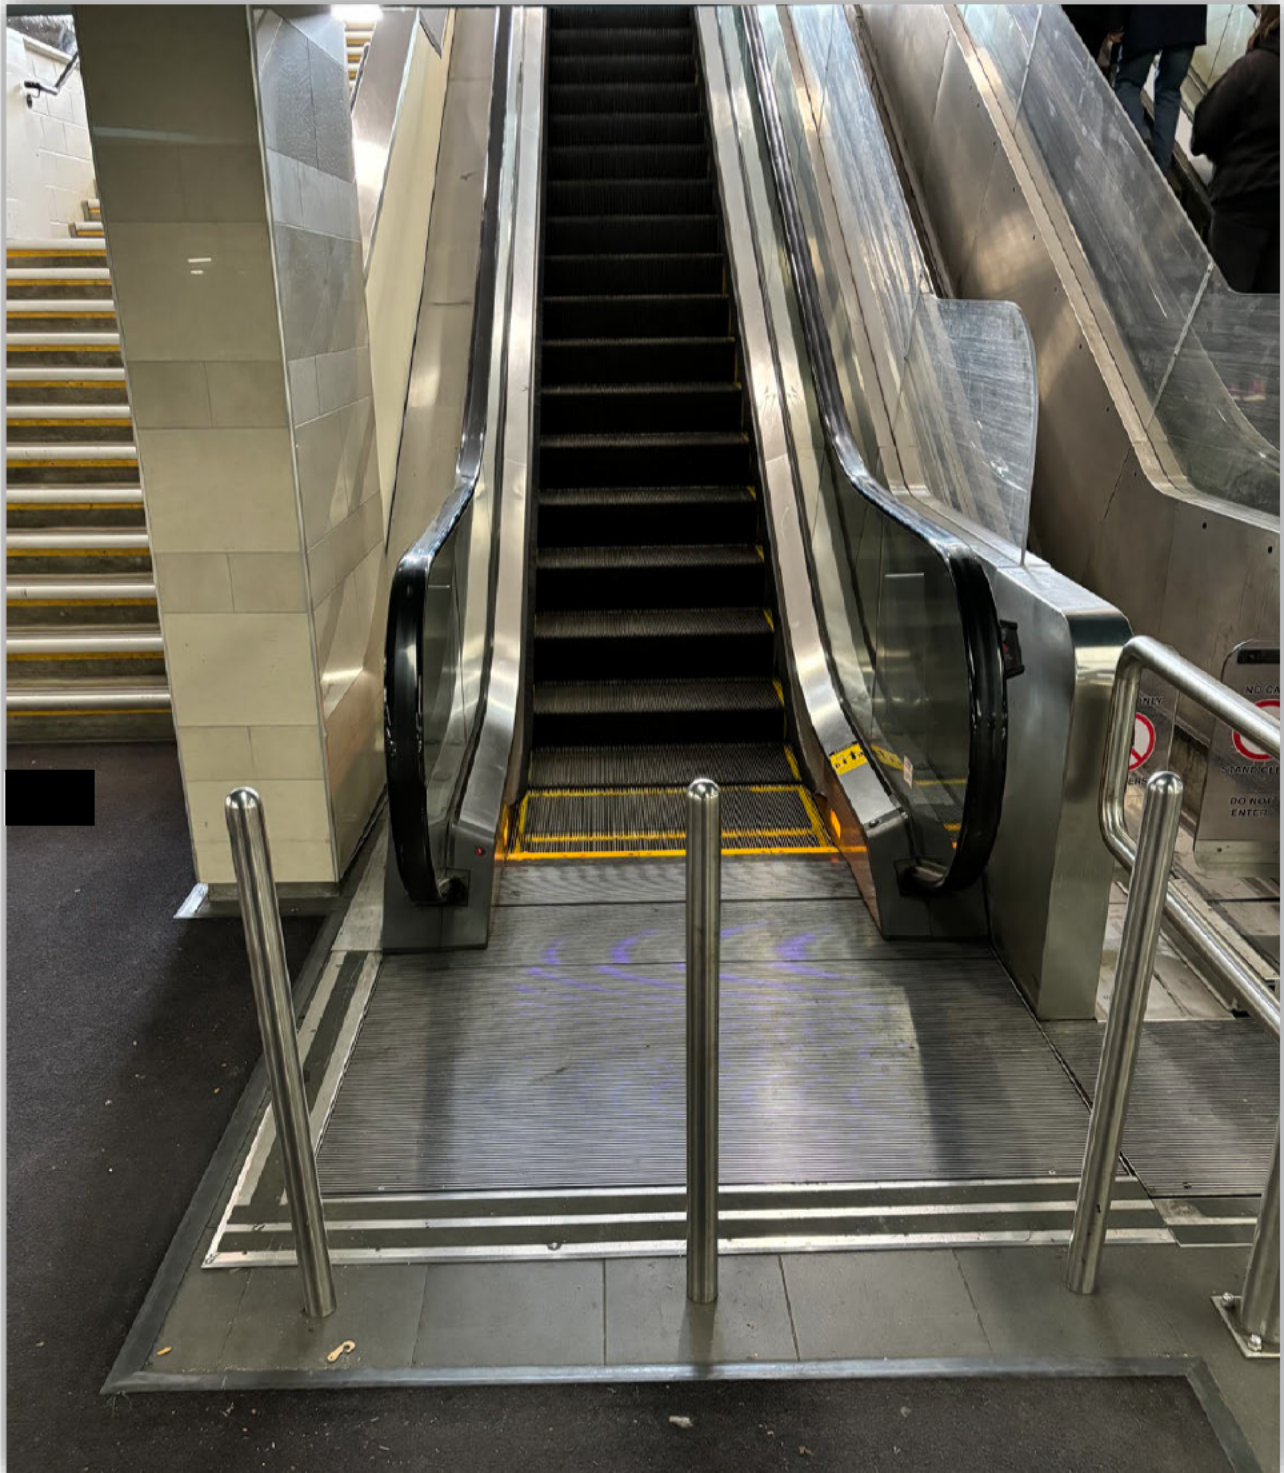
Image 2 – Escalator bottom.

INVESTIGATION CONCLUSIONS	Site, system and components	The shopping center is a three (3) story outdoor shopping complex with an underground parkade. To access the underground parkade, a person must use stairs, an elevator, or an escalator (Image 2).
		There is a street level entry to a parking lot that also has more access to covered parking areas. This entry level provides access to stores on the main level of the shopping complex. The shopping center has multiple stores and services including a large retail and grocery store. Once parked, patrons can use the stairs, elevator or an escalator to move between levels and vendors.
		The purpose of an escalator To move people vertically between levels inside or outside a building or other public space. They are often used in places where large numbers of people need to move, such as airports, shopping malls, and train stations. Escalators are a good choice for shorter distances because they can move more people as they are designed to operate constantly rather than on demand elevators (Image 1).

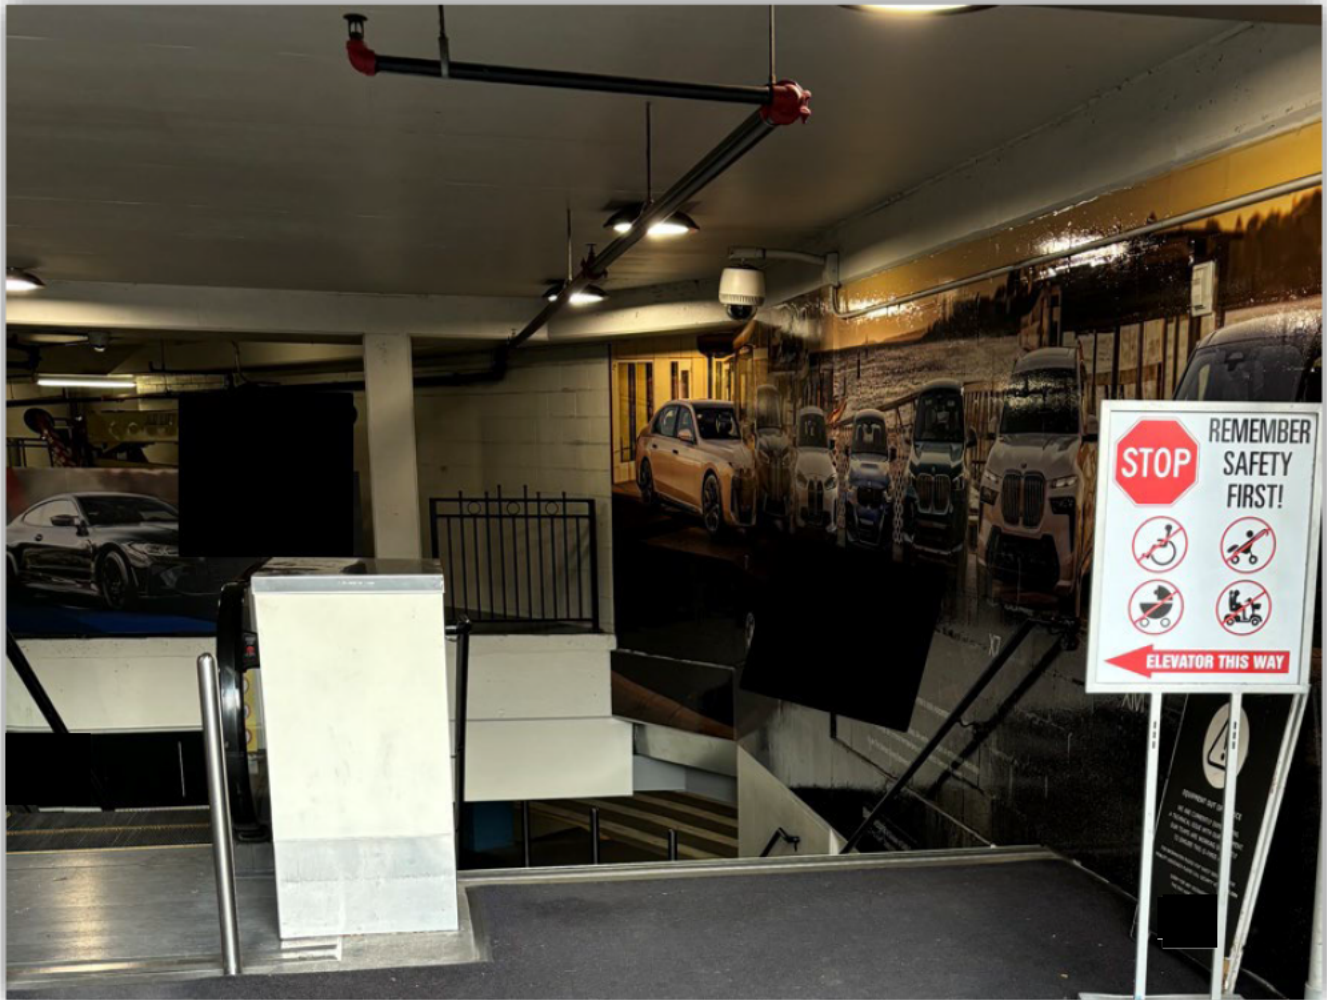
Image 3 - stairs next to escalator and signage at the top right.

Additional cautions signs were also located at the top of the staircase beside the escalator that highlighted no wheelchairs, strollers, shopping carts and mobility scooters as well as an arrow pointing to the location of the elevator next to the staircase and escalators to be used as an alternative. However, this was located on the opposite side of the stairs.

<p>Any additional signs or graphics related to safety need to be located so they do not obstruct boarding passengers' view of the required sign or obstruct passenger flow at the landings. (Image 3).</p> <p>Ruled out - Weather Factors and Escalator Exposure</p> <p>The weather on Sunday, November 24, 2024, was sunny with clouds, plus eight (8) Celsius as was found on the weather network. No water is seen anywhere around escalator and freezing temperatures would not be a factor in the functioning or traction.</p>
Causes and contributing factors	<p>The use of the escalator with a mobility assistance walker was very likely the main factor that caused the incident. It is very likely that the following factors also contributed to the incident:</p> <ul style="list-style-type: none">• Bypassing safety bollards that are intended to prevent taking bulky items on escalator.• Positioning of the bollards allowed a gap to the side of the entrance for the patron to enter with a bulky mobility cart in a direction where signage visibility was limited.• Failing to observe and or follow the posted warnings.• Warnings exceeding code requirements were ineffective at warning the individual who entered from the side of the bollards.• The weight of the groceries on the walker making holding the walker up as the escalator lowered difficult.

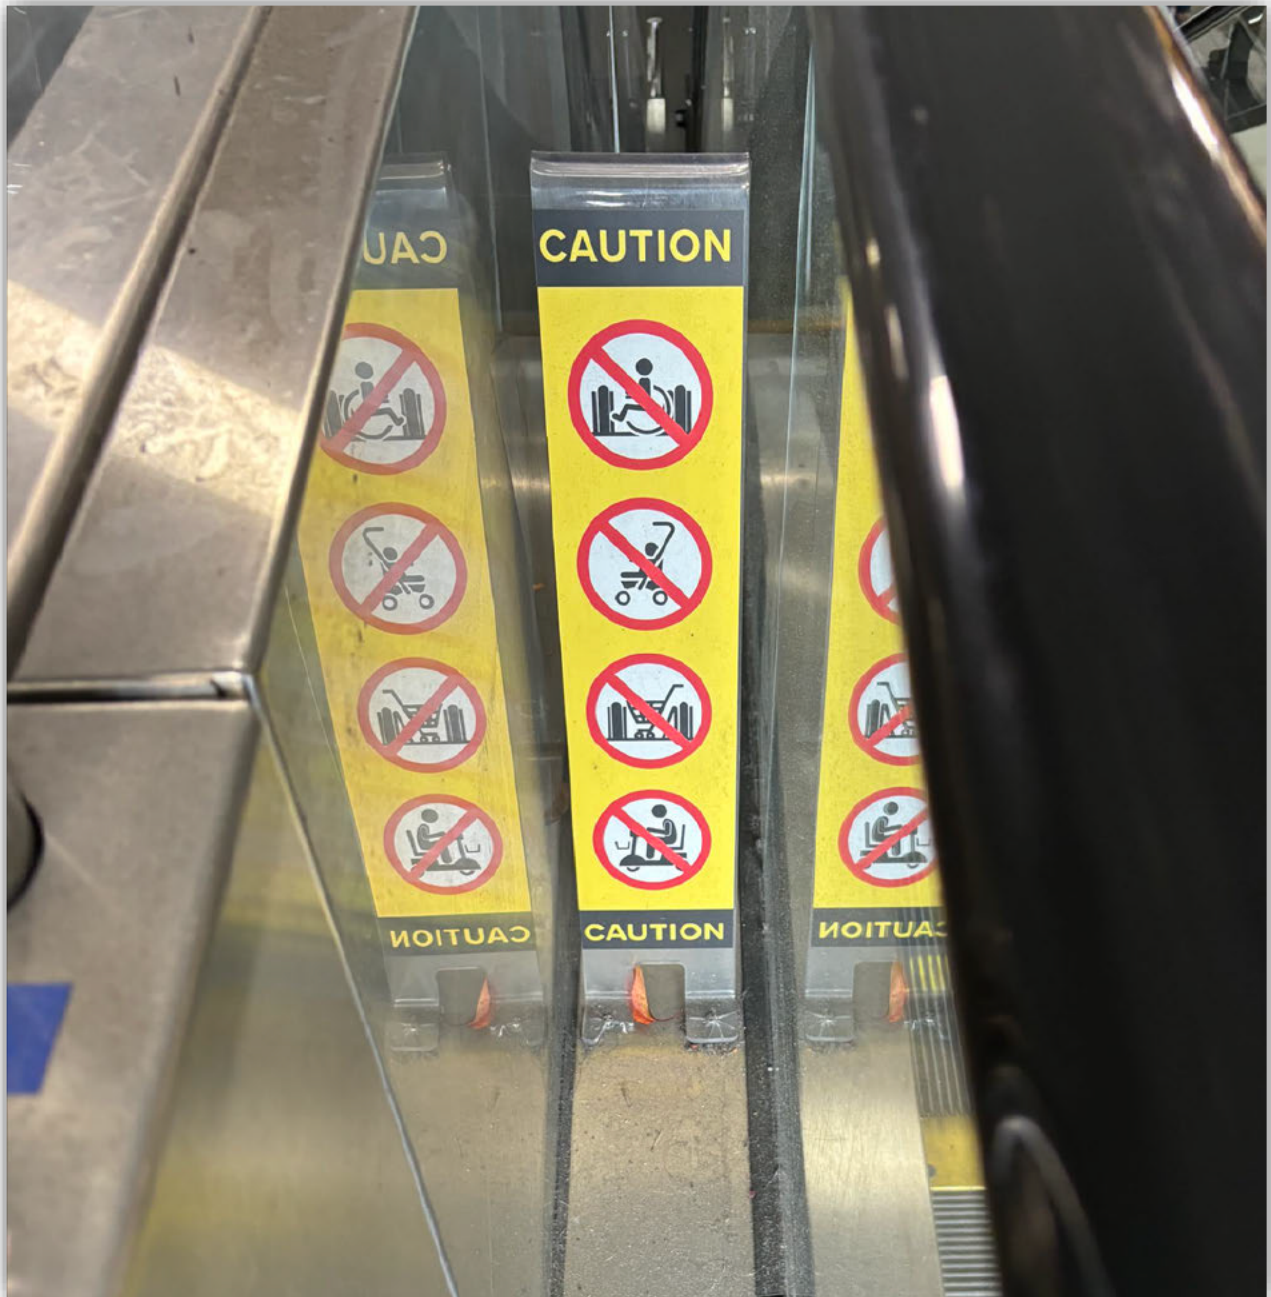
Image 4 – Signage warnings on escalator before boarding.

Warning signage ([Image 3](#) & [Image 4](#))

The escalator had the required caution signs posted on the escalators, located between the cart conveyor and handrail. Images on required signage did not highlight the potential hazard and consequences of the taking those items up or down the escalator.

Escalators are required in section 6.1 of the B44 code to have caution signs located at the top and bottom landings of each escalator readily visible to boarding passengers. The sign shall include the following wording:

- "Caution"
- "Passengers Only"
- "Hold Handrail"
- "Attend Children"
- "Avoid Sides"

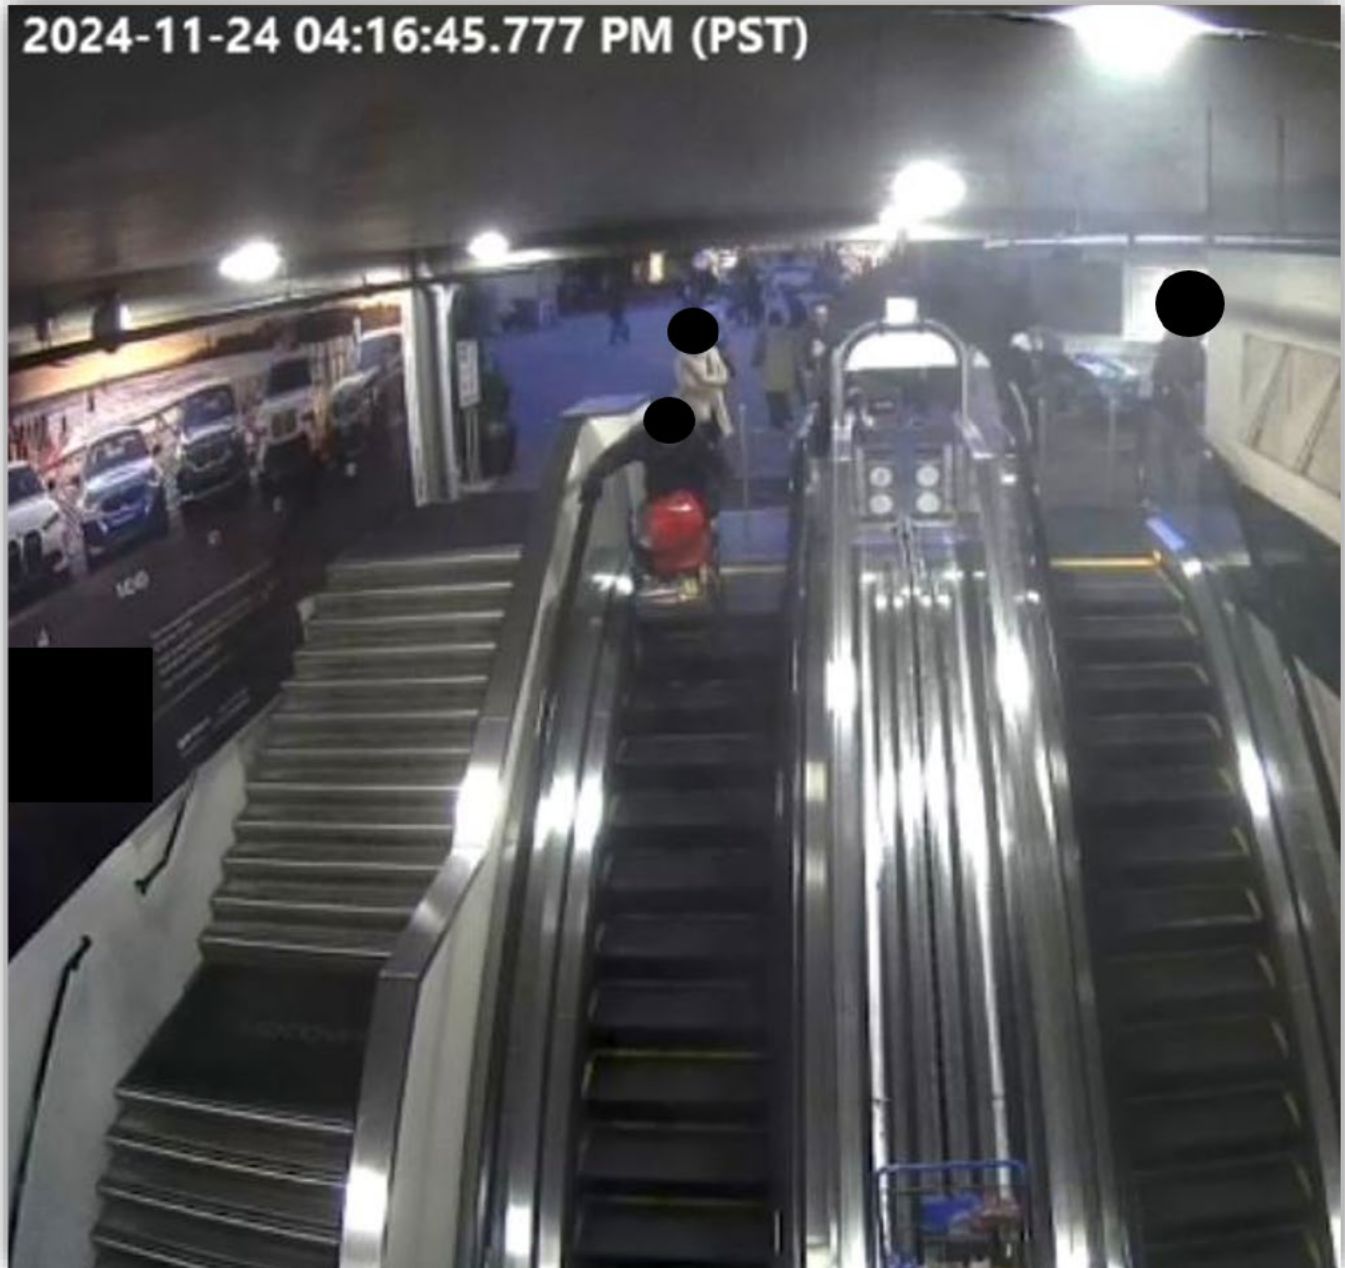
Image 5 – Footage still of a person with a walker and cart with groceries entering moving escalator.

At the initial descent of the escalator, the customers mobility walker tips forward and begins to fall. The customer attempts to grab and hold his mobility walker however the person loses balance and falls with groceries ejecting and mobility walker fully tipping as the patron falls and his head makes contact with the escalator stairs resulting in an injury.
