Incident Summary #II-1140811-2021 (#20659) (FINAL)

| SUPPORTING INFORMATION | Incident Date | | February 1, 2021 | |
| | Location | | Cowichan Bay, BC | |
| | Regulated industry sector | | Electrical - Low voltage electrical system (30V to 750V) | |

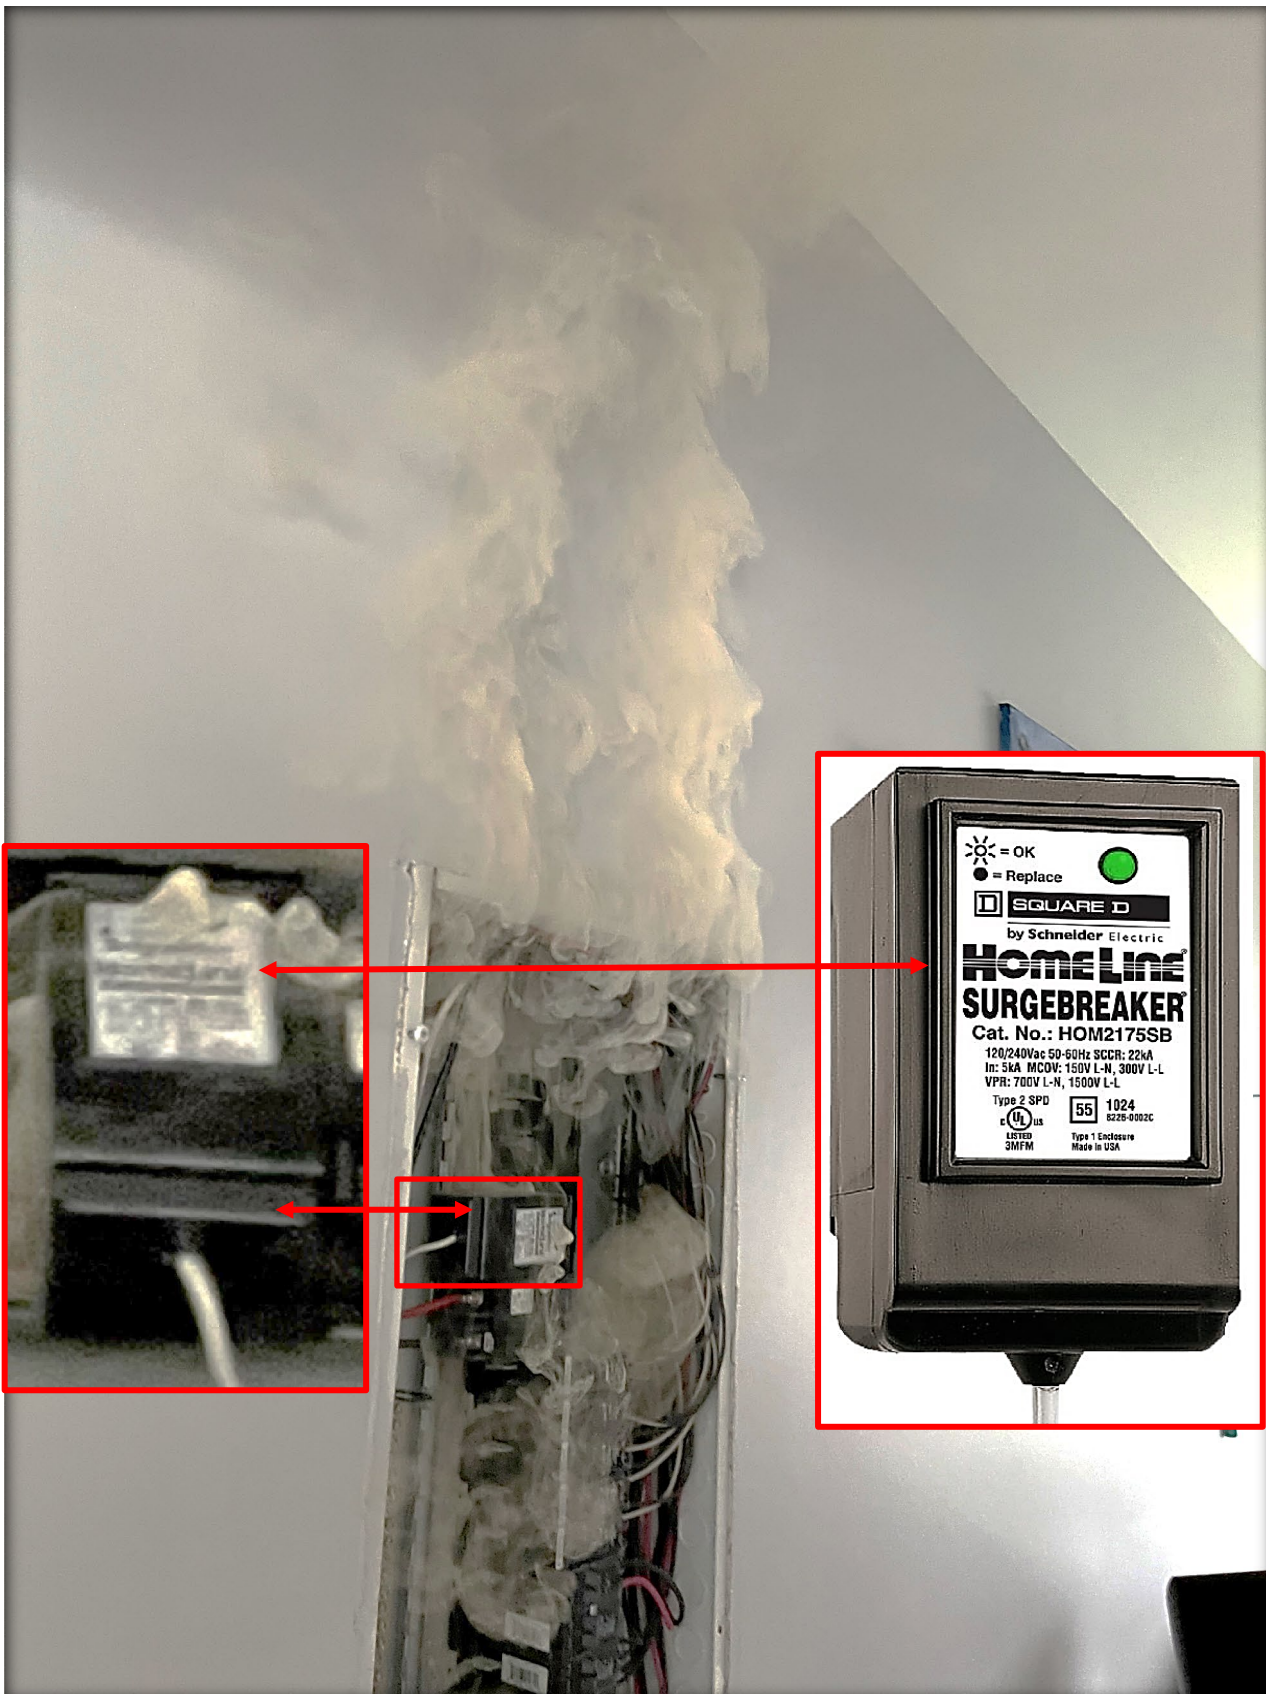
Image 1 – Main panel board with smoke billowing out, SPD, and example SPD on right.

| | <p>Surge protective device</p> <ul style="list-style-type: none"> • The main panel had an SPD (Image 1) designed to protect the electrical service and major household appliances, excluding electronic devices, from momentary surges by clamping excess voltage. • The SPD product standard is - Type 2 SPDs - CSA C22.2 No. 269.2-13, "Surge Protective Devices - Permanently connected", 1st Edition, dated June 2013. • UL1449 product standard item 3.47, which applies this SPD, defines a surge as a transient wave of current, potential, or power in an electric circuit. For the purposes of the standard, surges do not include temporary overvoltage's (TOV's) consisting of an increase in the power frequency voltage for several cycles. • The local power system utilizes typical 60 Hertz power (60 cycles per second) so a TOV would be a surge for 3/60ths of one second or more. • The SPD can withstand a line to neutral maximum continuous operating voltage (MCOV) of 175 Volt. • The SPD has an integral light emitting diode (LED) that indicates "OK" status if the LED is green or "Replace" status if the LED is off when the power is on. • For protection against surges, the SPD uses 3 radial metal oxide varistors (MOV's) per phase that are rated for 180 Volts maximum alternating current. • A varistor is a variable resistor whose resistance decreases when the voltage increases beyond the circuit ratings to absorb voltage surges. • The varistor acting as a resistive load, when the voltage is over the circuit ratings, can degrade from exposure to many voltage spikes that are not long enough or high enough current to trip the protective fuses. • Each MOV is protected by 1 thermal cut off and 1 current limiting fuse (Image 6). • The SPD's plastic case has sand insulating fill for the components (Image 7). |

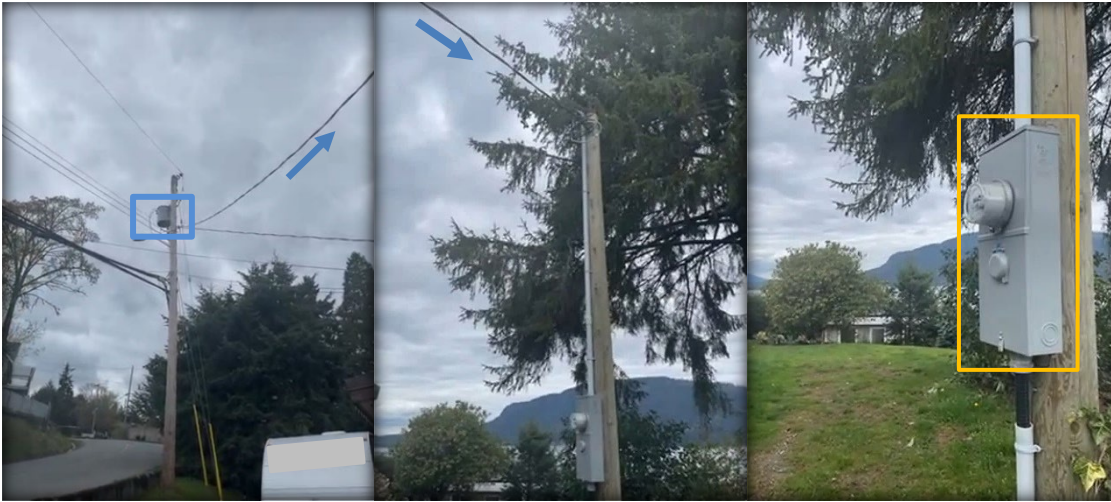
Image 3a,b,c – Supply transformer (blue rectangle), overhead supply line (blue arrows), and combination meter base with circuit breaker (orange rectangle).

| INVESTIGATION CONCLUSIONS | <p>Power system</p> <ul style="list-style-type: none">The home has a 120/240 Volt, 200 Amp rated service. The 240 Volt supply is fed from the secondary winding of the supply transformer at the center tap where the grounded neutral line connects (Image 3). The nominal voltage is 120 volt between the grounded neutral conductor and each 240 Volt conductor.The service transfers from overhead to underground at the pole mounted meter base and main breaker combo unit on the property (Image 3).Inside the combo unit are neutral conductor termination points and system bonding jumper (Image 4). This is the exclusive location for the home's electrical system where the neutral connects to the grounding system.An aluminum armoured cable feeds underground from the service equipment on the pole to the home's push-on panel (meaning the breakers push on to the panel, rather than bolt on), that has the neutral conductor isolated from ground. <p>Open service neutral</p> <ul style="list-style-type: none">Solid neutral terminations from the service all the way to the connected electrical equipment is an important factor in maintaining proper system voltages.If a three wire 120/240 Volt system's neutral conductor becomes loose or disconnected it can result in power quality issues. Depending on the difference in connected loads between the two 120 Volt lines, the respective voltages may vary between 0 to 240 Volts from the nominal 120 Volt (Image 5).The results of the voltage variations may include flickering, dimming, and brightening of lighting as well as overvoltage damage to 120 Volt rated appliance components or devices. | | | |

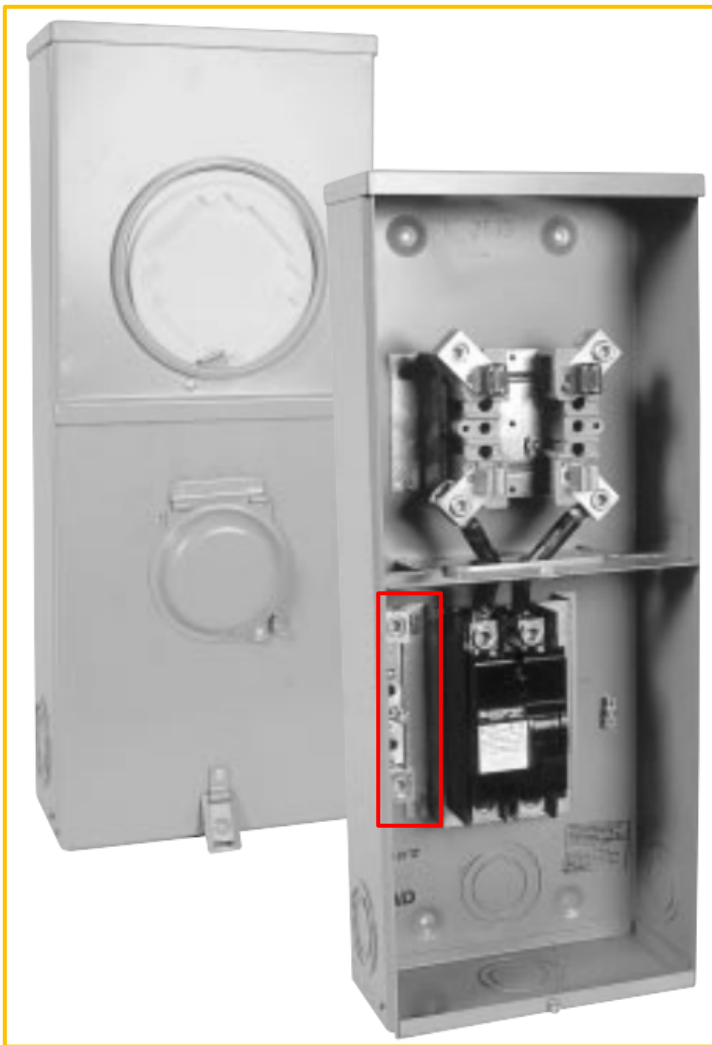
Image 4 – Meter base combination unit example showing neutral termination location (red rectangle).

| <p>Failure scenario(s)</p> | <p>During the original electrical installation, two years before the incident, the neutral lug in the meter base was left untightened creating an open neutral condition.</p> <p>Eight months before the incident, the control panel for the oven and various light bulbs in the house stopped working from over voltage occurrences. An electrical contractor was called to site and found the voltage levels at a receptacle to be 204 Volts but returning to 120 Volt after they went outside briefly. At that time, the electrician attributed the over voltages to utility power surges and installed the SPD in the panel to protect against any further surges.</p> <p>One day before the incident, another over voltage occurrence again damaged some light bulbs, the television, and the oven panel, so the occupant called the electrician to arrange for them to re-examine. Prior to the electricians scheduled visit, when an occupant turned on a light in a bedroom, the light bulb stopped working. They went to the panel to check on the status of the SPD's green light and upon opening the panel door, the SPD sparked, exploded and then the top half of the panel burst into flames.</p> <p>The open neutral condition led to intermittently fluctuating voltages varying with the quantity of loads energized at any given time between each line conductor and the neutral. The SPD was exposed to voltages that reached beyond the nominal 120 Volts to at least 204 Volts. The voltages intermittently reaching over 180 Volts degraded the MOV's while they acted as a load. Overvoltages of short duration and/or levels of current not high enough to trip the thermal cut-off or current limiting fuses allowed the MOV's over time to degrade until catching on fire with the SPD melting and bursting into flames.</p> |

| Causes and contributing factors | <p>The cause of the incident was a loose termination in the meter base unit that caused an open neutral condition in the home. The open neutral condition resulted in intermittent over voltages that caused the MOV's to ignite in flames that melted through the SPD enclosure. The SPD's integral thermal cut off and current limiting fuses not opening in time to prevent damage to the MOV's was a contributing factor. The open neutral also caused the damage to various 120 Volt rated equipment.</p> |
