## Incident Summary (Reference # 5616737)

SUPPORTING INFORMATION	Incident Date		April 7,2017	
	Location		Quathiaski Cove	
	Regulated industry sector		Gas	
	Impact	Injury	Qty injuries	None
			Injury description	N/A
			Injury rating	None
	Damage	Damage description	Minimal damage to wiring in the immediate vicinity of the fire	
			Damage rating	Minor
	Incident rating		Minor	
Incident overview		Over time, the low voltage control wiring for the gas valve had been pinching between the Corrugated Stainless Steel Tubing ( CSST) gas line and the shell of the stove cabinet. When it finally broke through the wiring insulation, there was an electrical arch to ground, causing the gas to ignite.

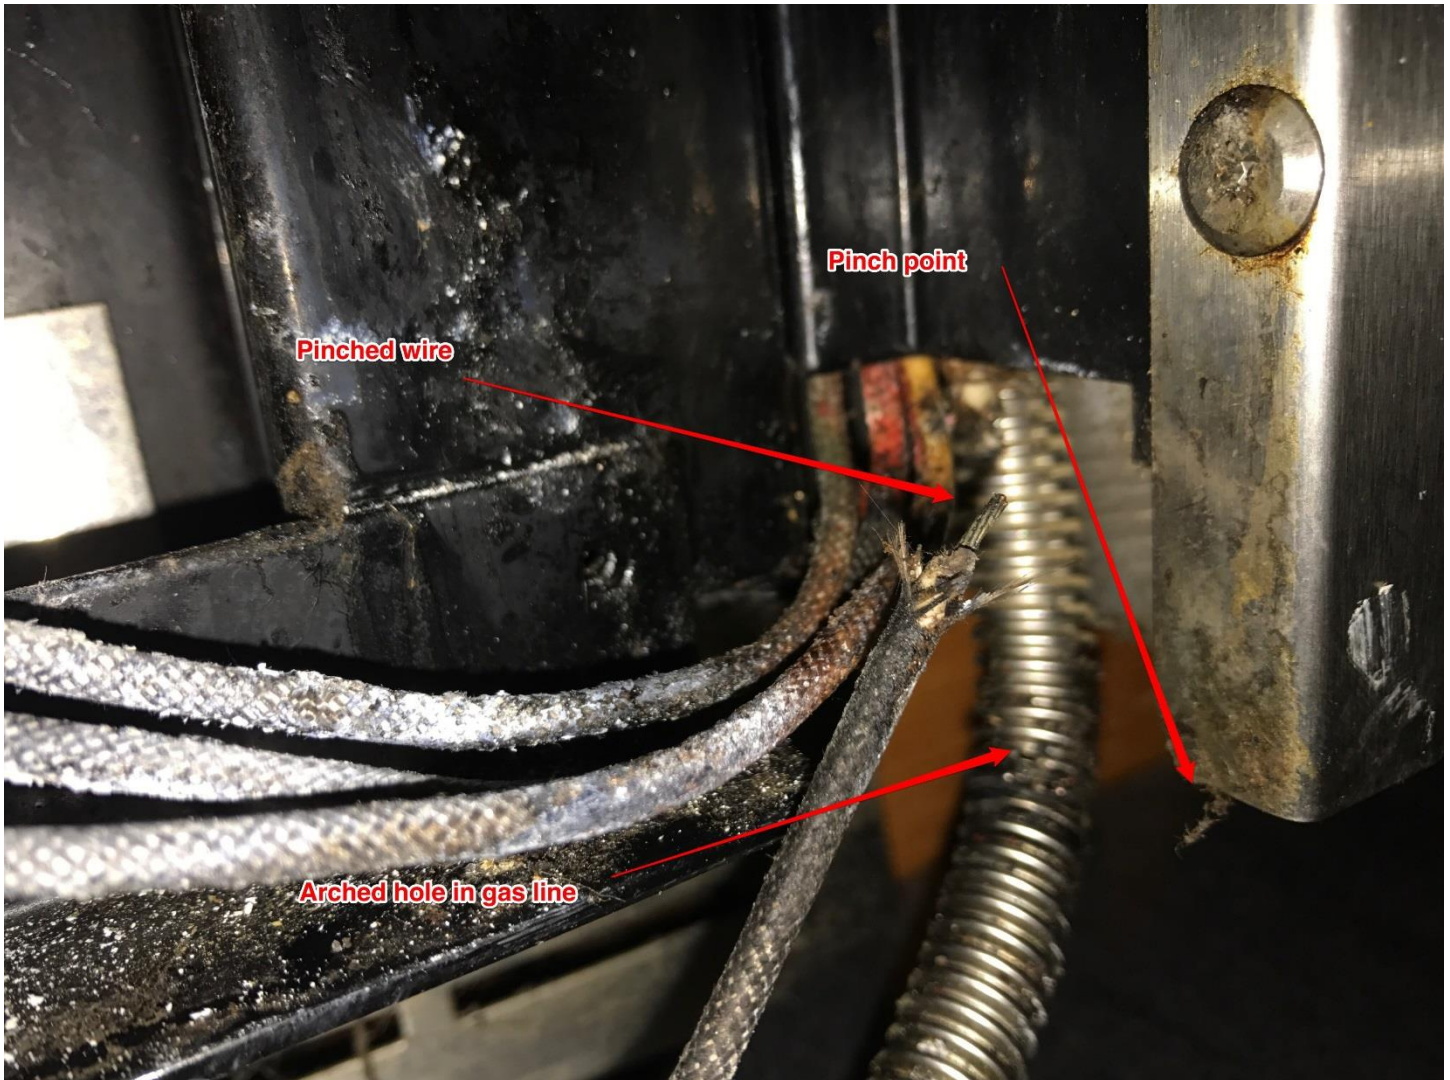
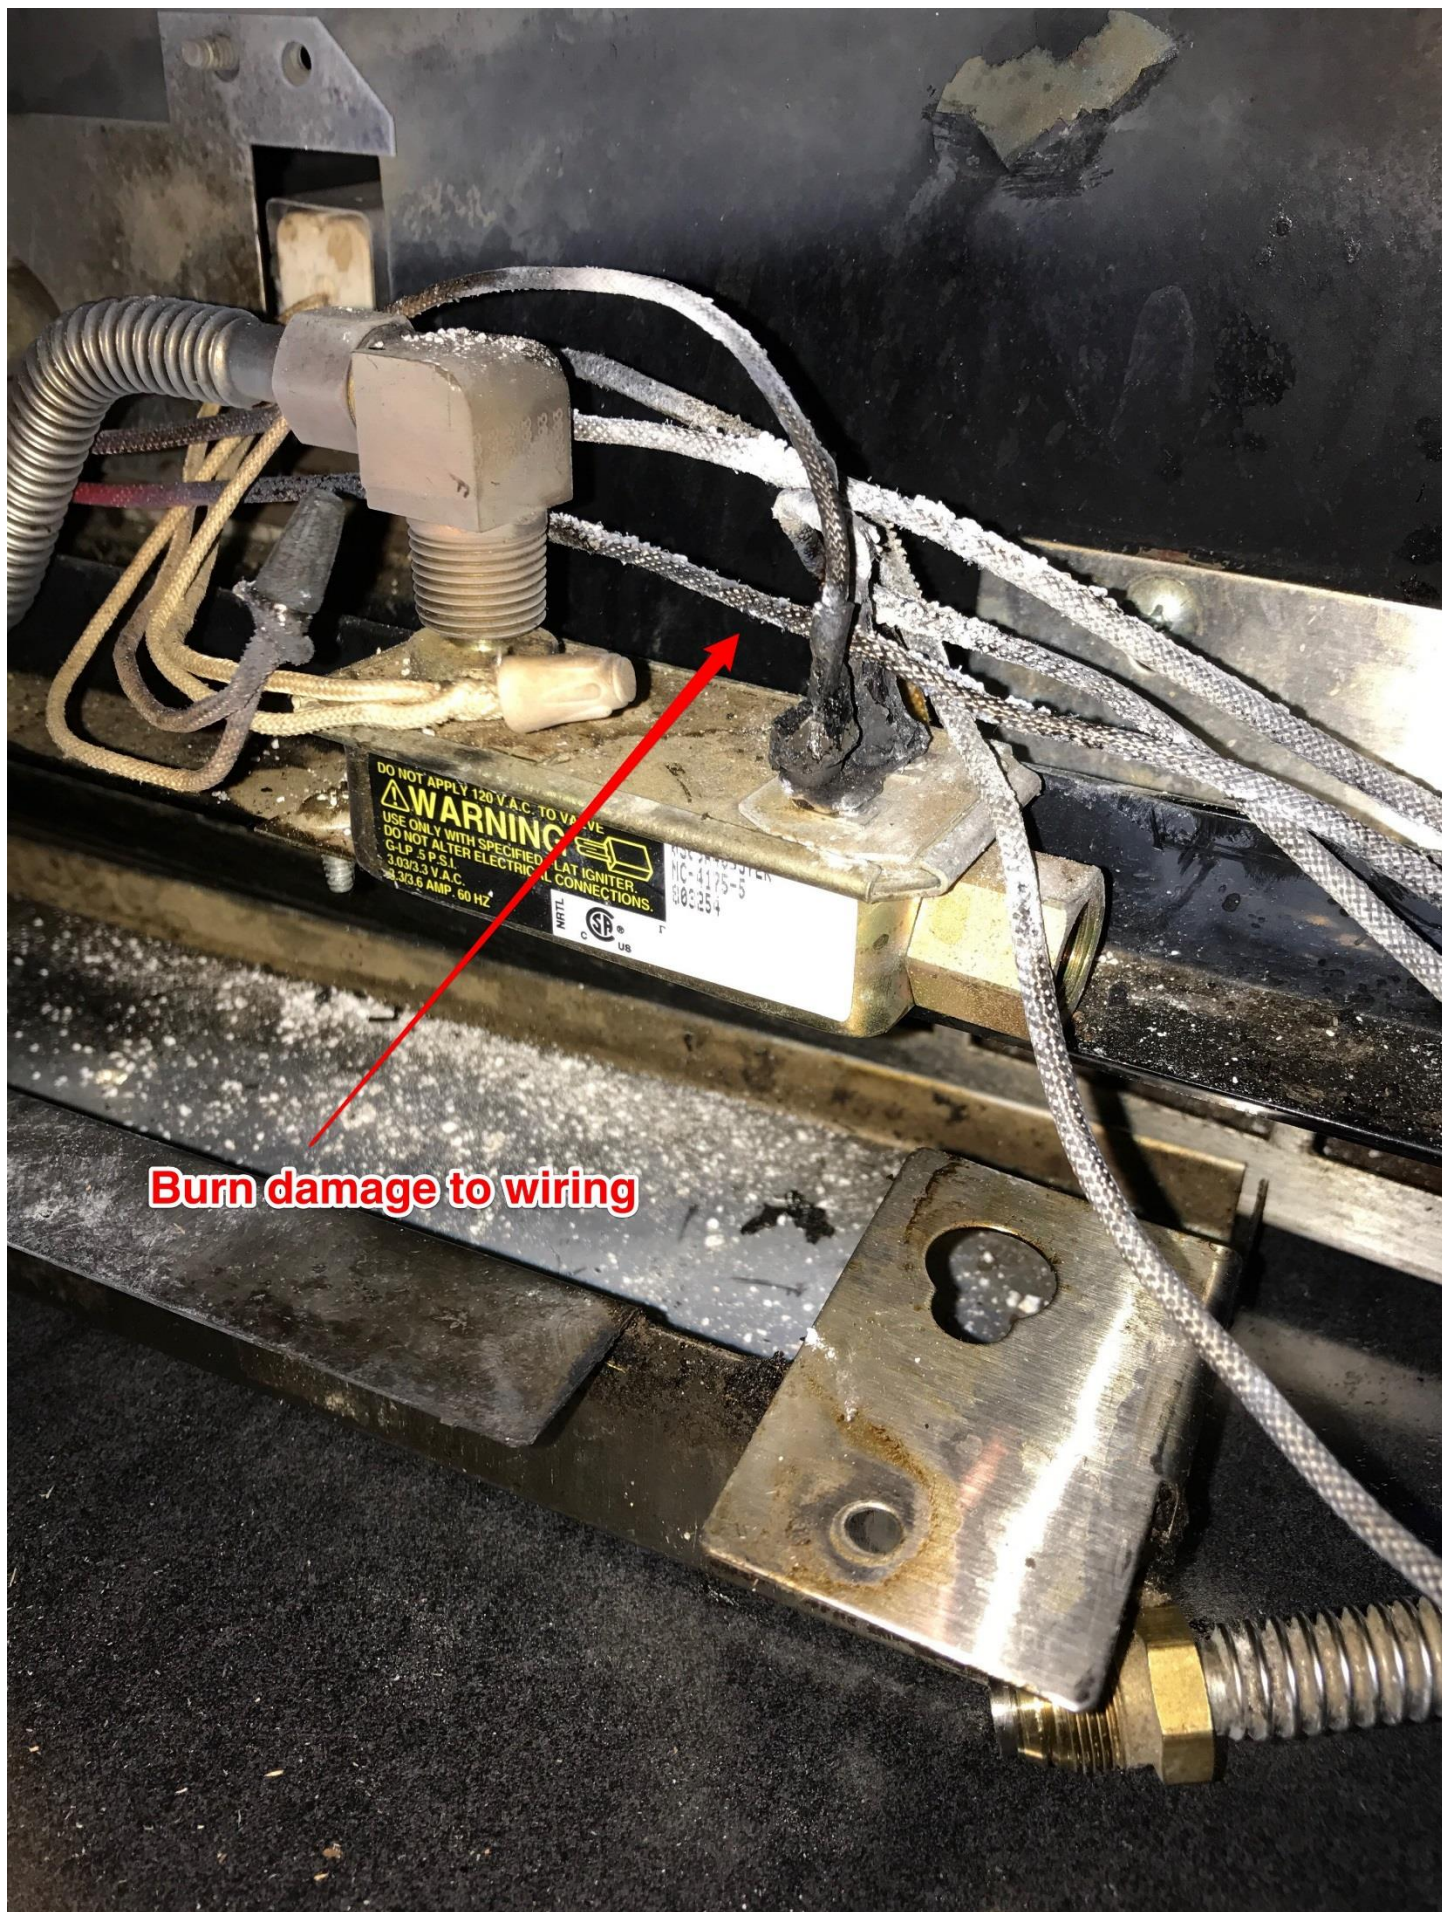
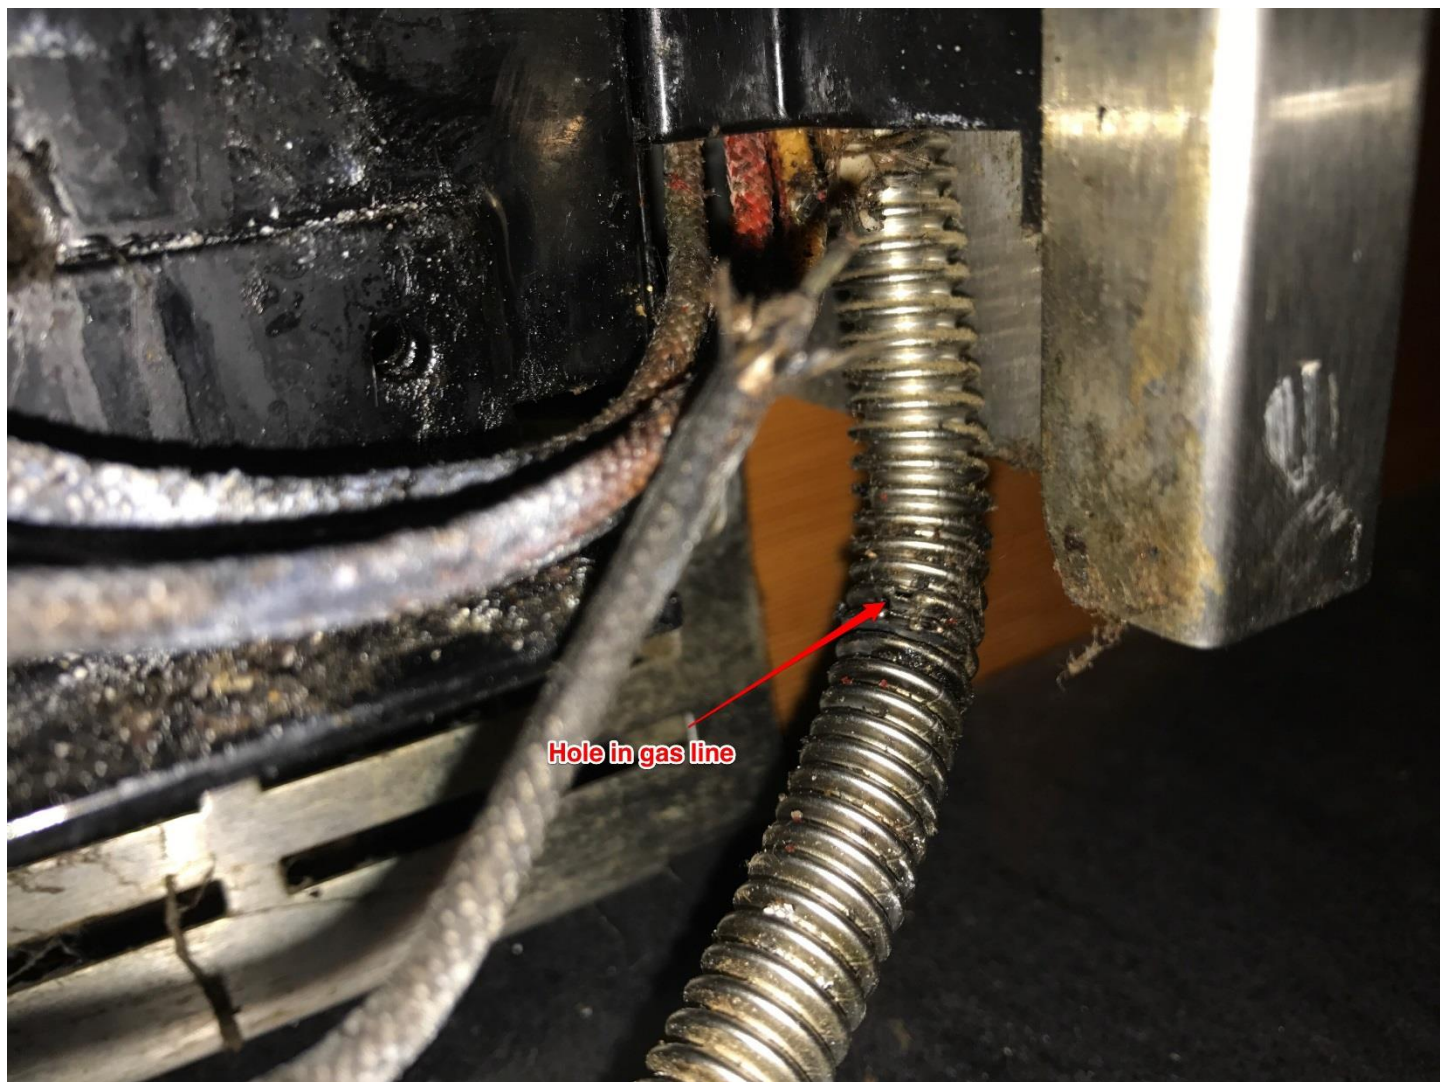
Photos or diagrams (if necessary)

INVESTIGATION CONCLUSIONS	Site, system and components		The electrical wiring and oven control gas line are routed through the same channel in the stove cabinet. When the oven is turned on, there is an electrical current sent to the ignition module and in turn opening the gas valve. When the oven reaches temperature, the valve then shuts off. This cycle is repeated until the oven is turned off.	
	Failure scenario(s)		The occupant was using the stove to cook dinner. When he turned on the oven, he heard a pop down by his feet, when he looked down, he saw flames coming from under the stove. He ran outside and turned off the gas at the propane tank.	
	Facts and evidence		Evidence shows that the wiring was being pinched between the CSST gas tubing to the oven control valve, and the sharp metal edge of the stainless steel side panel of the stove(see photos). Over time, the insulation on the wiring wore through to the energized conductor and when it arched to ground, it blew a hole in the tubing and ignited the gas, starting the fire.

Causes and contributing factors		Contributing factors were likely the sharp metal edge of the side panel of the stove wearing through the insulation on the wiring from being pinched against the CSST tubing.
