## Incident Summary #II-1718284-2024 (#47160) (FINAL)

| | Regulated industry sector | | Gas - Propane system | | | |
| | Incident overview | | Gas built up for approximately 30 minutes in a commercial cooktop/oven appliance. A worker then lit the pilot light with a lighter, igniting the buildup of gas causing an explosion inside the oven. Resulting in damage and injury. | | | |

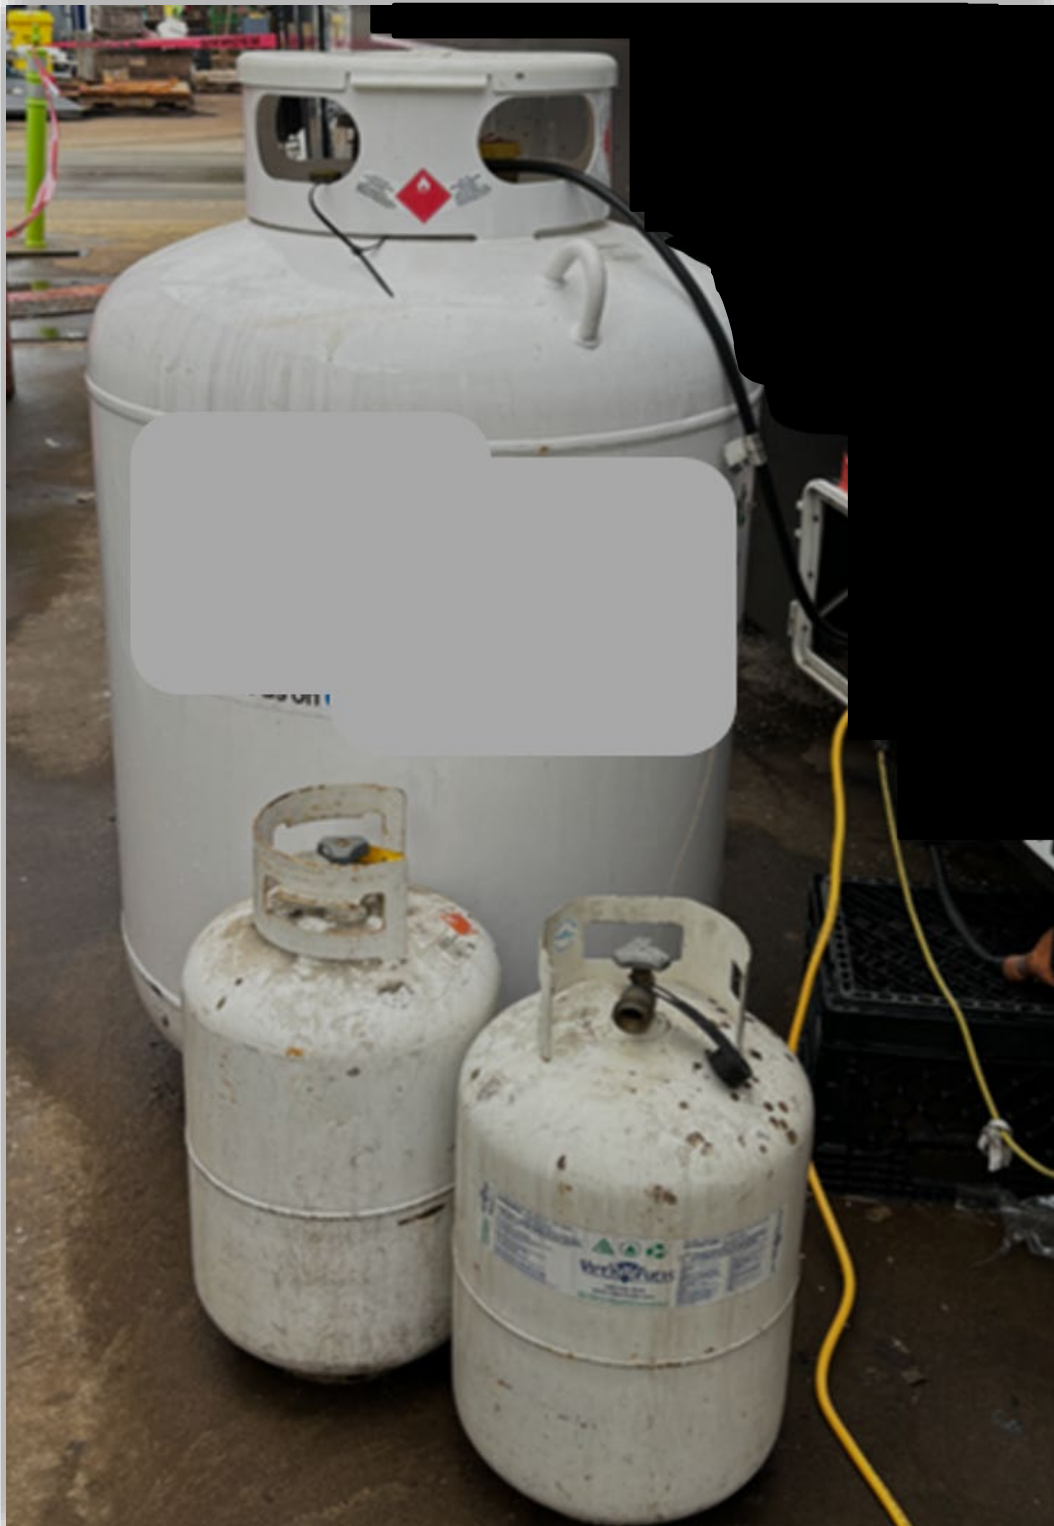
Image 1 – Example of propane cylinder sizes.

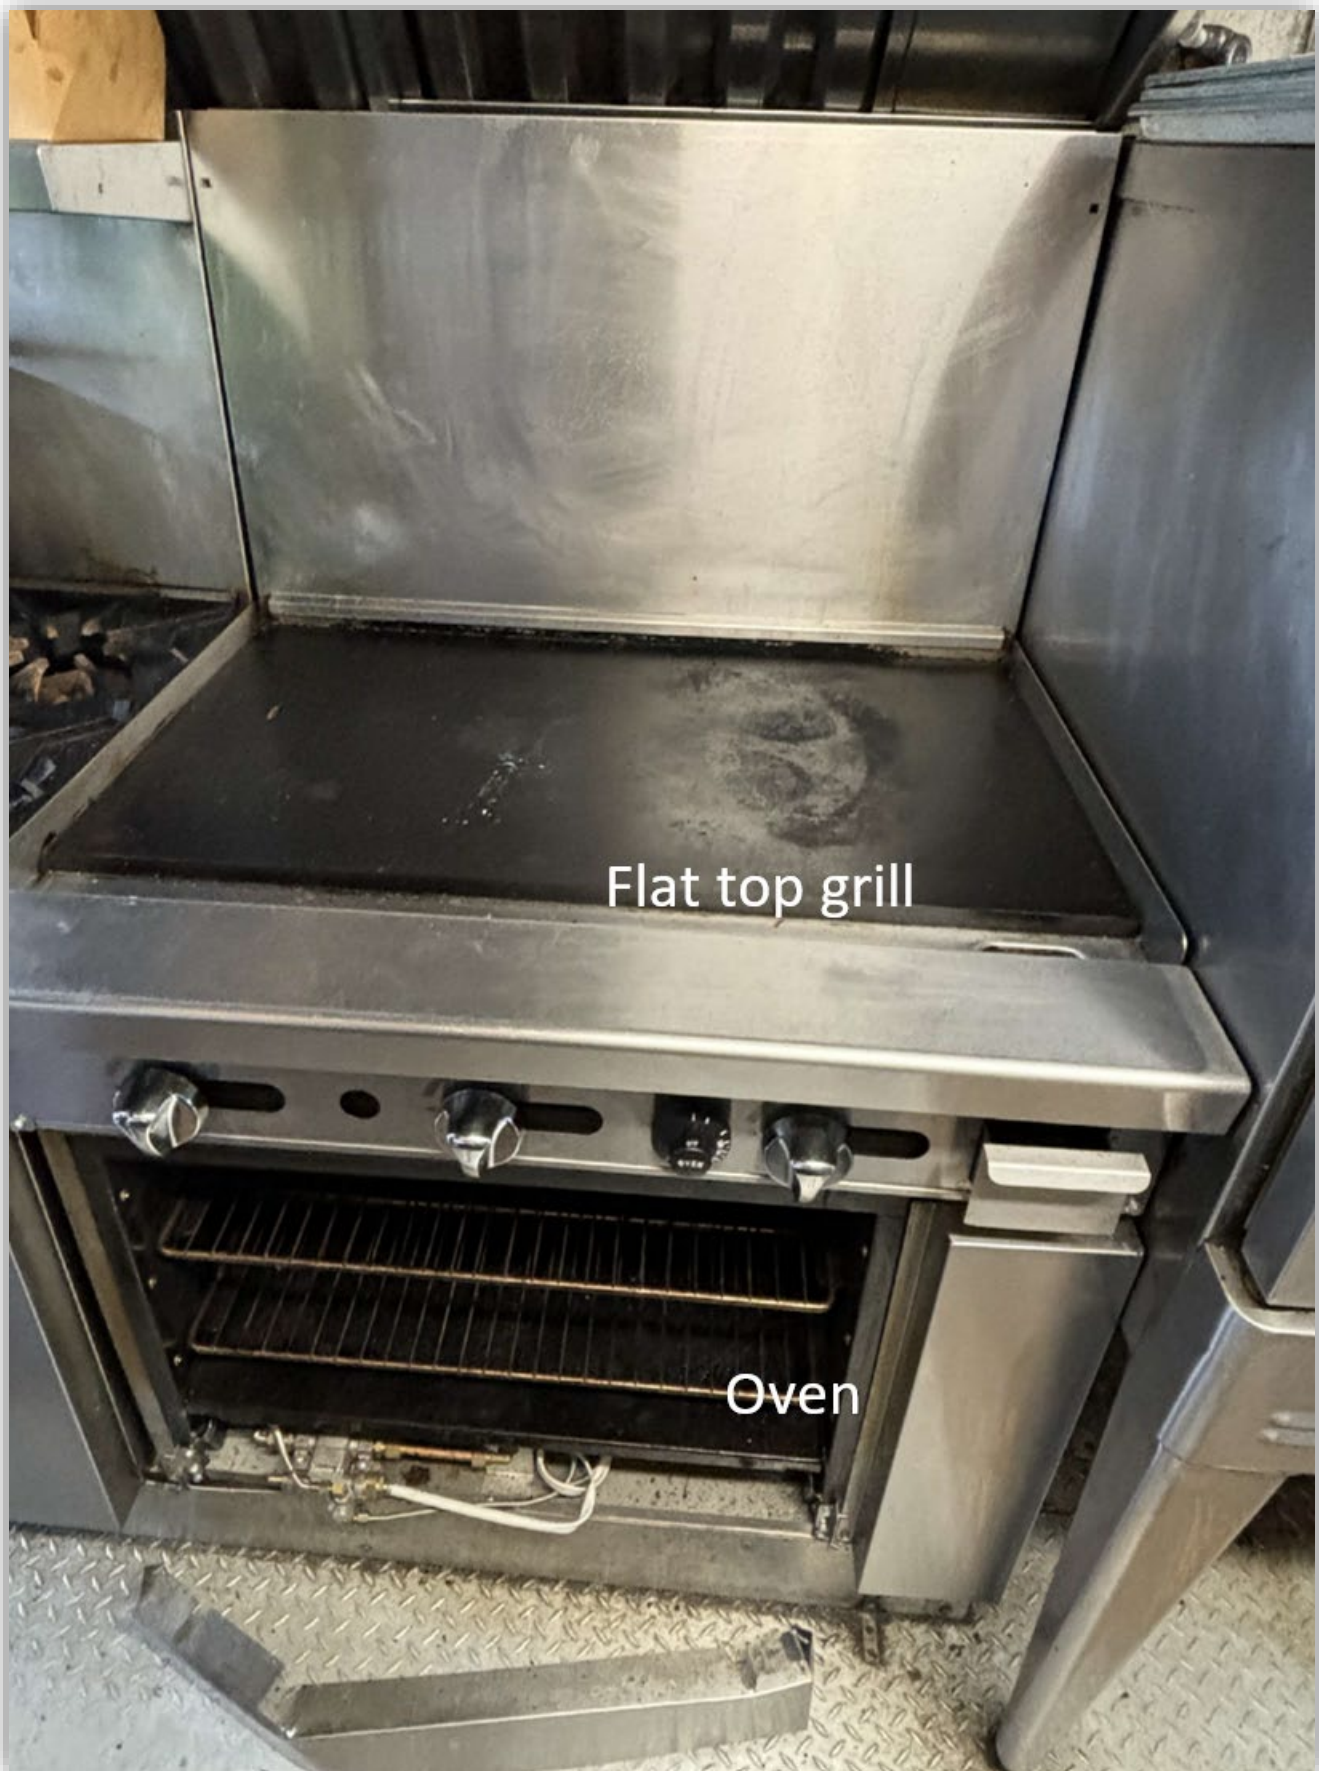
| | <p>Unbeknownst to the cook, the flat top oven did not have a pilot valve or safety thermocouple. As a result, once the propane system was energized, propane continually discharged from the pilot assembly. This gas accumulated in the oven chamber.</p> <p>Approximately 30 minutes after the propane system was engaged, a second worker arrived on site to begin meal prep. Assuming that the propane pilot had been lit, he turned on the flat top oven's main burner valve and proceeded to place bacon on the flat top grill. Turning on the main burner added further propane to the oven chamber. Recognizing that the bacon was not sizzling the worker realized that the pilot had not been lit.</p> <p>He proceeded to light the pilot with a wand (BBQ style) lighter, at which point there was a loud explosion that dislodged the oven door and blew out the windows of the food truck, injuring the workers knee.</p> |

Image 2 – Upper view of cooktop and oven post explosion.

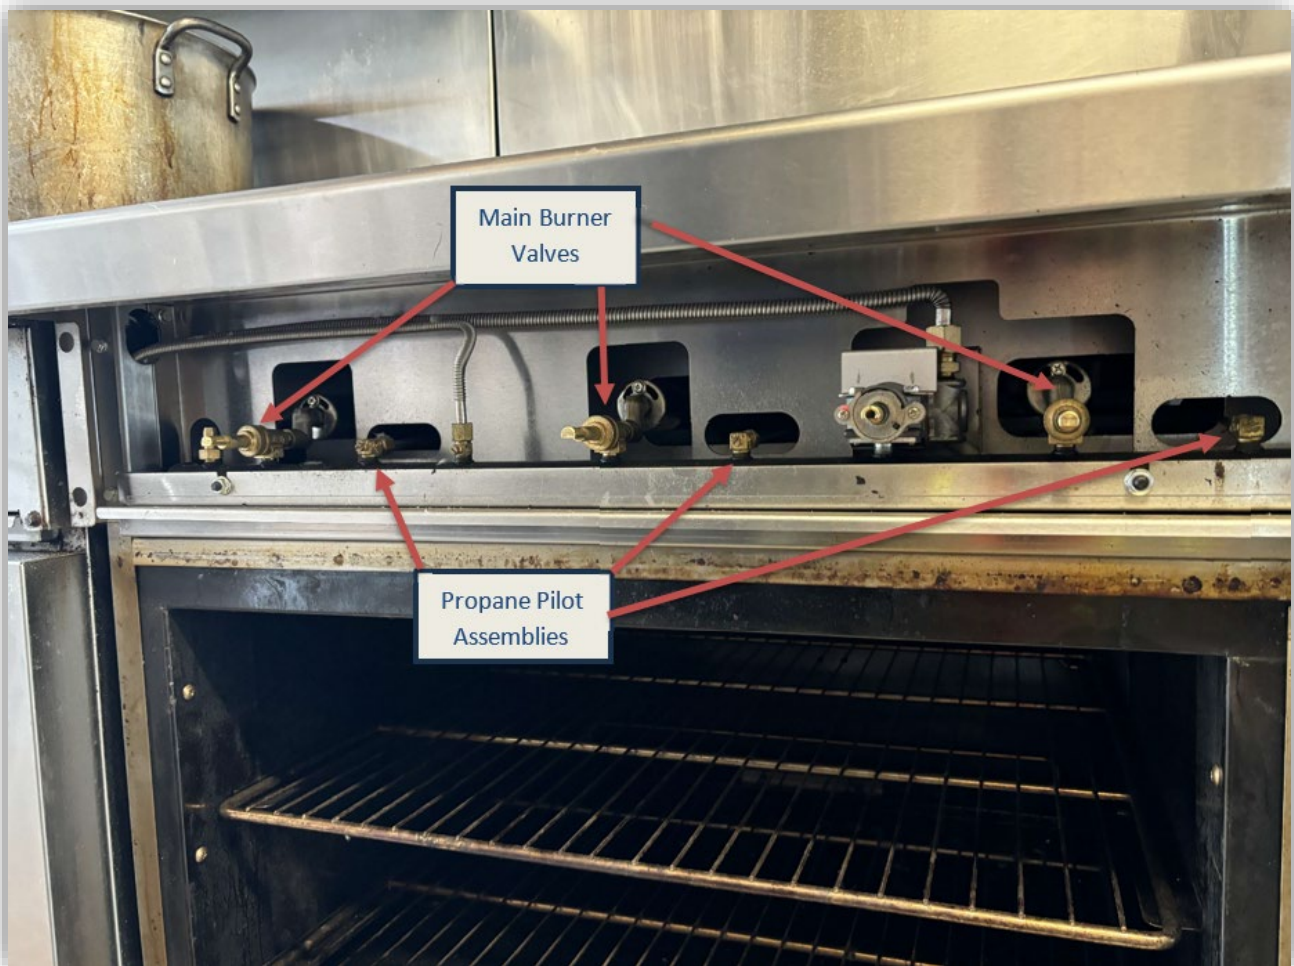
| | <p><b>Uncontrolled Pilot</b></p> <p>The appliance central to the incident is a flat top oven that incorporates a flat top grill and oven.</p> <p>This certified appliance has an uncontrolled pilot system that allows a small quantity of gas through the pilot assembly, which must be lit by hand before lighting the main burner. This pilot assembly does not include a safety thermocouple which would ensure that the pilot is lit before gas is allowed to freely flow through the pilot valve.</p> <p>With this type of pilot system, gas will continually emit from the pilot valve, even when there is no flame, creating a buildup of gas within the appliance. For appliances that incorporate this type of pilot assembly, it is critical to light the pilots immediately after the appliance has been gasified.</p> <p><b>Pilot with safety thermocouple</b></p> <p>Other gas appliances incorporate a pilot with a safety thermocouple. In this configuration, the pilot must be lit and proven by the thermocouple before gas is allowed to flow freely to the pilot valve. The user presses a button which allows gas to flow to the thermocouple, where a handheld lighter is used to ignite the gas. Once the gas is lit, the safety thermocouple heats up and holds the pilot gas valve open. If the pilot light goes, out the safety thermocouple will close the pilot gas valve, stopping the flow of gas. This prevents any gas build up inside the appliance, should the pilot fail to light or lose flame.</p> |

Image 3 – Oven burner valves and pilot assemblies.

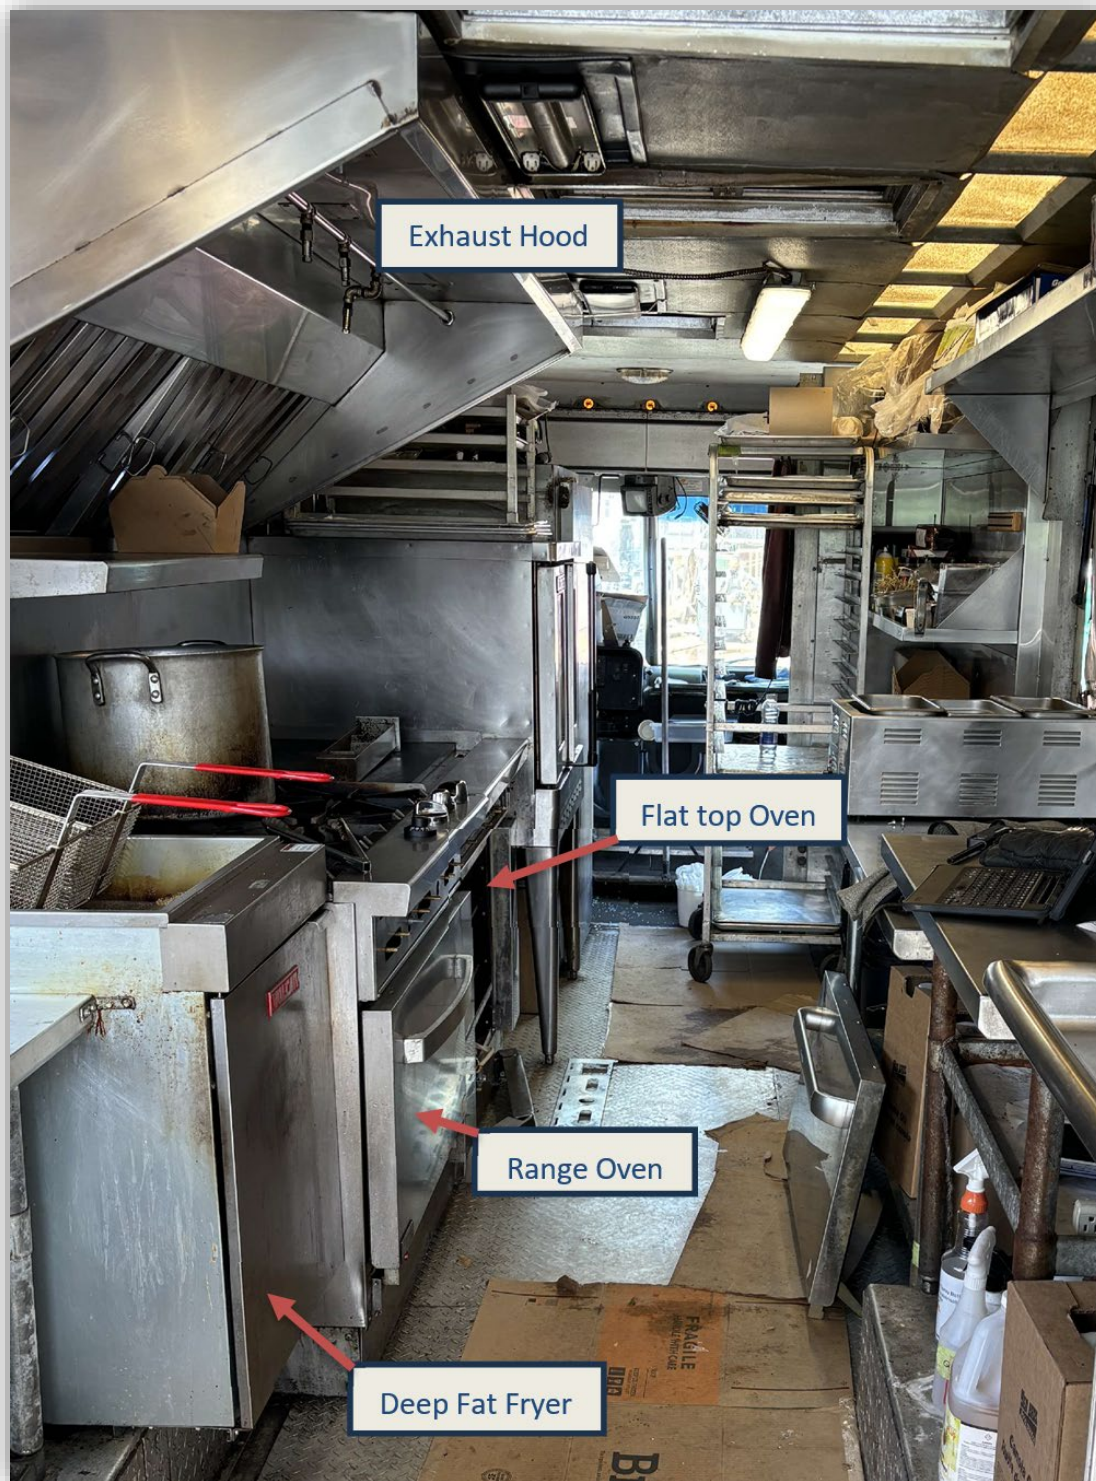
Image 4 - Inside food truck.

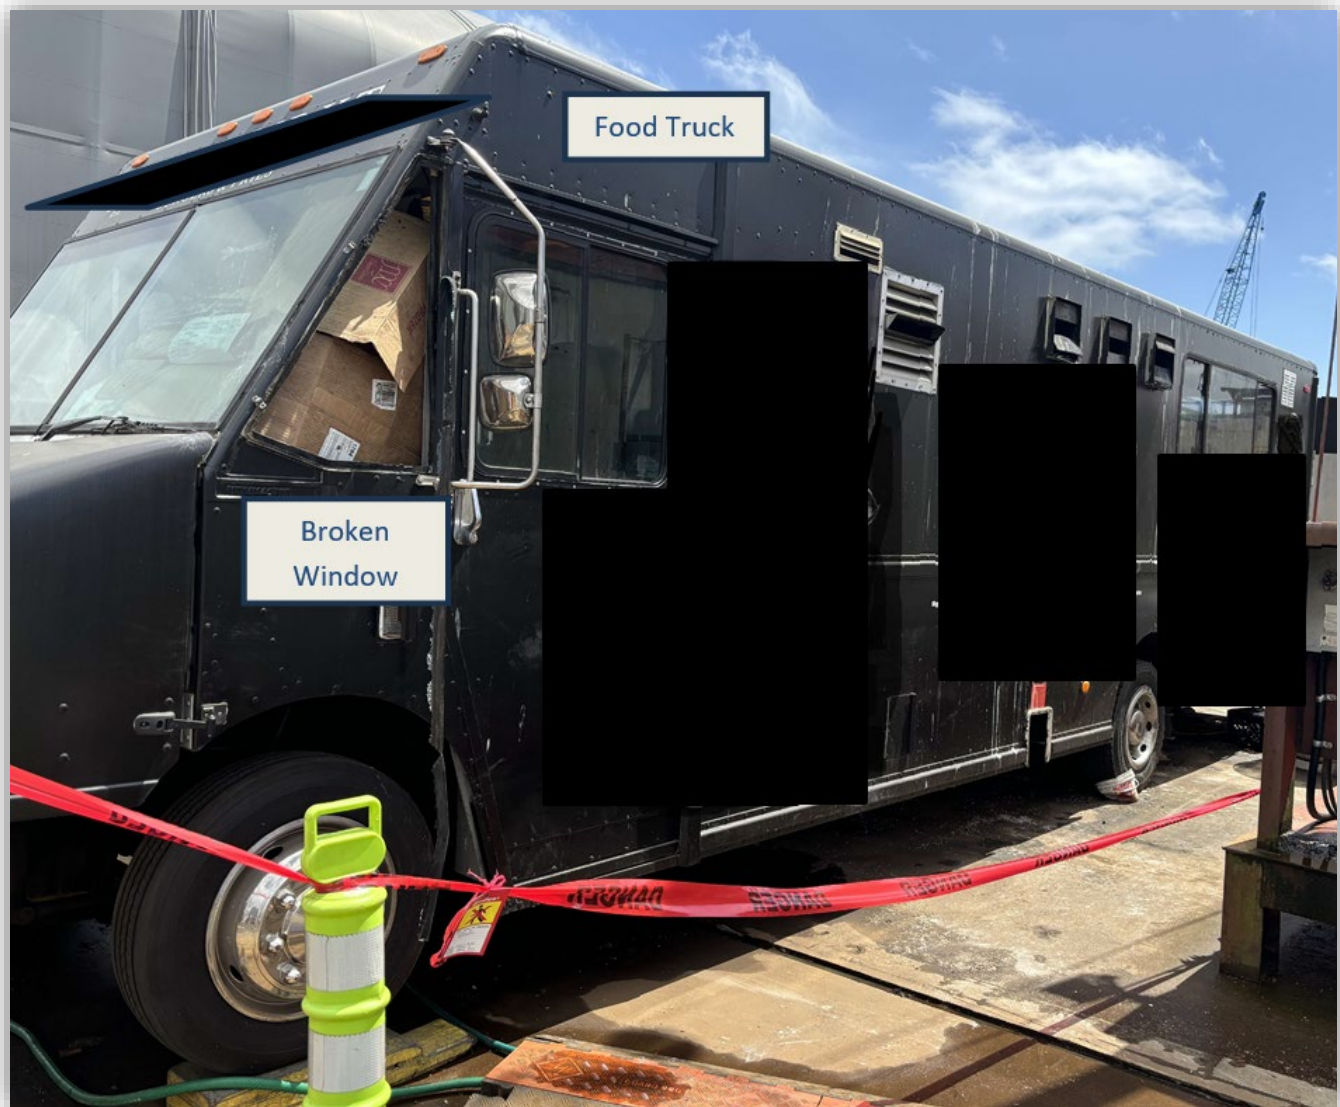
| | | Damage | Damage description | Dislodgement of oven door, shattered windows of food truck. | | |

Image 5 - Damage to food truck post explosion from front driver side.
