## Incident Summary (Reference # 5618323) ( Final)

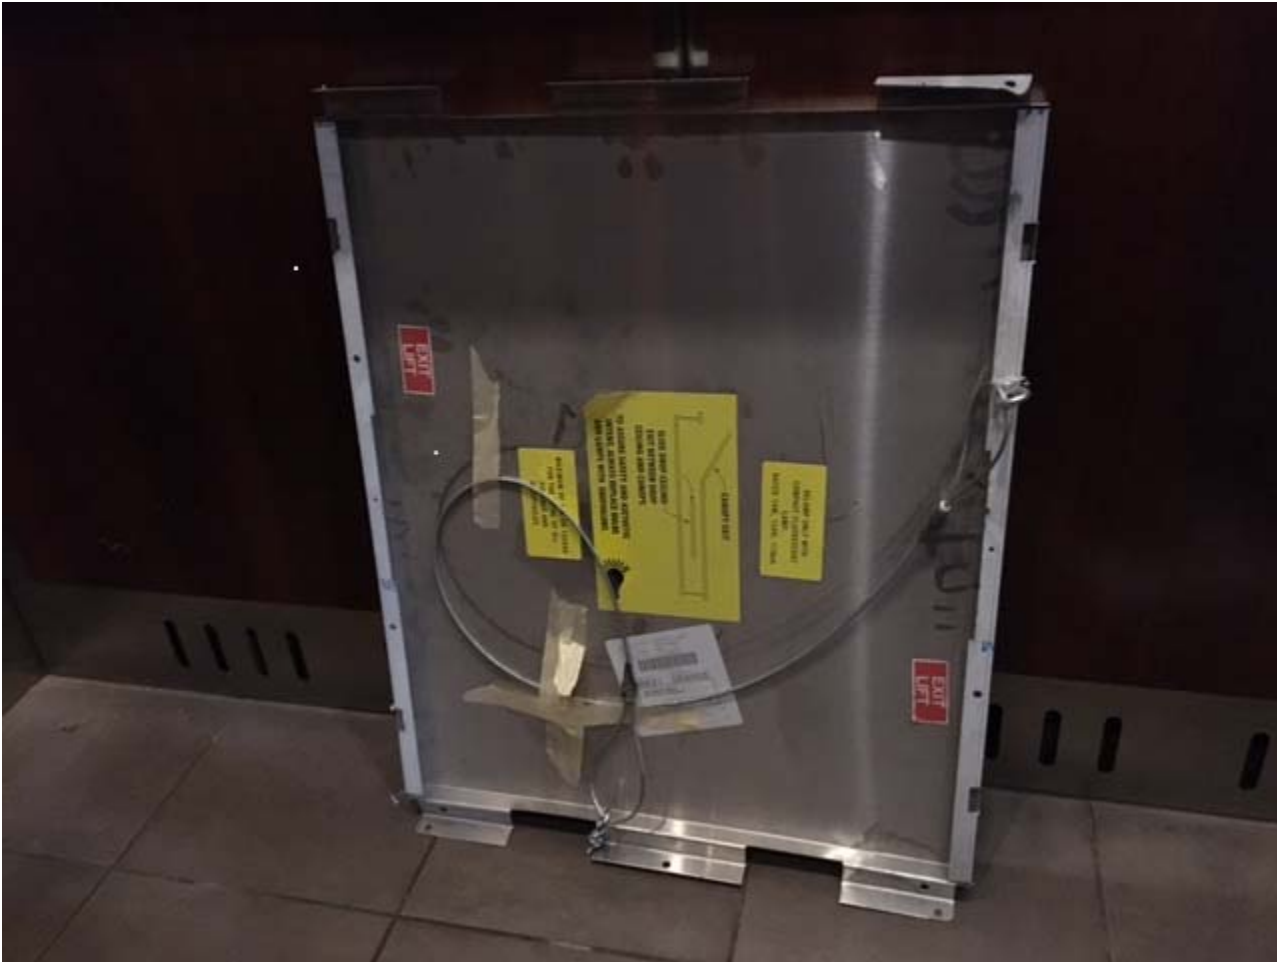
Failure scenario(s)		The elevator escape hatch panel shifted from its normal secure position and fell from the ceiling. The escape hatch securing cable was not attached allowing the hatch to drop to elevator cab floor.	
	Facts and evidence		<ul style="list-style-type: none"><li>• Photo of escape hatch and securing cable. Photo shows the securing cable taped to inside of hatch panel indicating that cable may not have been secured. ( Photo 1)</li><li>• Elevating contractor states panel appears to be in normal condition.</li><li>• Notifier reported “panel fell from elevator cab interior on to passenger inside car.”</li><li>• See attached photos.</li></ul>	
	Causes and contributing factors		It is likely that the elevator emergency escape panel moved from its proper secured position due to improper installation or tampering by a user. It is highly probable that the securing drop cable was not attached to elevator cab. This would allow the hatch to fall and strike the user in the head and then drop to the floor.

*Photo 1- Emergency Escape hatch. Hatch securing cable taped to the interior of the hatch. Photo taken on-site by notifier after incident occurred prior to any repair work.*

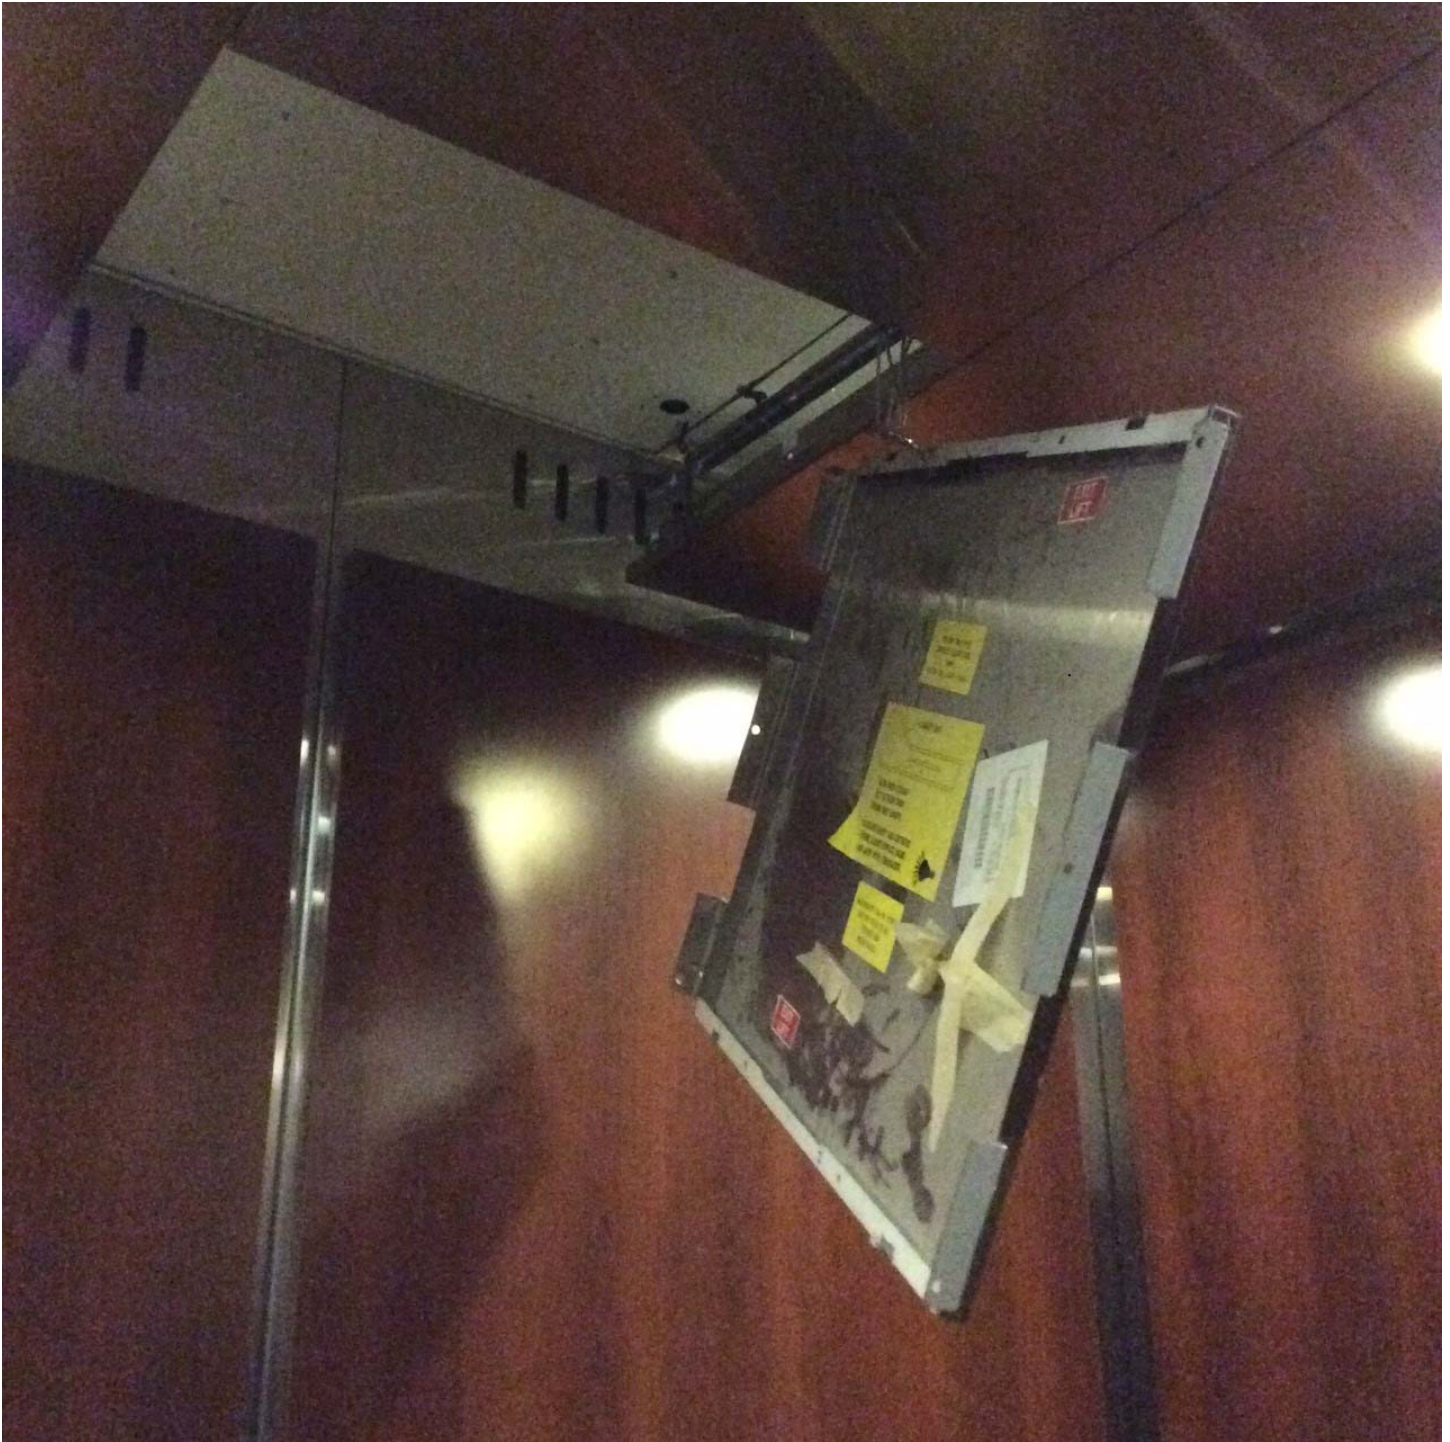
*Photo 2. Elevator escape hatch panel securely fastened to elevator cab. Approximately 72 inches from cab floor to lowest edge of escape hatch panel. Photo taken after hatch re-installed.*
