## Incident Summary #II-1183960-2021 (#21757) (FINAL)

SUPPORTING INFORMATION	Incident Date		April 22, 2021	
	Location		Whistler	
	Regulated industry sector		Gas - Natural gas system	
	Impact	Injury	Qty injuries	0
			Injury description	Not Applicable as no one was injured
			Injury rating	None
		Damage	Damage description	The unit where the portable BBQ was located, sustained fire damage to middle floor balcony's party wall and the overhang above the backdoor entrance, the fire traveled up the party wall and entered the attic space of the unit next door which spread through the unit's entire top floor and attic.
			Damage rating	Major
Incident rating		Major		
Incident overview		A portable BBQ was connected to the unit's gas supply by the means of a quick connect device, located at the right-hand side of the door leading into the unit from the balcony, the portable BBQ was located close to the combustible party wall and below the combustible overhang. The portable BBQ was lit and left unattended. During this time the portable BBQ ignited the party wall.

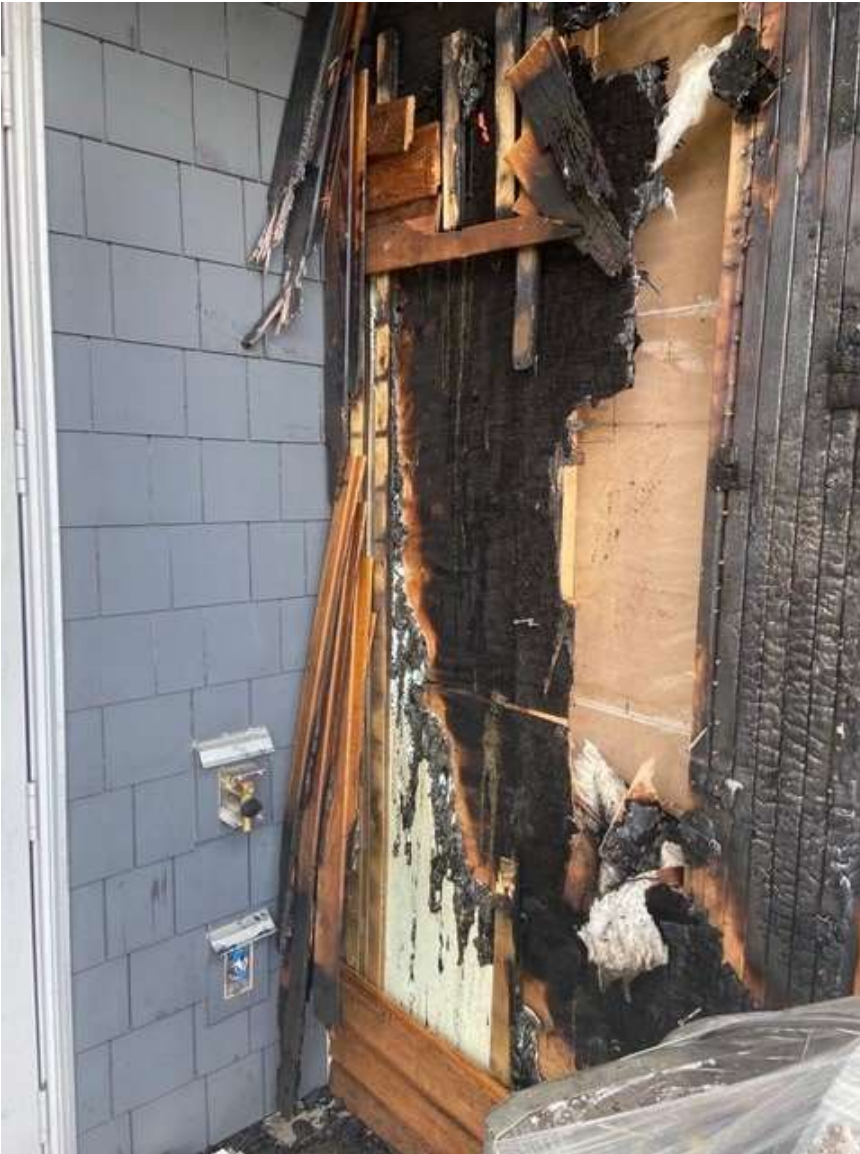
Image 1 - Damage to party wall where the portable BBQ was being operated

Causes and contributing factors	<p>The cause of the incidence is most likely to be that the portable BBQ was positioned within the prohibited area surrounding and above the portable BBQ as required by the manufactures certified installation instructions, together with the portable BBQ being left unattended while in operation which was also prohibited by the manufactures certified installation instructions. The event that happened within the portable BBQ was a contributing factor but if the manufactures certified installations had been adhered to the severity of the event could have been drastically reduced or even been avoided.</p>

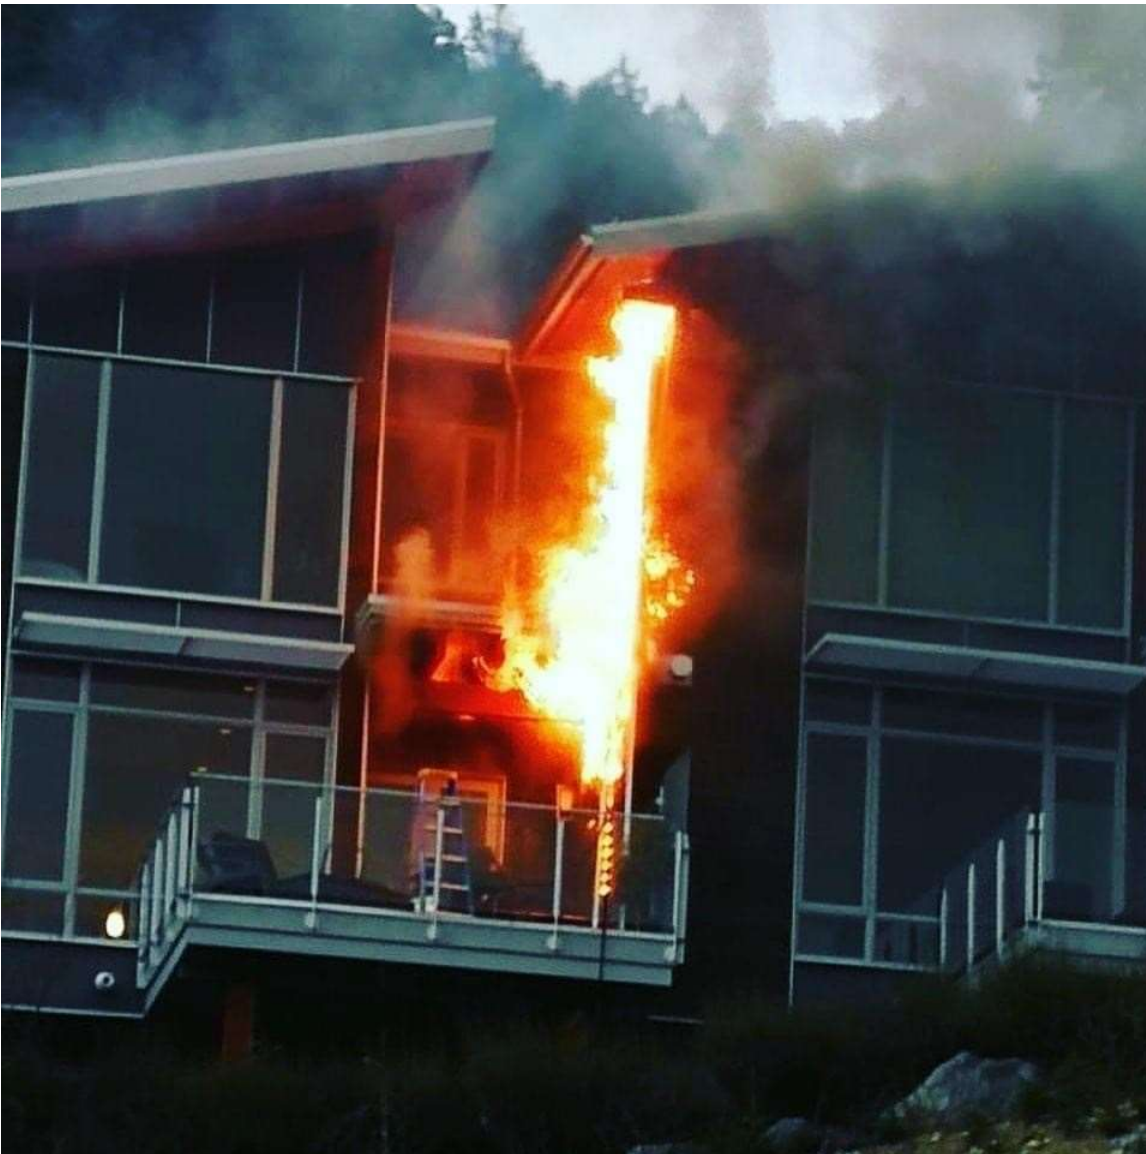
Image 2 - Actual fire where the portable BBQ was

portable BBQ was being used there was a period of time where the portable BBQ was left unattended, whereupon an event happened within the confines of the portable BBQ which allowed flames passed its confines. The flames then ignited the combustible party wall, the flames then traveled up the party wall and into the attic space of the unit next-door which then spread throughout the top floor of said unit.
Facts and evidence	<p>Manufacturer's installation and operating instructions</p> <ul style="list-style-type: none"> <li>• Clearance of 24" minimum is required to combustible material on all sides</li> <li>• It must not be used under any combustible construction</li> <li>• It must not be left unattended</li> </ul> <p>Interviews</p> <ul style="list-style-type: none"> <li>• The occupant started the portable BBQ and was reported to have left it unattended.</li> <li>• The fire originated from the rear of the BBQ and spread up the wall into the attic space of the unit next-door</li> </ul> <p>Photos (Supplied by municipality building official)</p> <ul style="list-style-type: none"> <li>• The BBQ was directly in front of a combustible wall</li> <li>• The burn patterns show the origin of the fire was from behind the BBQ</li> <li>• There was a hole in the back of the BBQ</li> </ul>

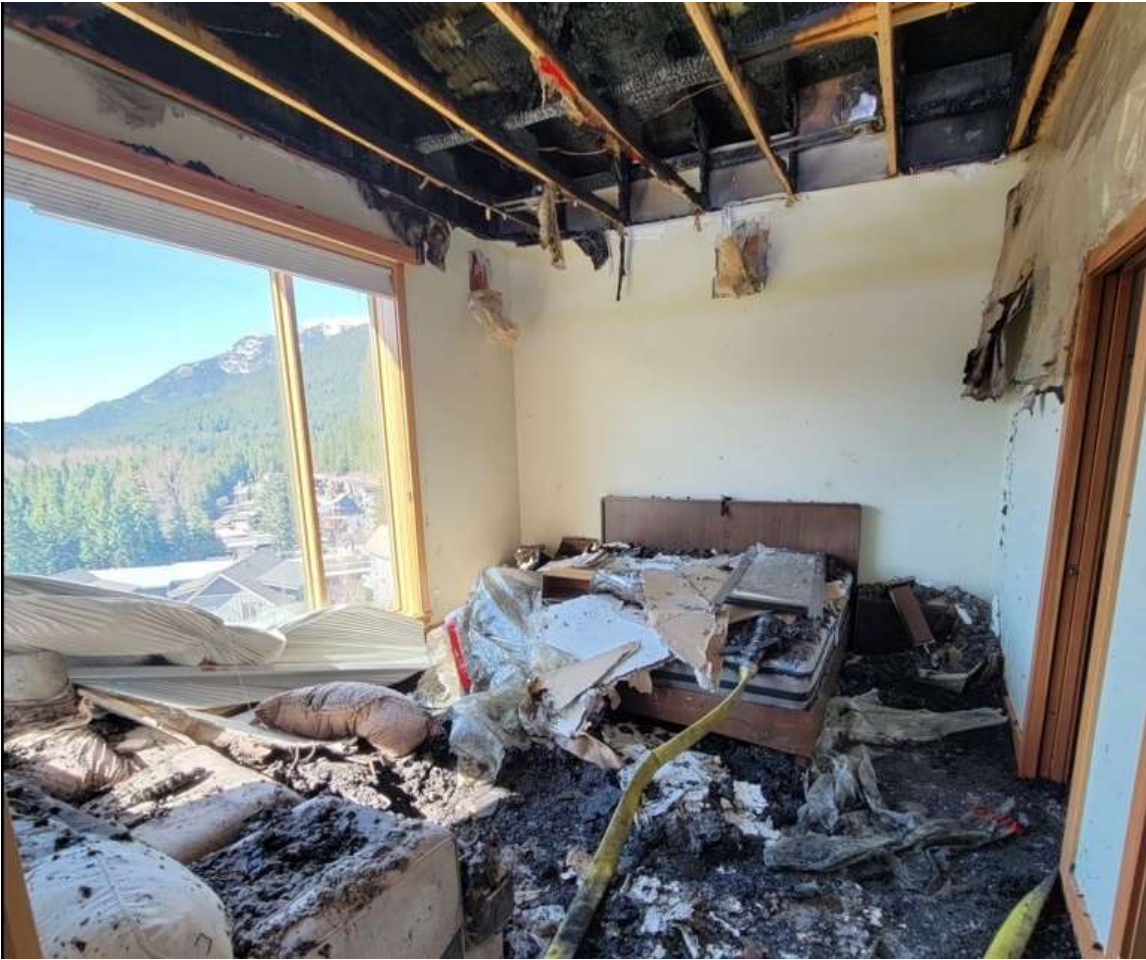
Image 3 - Fire entry point to next-door
