Incident Summary (Reference #II-636571)

| SUPPORTING INFORMATION | Incident Date | | January 1, 2018 | |

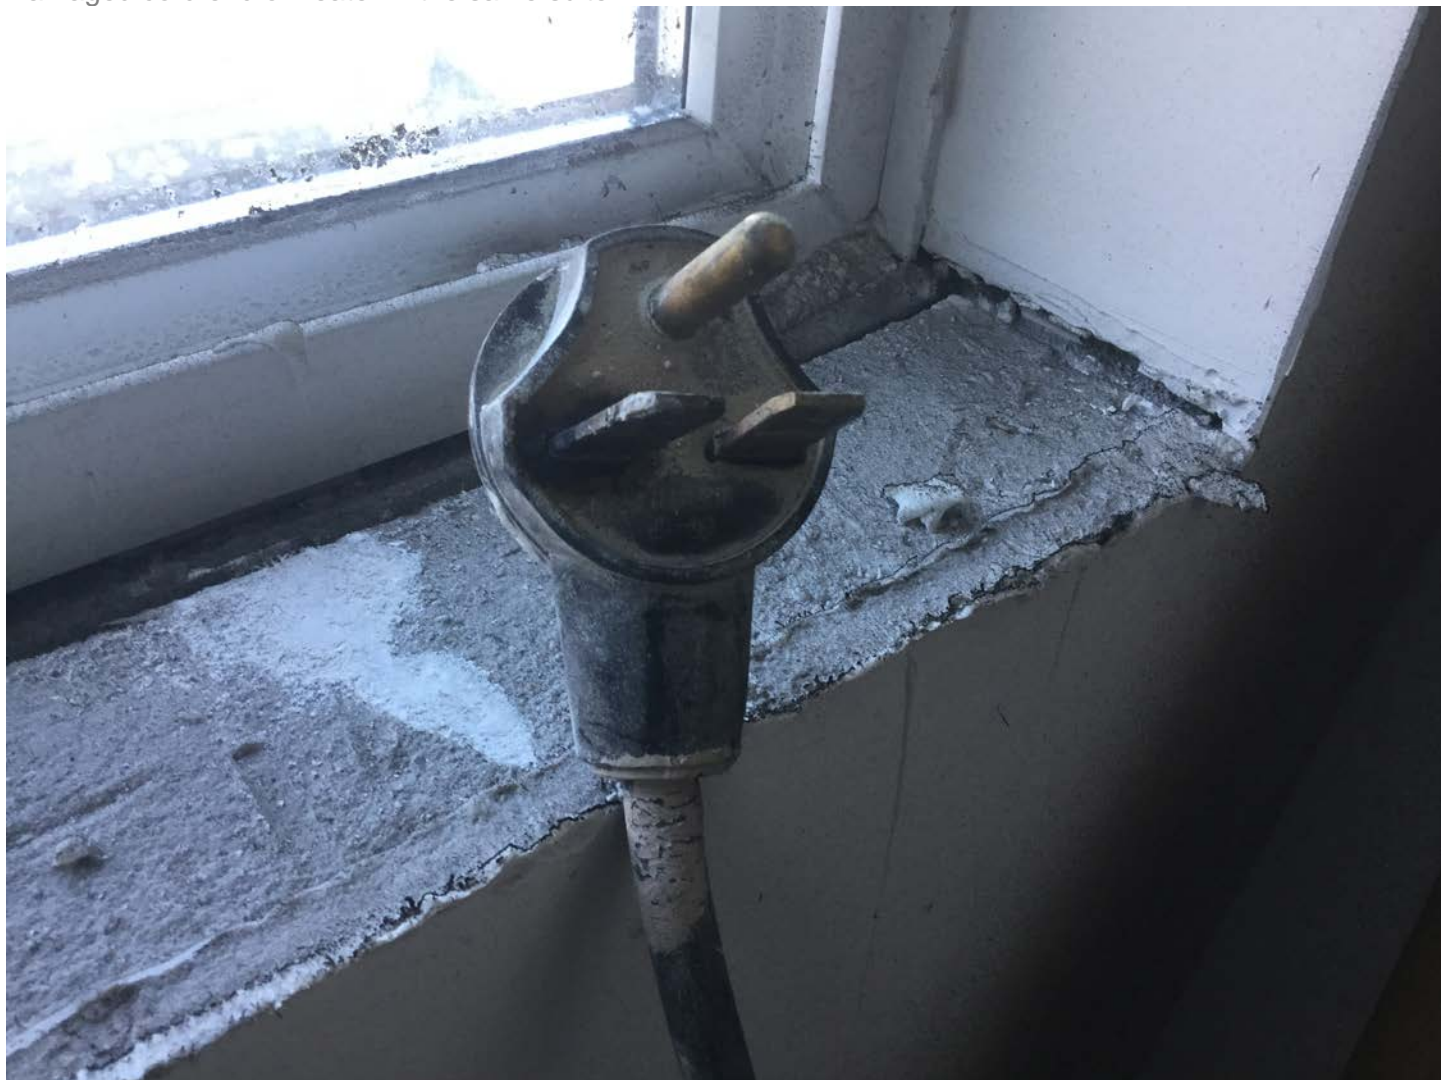
Drywall heater label.

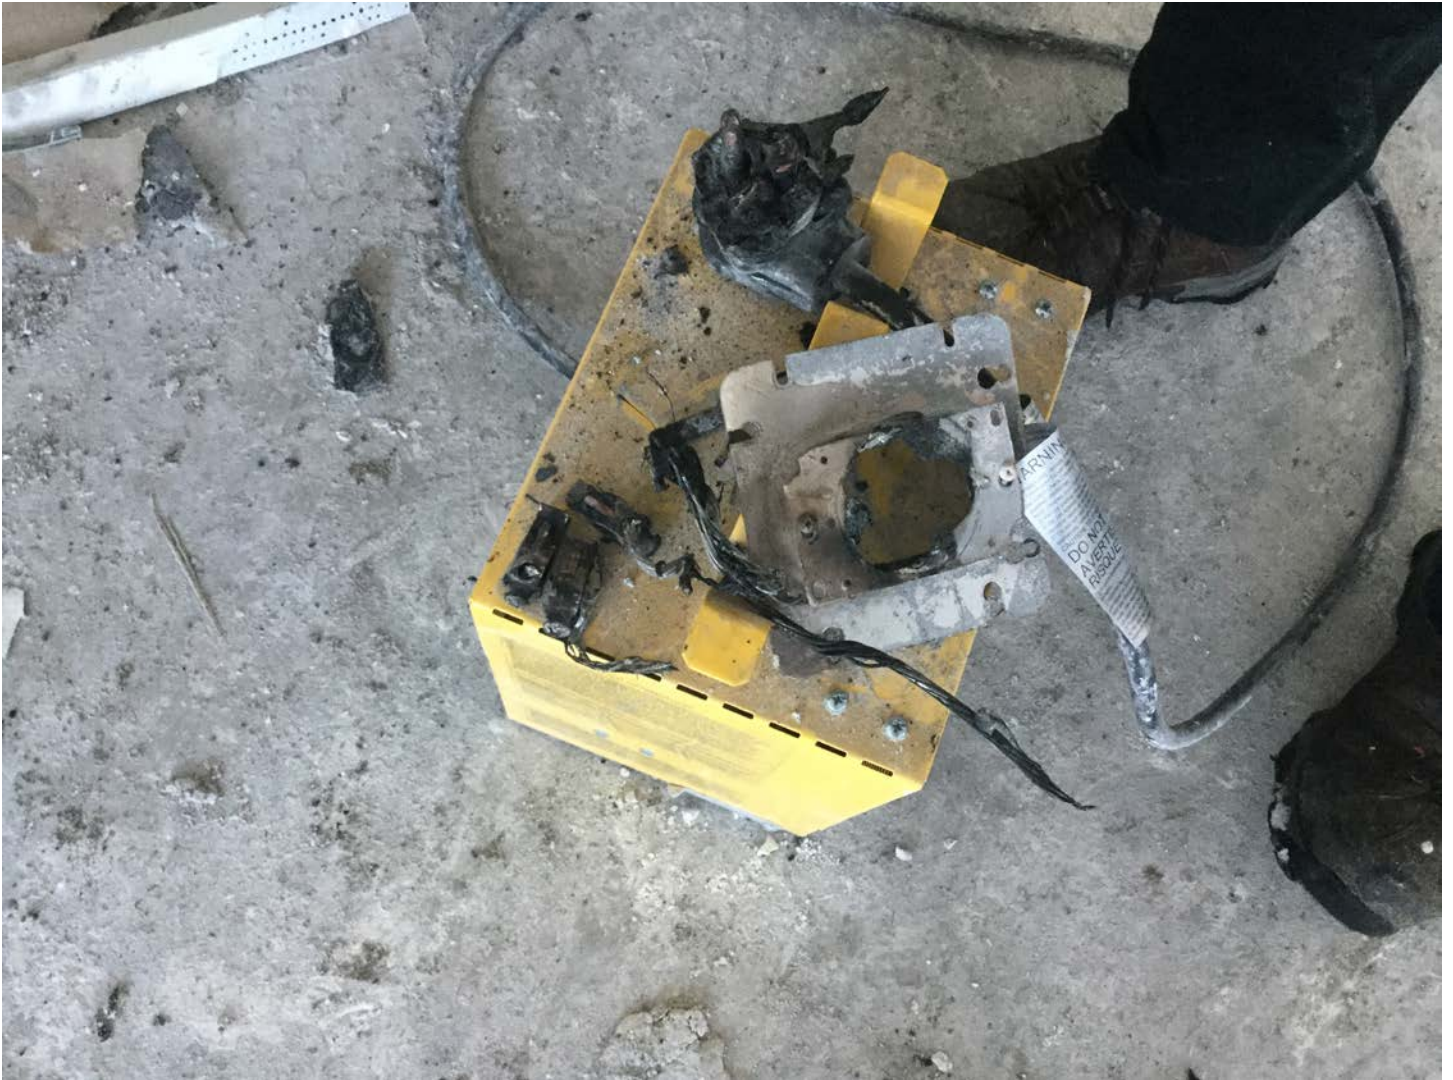
Heater used at time of fire.
