Incident Summary #II-1232047-2021 (#23052) (FINAL)

SUPPORTING INFORMATION	Incident Date	August 4, 2021	
	Location	Williams Lake B.C.	
	Regulated industry sector	Gas - Propane system	
	Impact	Qty injuries	1
		Injury description	Propane explosion, first degree burns to forklift operator.
		Injury rating	Moderate
	Damage	Damage description	Propane dispensing system taken out of service
		Damage rating	Insignificant
	Incident rating	Moderate	
Incident overview	A forklift operator at an industrial site was filling a liquid propane cylinder on the forklift and also heard a hissing sound. The operator then started the forklift and a flash fire explosion occurred at the forklift and propane dispensing system.		
INVESTIGATION CONCLUSIONS	Site, system and components	<p>The facility is an industrial wood processing plant with a propane dispensing system.</p> <p>Propane fuelled forklifts are used at this facility for movement of product. When necessary, the employees operate the propane dispenser to fill empty propane cylinders located on the Forklifts to continue in service operation.</p> <p><u>Cylinder</u> — a container designed and manufactured in accordance with a cylinder specification a

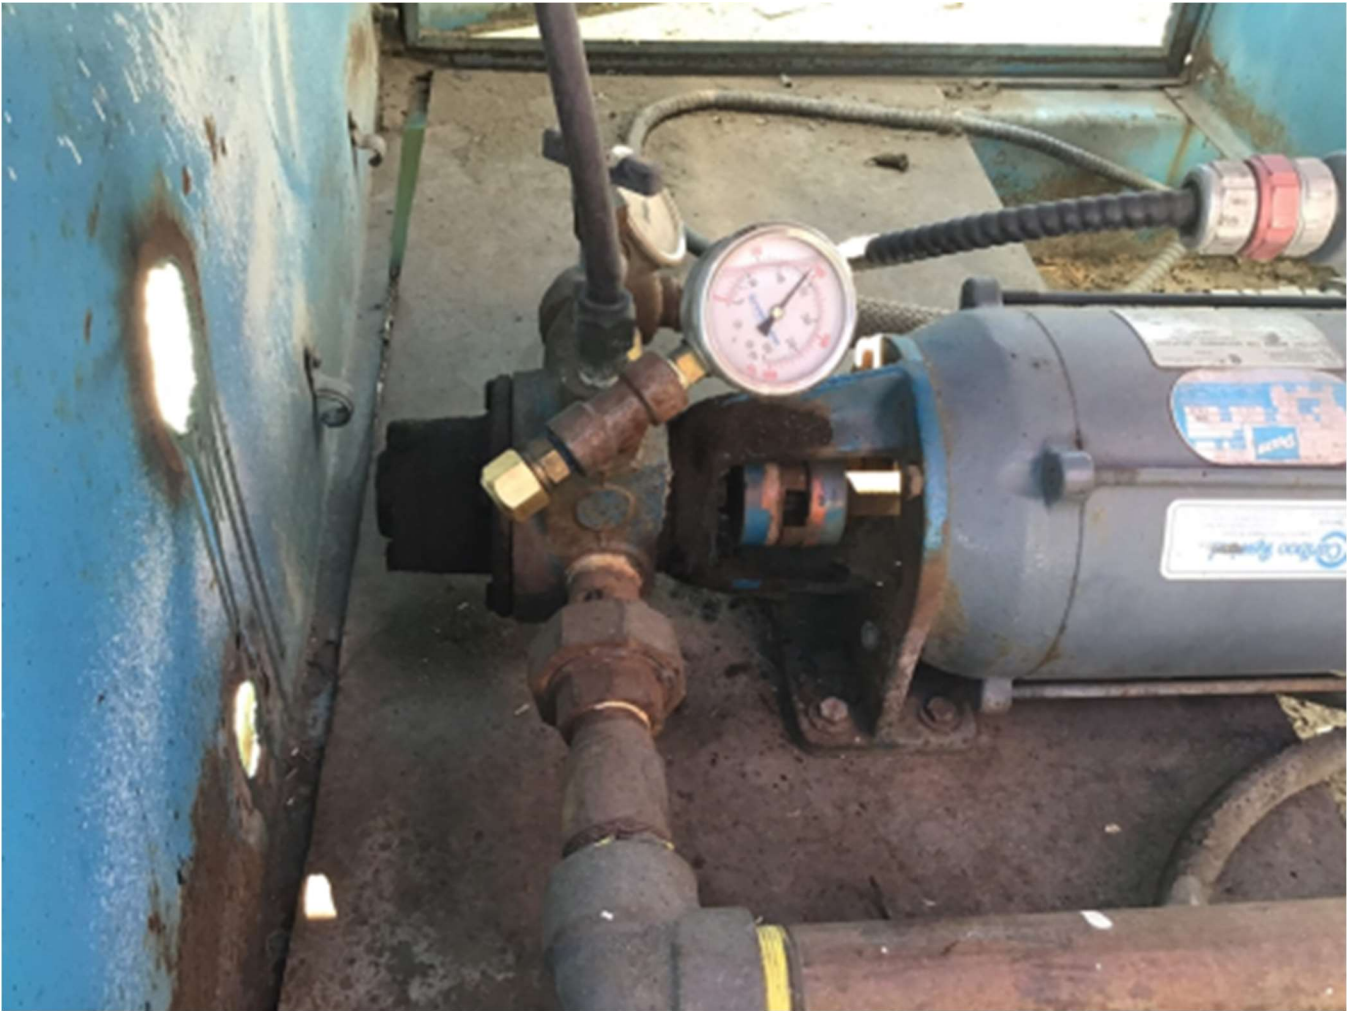
Image 1 - Discharge gauge on liquid pump, and hydrostatic relief removed

<p>Facts and evidence</p>	<p>Site observation</p> <p>A hydrostatic relief valve installed in the liquid piping of the propane dispensing system was found to have an identified discharge setting of 250 psi marked on the valve. This did not meet the minimum required discharge pressure of 375 psi.</p> <p>Witness statements</p> <p>The forklift operator had not received training on how to properly fill a cylinder and did not hold a required training certificate. The operator did not know the location of the emergency shutdown for the propane dispensing system.</p>
<p>Causes and contributing factors</p>	<p>The cause of the incident was likely due to an incorrect hydrostatic relief valve with too low of a pressure setting on the liquid pump at the propane dispenser.</p> <p>The lack of training and qualifications of the operator filling the cylinder likely contributed to the incident by them creating a source of ignition by starting the forklift while it was surrounded by the propane gas that had leaked out.</p>

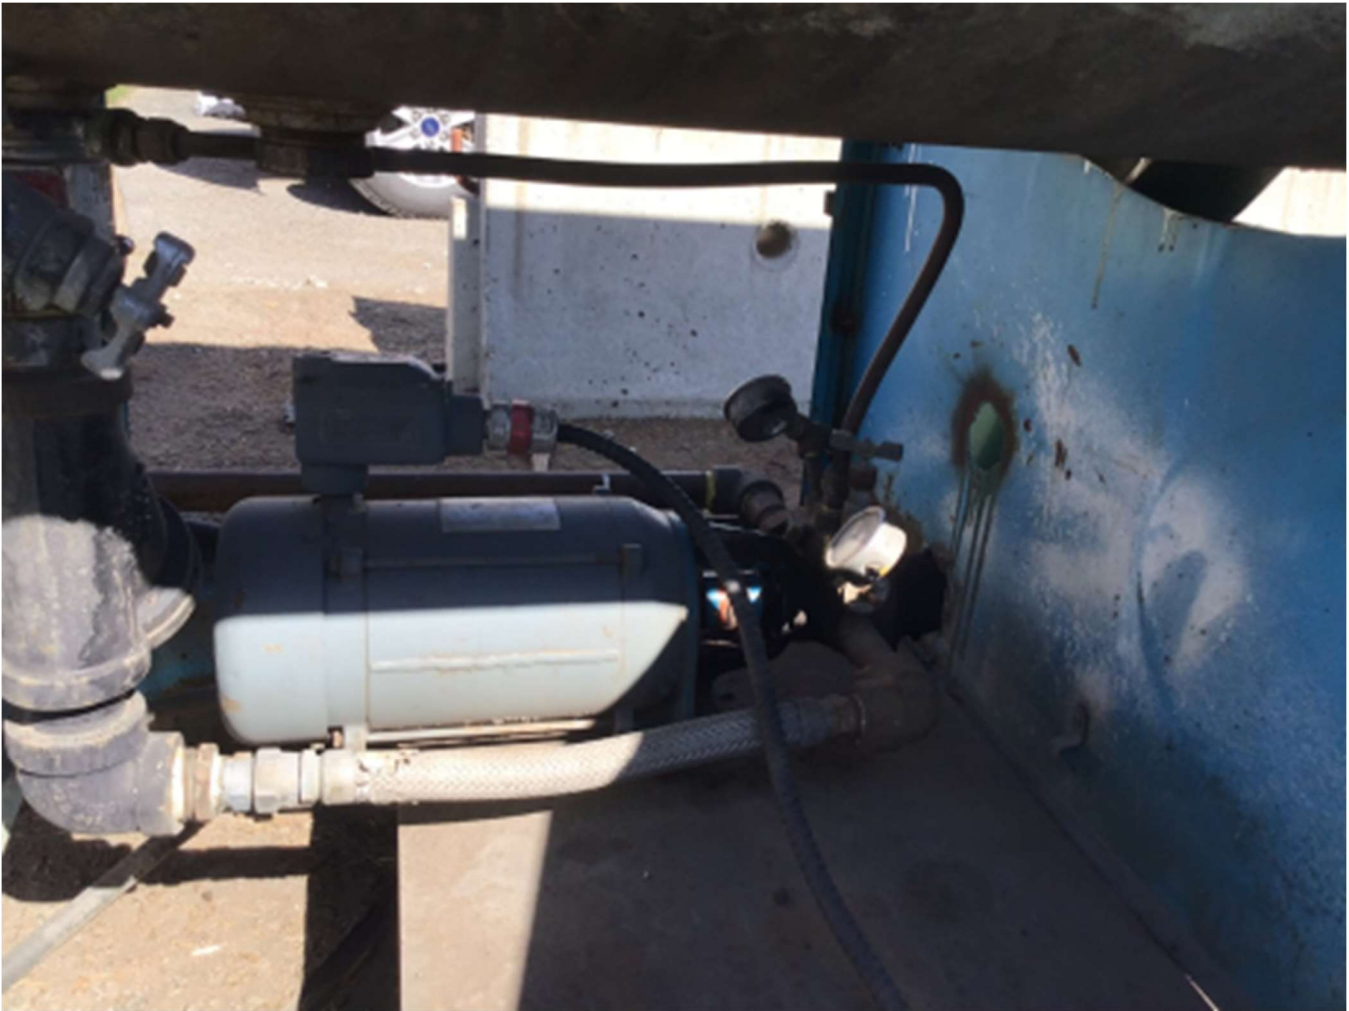
Image 2 - Pump overview and bypass

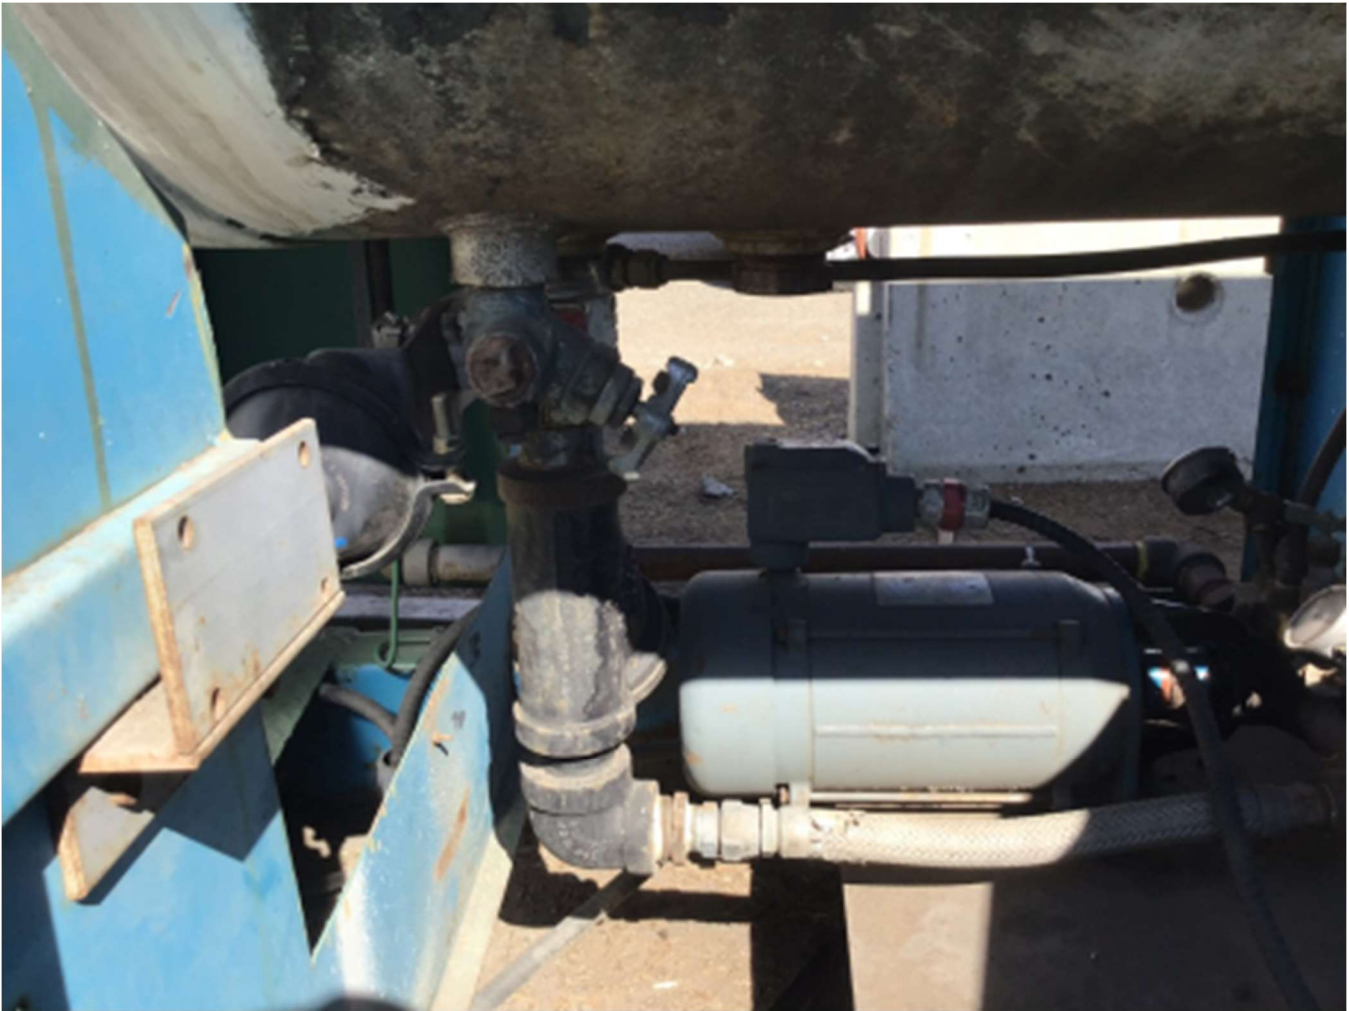
Image 3 - Internal safety control and emergency shutdown

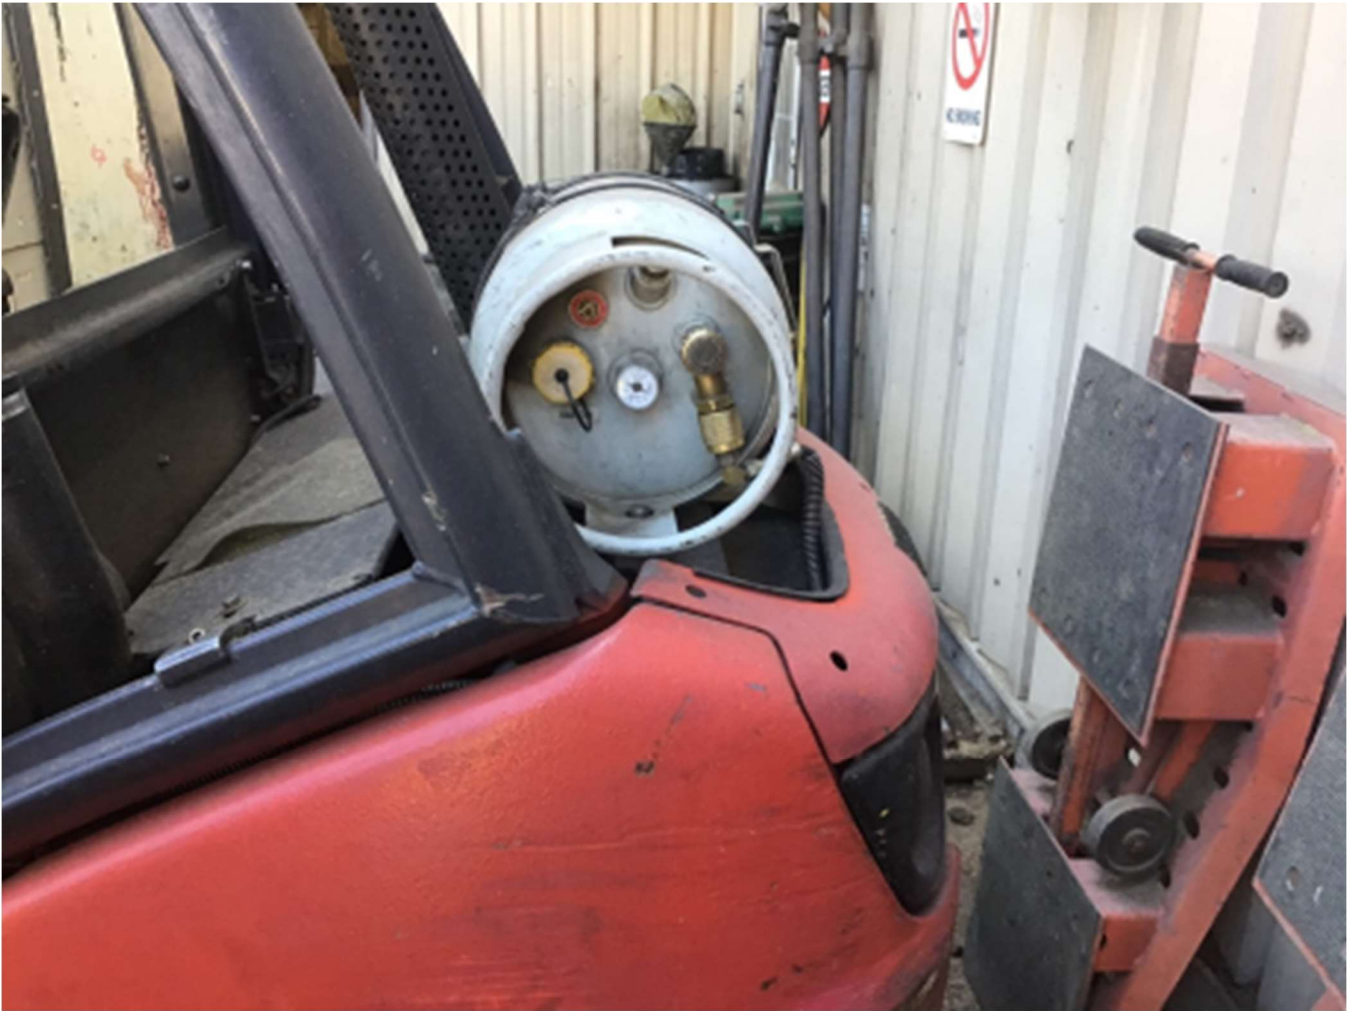
Image 4 – Propane cylinder mounted on the forklift
