Incident Summary 5584191

SUPPORTING INFORMATION	Incident Date		March 11, 2016	
	Location		Surrey	
	Regulated industry sector		Gas - Natural gas system	
	Impact	Injury	Qty injuries	1
			Injury description	Fatality
			Injury rating	Fatal
	Damage	Damage	Damage description	Heat scorch on the insulation of the wiring located above the furnace burner section and soot on the inside of the lower furnace burner section cover panel.
			Damage rating	Moderate
	Incident rating		Severe	
Incident overview		Fire department personnel responded to a 911 call indicating an infant in medical distress. As they entered the home they were alerted to the presence of carbon monoxide by their personal gas monitors. The air in the home was tested and found to contain low levels of carbon monoxide. The natural gas forced air furnace was examined and found to be the source of the carbon monoxide spilling into the home.		
INVESTIGATION CONCLUSIONS	Site, system and components		A natural gas forced air furnace was located in a room adjacent to the front entrance into a split level designed home. The unit was designed with burners firing into a combustion chamber, heat exchanger and a venting system. The natural

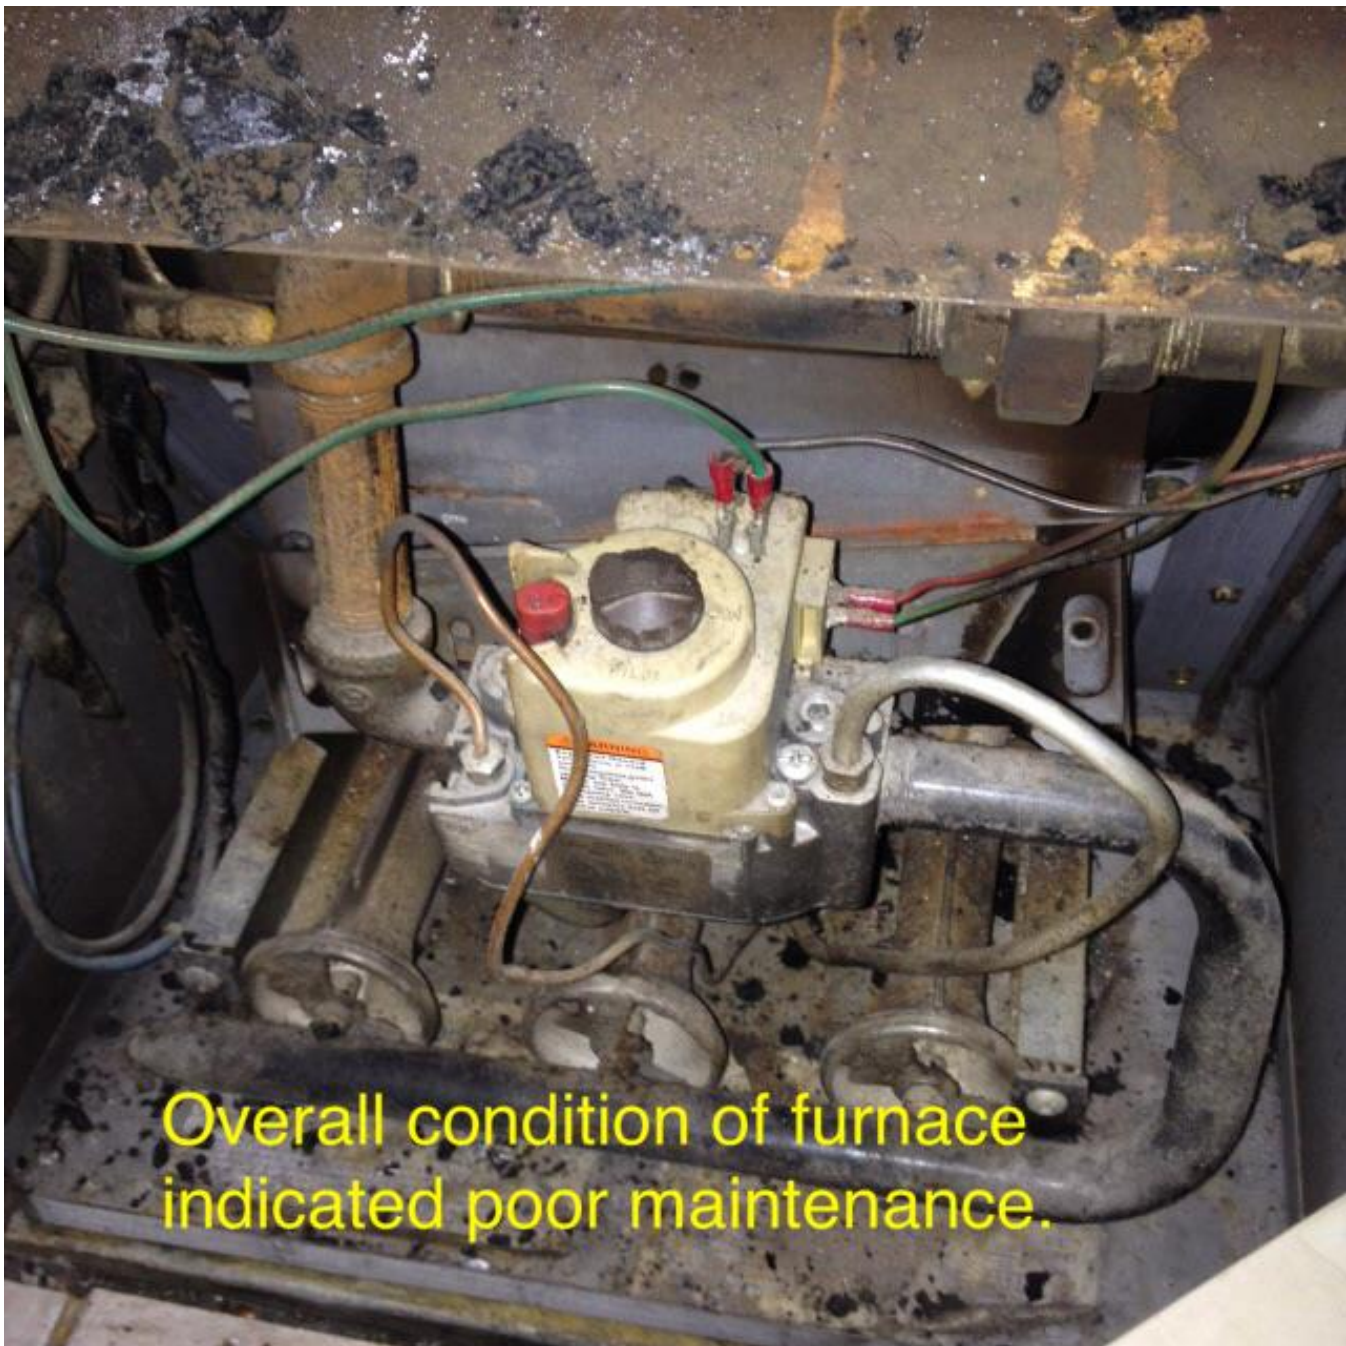
Image 1 – Dirt, debris and carbon deposits indicate extended furnace operation without service and maintenance. The last indication of furnace service by a qualified individual was six years prior.

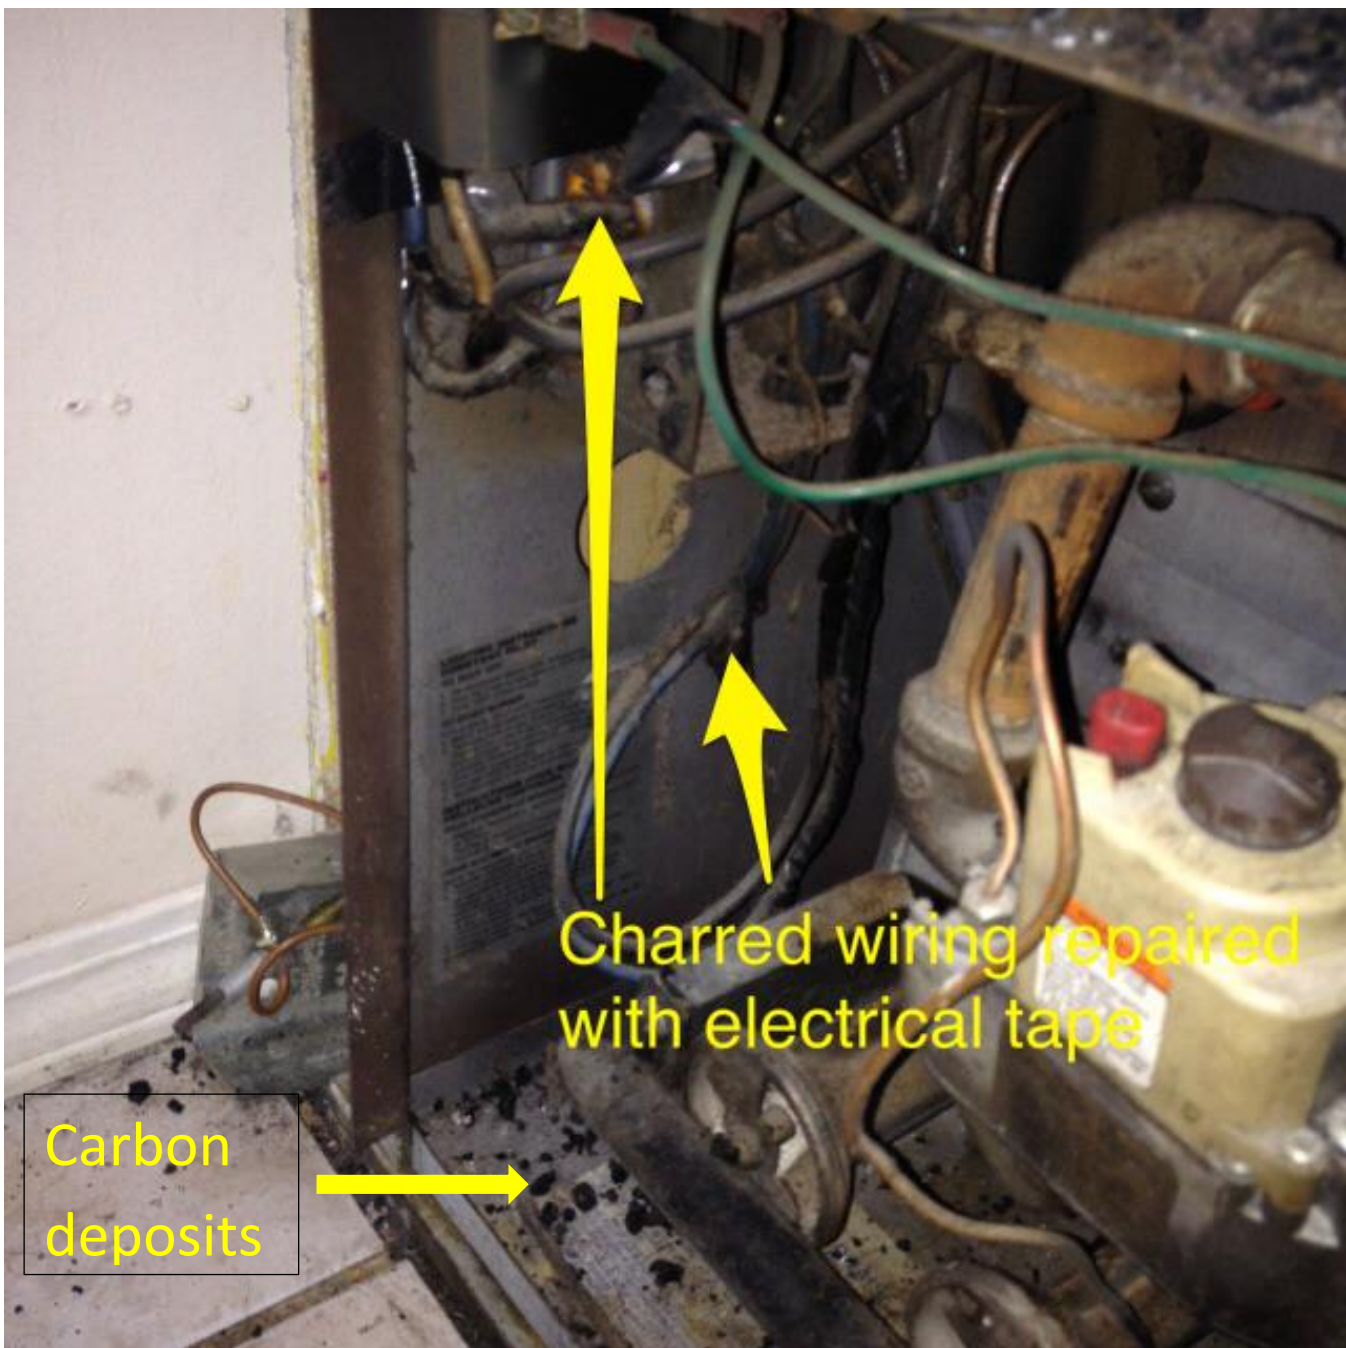
Image 2 – Charred wiring is an indication of flame rollout usually caused by restrictions or blockages in the heat exchanger flue passages. Presence of carbon deposits indicate flame impingement and incomplete combustion that can produce elevated levels of carbon monoxide.

<ul style="list-style-type: none"> • The gas valve feeding the furnace had been partially closed restricting the amount of gas supplied to the furnace. • The furnace wiring had been repaired with electrical tape where it had been exposed to the heat from the burners, which supports the “flame roll out” condition. • There were large soot particles on and around the burners and draft hood. • The furnace flue passages were heavily crusted with some kind of material. The inside of the lower furnace cover panel showed signs of soot build up. <p>Furnace testing</p> <ul style="list-style-type: none"> • During operation the furnace burner flame came out the front of the combustion chamber and up the front of the furnace. • When the furnace was put into operation testing indicated high levels of carbon monoxide being produced by the furnace and spilling into the occupied space. <p>Medical reports</p> <ul style="list-style-type: none"> • Elevated level of carboxyhemoglobin was measured in the infant’s bloodstream indicating exposure to carbon monoxide. • The level was below a range considered toxic to an adult. • An underlying medical condition was identified which increased the victims susceptibility to carbon monoxide poisoning. • Carbon monoxide was identified as a secondary contributing factor to the infant’s cause of death. <p>Note: Technical Safety BC limits its investigation scope to the technical equipment failure. Technical Safety BC does not diagnose medical conditions and does not determine cause of death. Medical information and conclusions are included to contextualize the health effects and consequences related to equipment failures.</p>

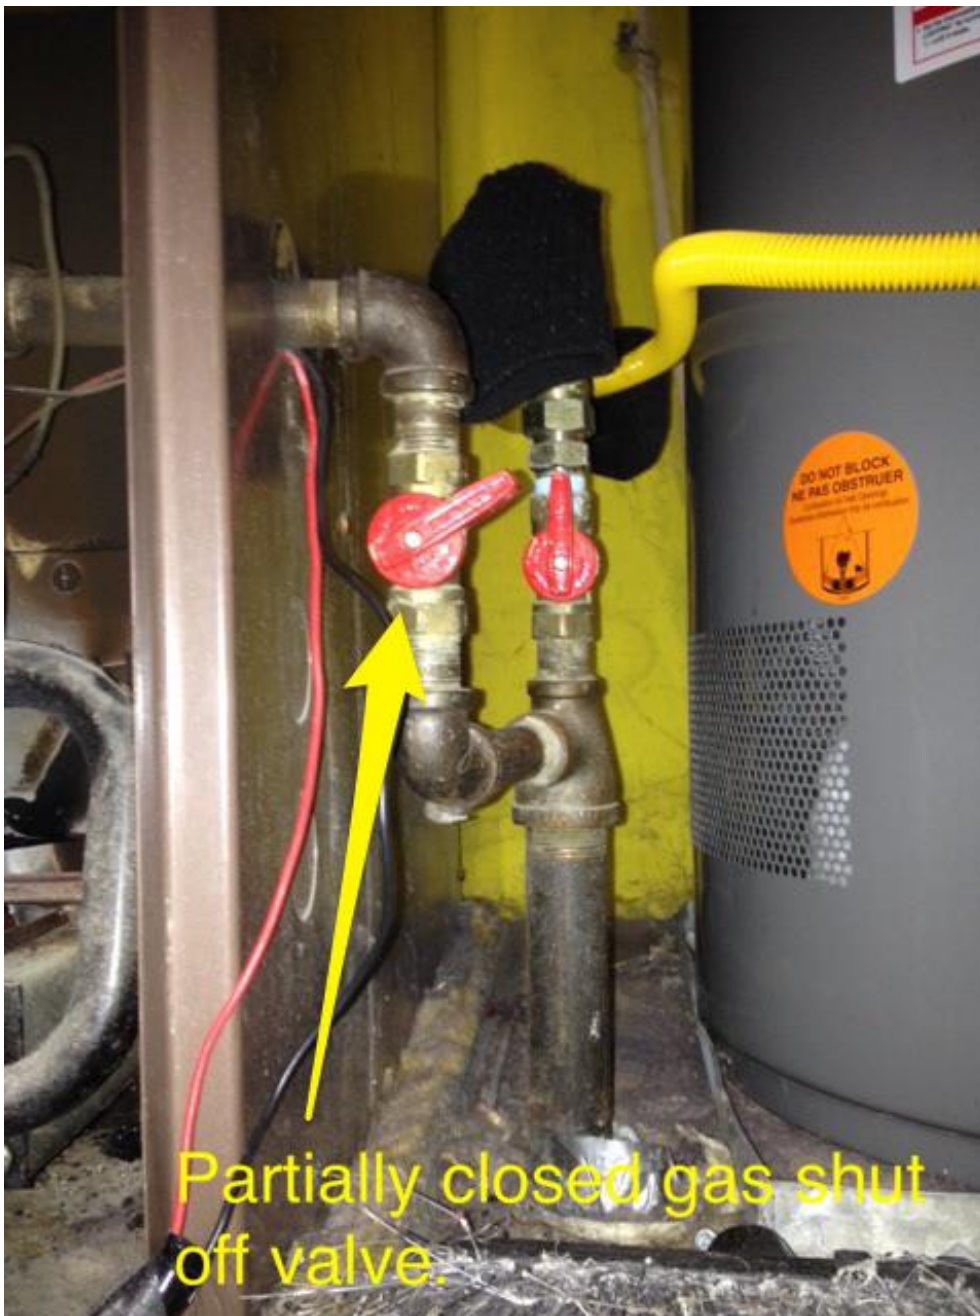
Image 3 – A partially closed valve can restrict the amount of gas required by the furnace and lead to incomplete combustion and the production of elevated levels of carbon monoxide.

<p>Causes and contributing factors</p>	<p>It’s very likely that the restriction in gas supply to the furnace caused incomplete combustion creating blockages in the flue gas passages. Incomplete combustion allowed the flue products (that contained elevated levels of carbon monoxide) to enter the home.</p> <p>The absence of furnace maintenance and carbon monoxide detectors in the home were contributing factors to the incident.</p>

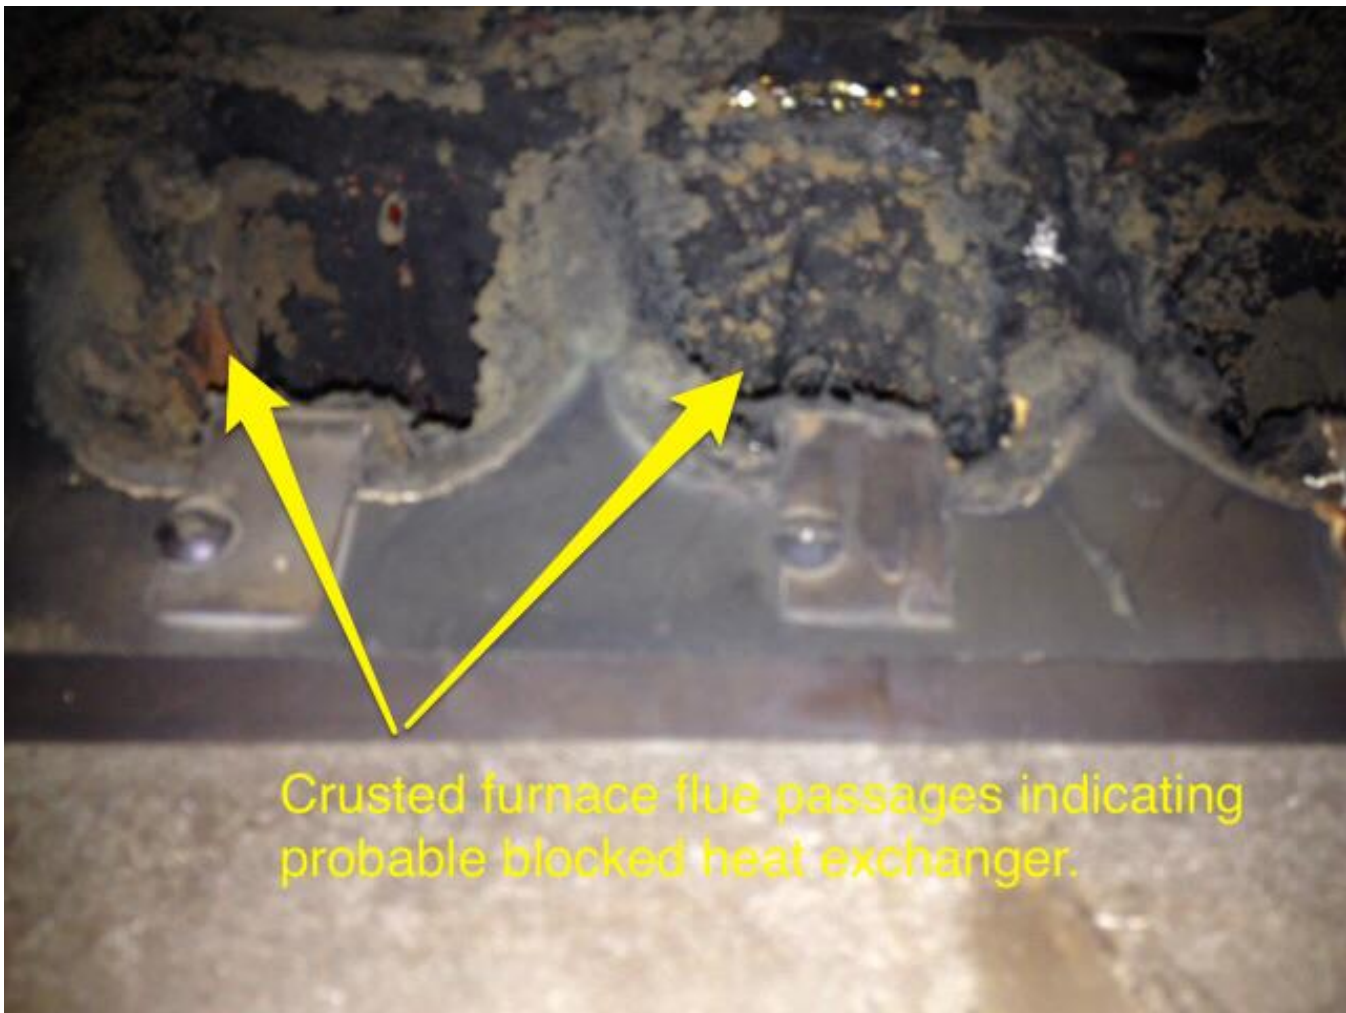
Image 4 – Deposits found at the outlets of the heat exchanger passages indicate incomplete combustion and the possibility of restricted or plugged flue passages that can allow the flue gas containing carbon monoxide to spill into the home.

Failure scenario(s)		Incorrectly adjusted burners likely created residue (soot) to build up on the inside of the heat exchanger (Image 4). Restriction in the flow from the combustion chamber to the venting system lead to a condition where the burner flame and products of combustion found another pathway to exit the combustion chamber. This resulted in what is termed “flame roll out” causing heat damage to the controls, wiring and furnace panels and carbon monoxide being produced which subsequently migrated throughout the home.	
	Facts and evidence		Witness statements <ul style="list-style-type: none">When the first responders entered the home they were alerted to the presence of carbon monoxide in the home by their personal gas monitors.No other occupants of the home reported experiencing symptoms of carbon monoxide poisoning. Site observations <ul style="list-style-type: none">The service tag on the furnace indicated that the natural gas forced air furnace had not been serviced by a qualified individual since 2010 (6 years).The furnace air filter was old and found to be plugged.
