Incident Summary #II-1490880-2023 (#30925) (FINAL)

SUPPORTING INFORMATION	Incident Date	January 7, 2023	
	Location	Richmond	
	Regulated industry sector	Gas - Natural gas system	
	Impact	Qty injuries	0
		Injury description	No reported injuries
		Injury rating	None
	Damage	Damage description	Natural gas leaked from a cement kiln and ignited in a fireball.
		Damage rating	Minor
Incident rating	Minor		
Incident overview	A removable pilot is used to ignite the main burner of a large cement kiln. The automatic pilot was damaged and stopped working. While attempting to manually operate the pilot with bypassed safety switches, gas leaked from an opening where a safety sensor was removed and ignited in a fireball.		
INVESTIGATION CONCLUSIONS	Site, system, and components	<p>The facility uses a large kiln to produce cement products that has been in operation since 1999. The kiln has a 200,000,000 btu natural gas fired burner system to produce the high heat needed for the kiln. When the kiln is operating it can also be supplied with additional solid fuels to aid in the heat production. The main gas burner for the kiln is ignited by a 200,000 btu natural gas pilot burner system that was approv

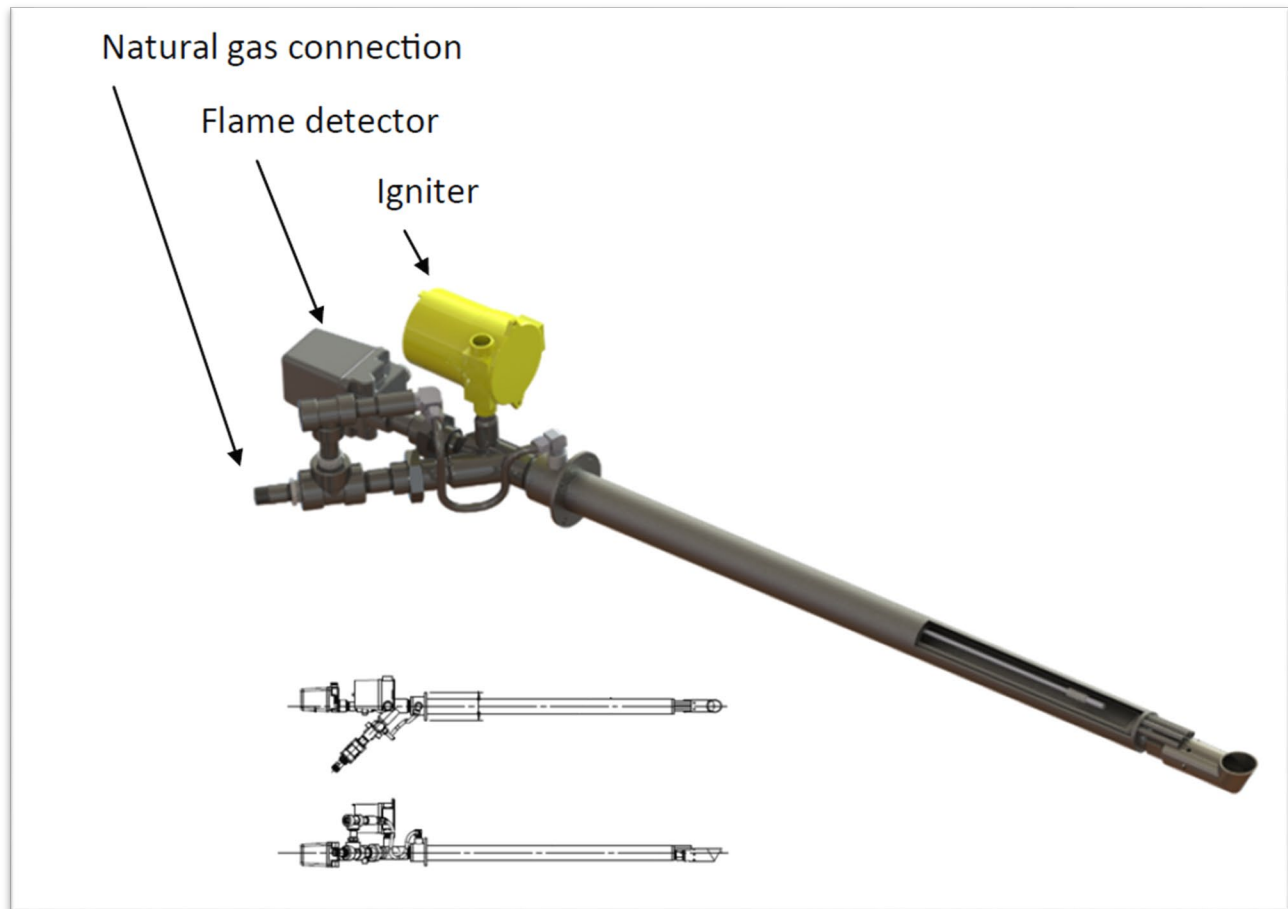
Photo 1 – Example of a similar pilot assembly from manufacturer brochure showing a shorter tube, igniter, flame scanner and gas connection.
