Report No. RPT-5103-00

BC Safety Authority – Incident Investigation – Jurisdiction and Role

Incident Synopsis

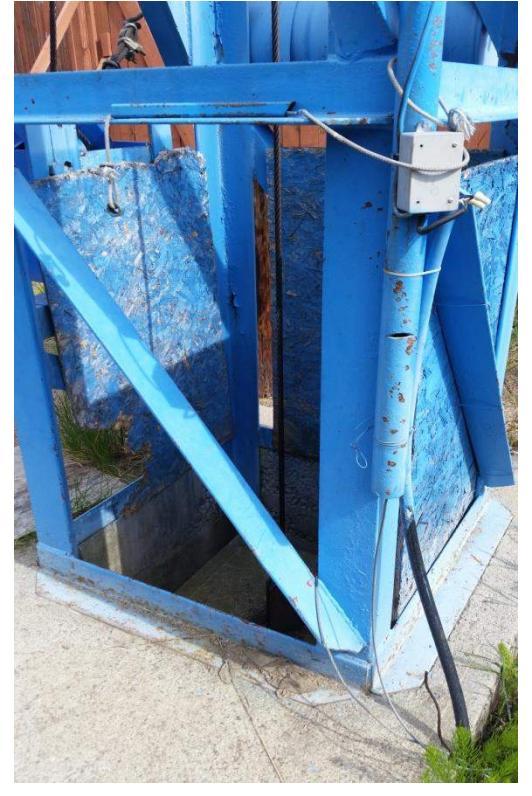
Photograph 3: Counterweight within pit. Position of counterweight is representative of the day of the incident

Only the top of the counterweight is visible during operation. The position of the counterweight relative to the bottom of the pit is not visible as shown in figure 4. The top of the counterweight relative to the ground level was visible to employees at the time of the incident as shown in photographs 2 and 3 below.

The lift mechanic stated that daily inspections for full suspension of the counterweight consisted of putting "my foot on the cable ensuring that the counterweight rocks and moves; ensuring it is not frozen in...that's about it....Sometimes when I can't move the cable with my foot and see the counterweight move I've gone to get a [pry] bar to ensure that it is free moving". The lift mechanic also stated that he had no reason to be concerned that the counterweight may be in contact with the bottom of the pit based upon his evaluations.

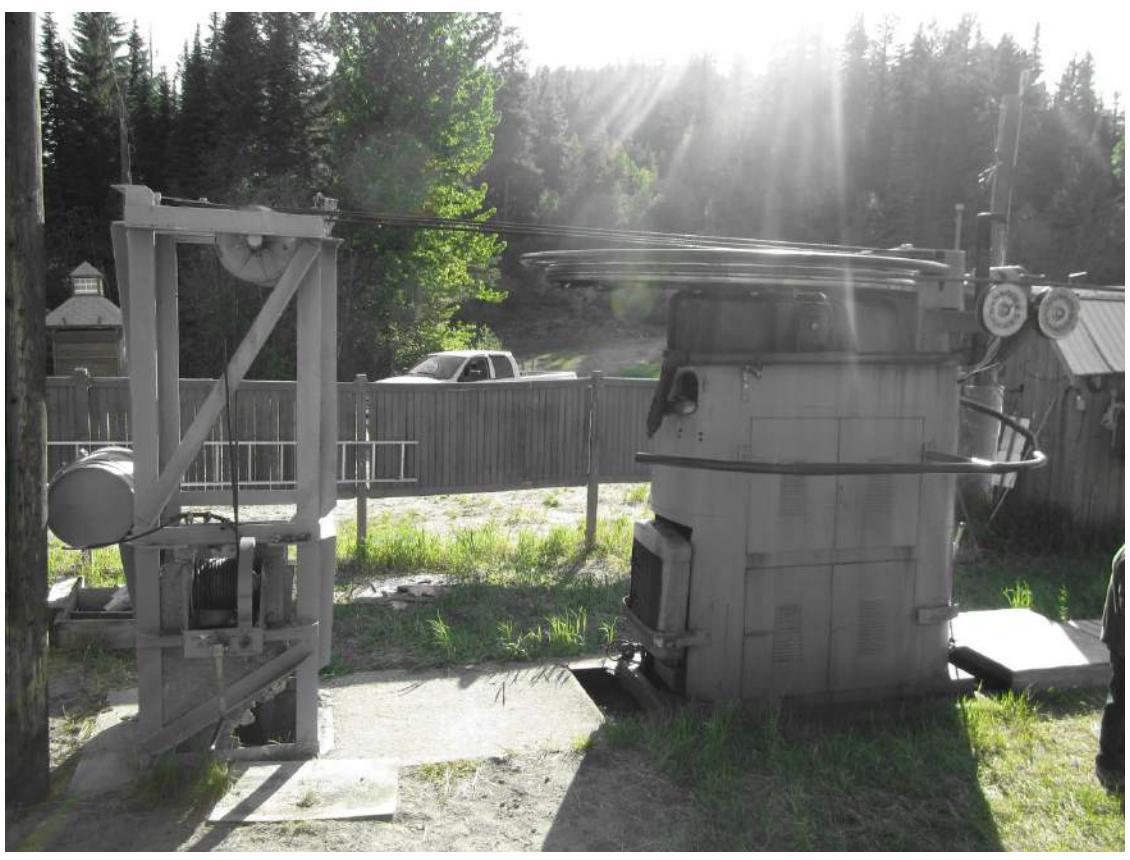
Photograph 4: The Blue Chairlift Drive Station Tension System

The Blue Chairlift utilizes a gravity counterweight tension system in order to achieve the required tension within the haul rope. A concrete counterweight is suspended such that it applies a force onto the bull wheel, moving the drive station carriage backwards on a set of rails until there is a balance between the tension in the haul rope and the suspended counterweight (see figure 2).

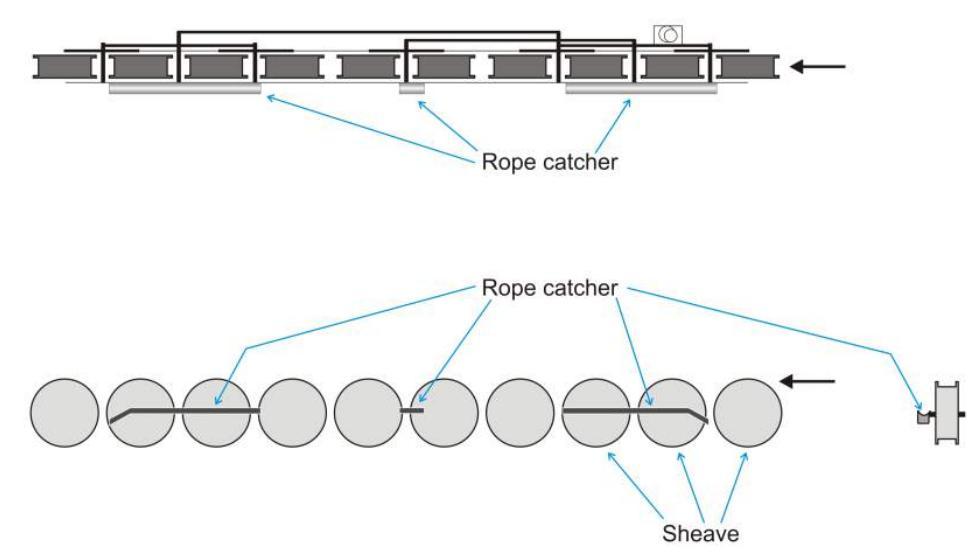
Figure 5: Mueller 10-Sheave assembly illustration. Top view; Side view and Front-side view

On the Blue Chairlift at tower #2, a contoured angle bracket is attached at the entrance, middle and exit sections, shown in figure 5, on the outside of the sheave assembly's frame located approximately half a sheave diameter below the haul rope. This design is common to all Mueller chairlift installations. The Mueller design has a sharp 90° corner at its leading edge in the horizontal plane as shown in photograph 8.

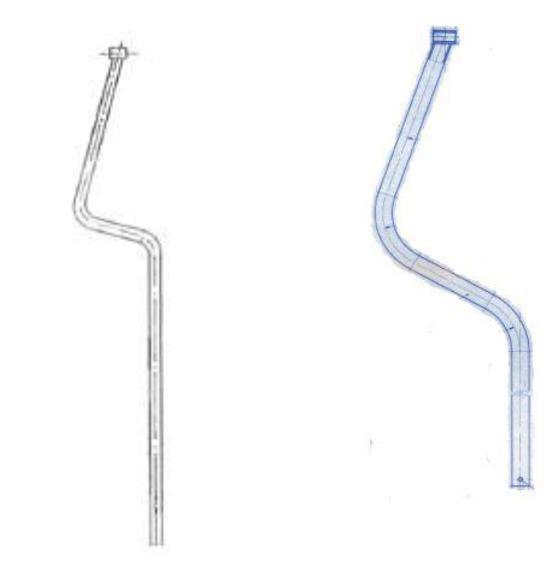
Figure 7: Hanger Arm Comparison

This modification was never performed on the Blue Chairlift due to a letter that was issued by Mueller Lifts to CMRL that stated if the hanger arms were replaced with a new design hanger arm with a profile that provided additional clearance then the modification was not necessary. The new design hanger arm was installed on the Blue Chairlift many years prior to this incident but the exact date of completion is not known. Figure 7 compares the profiles of the original and modified hanger arms.

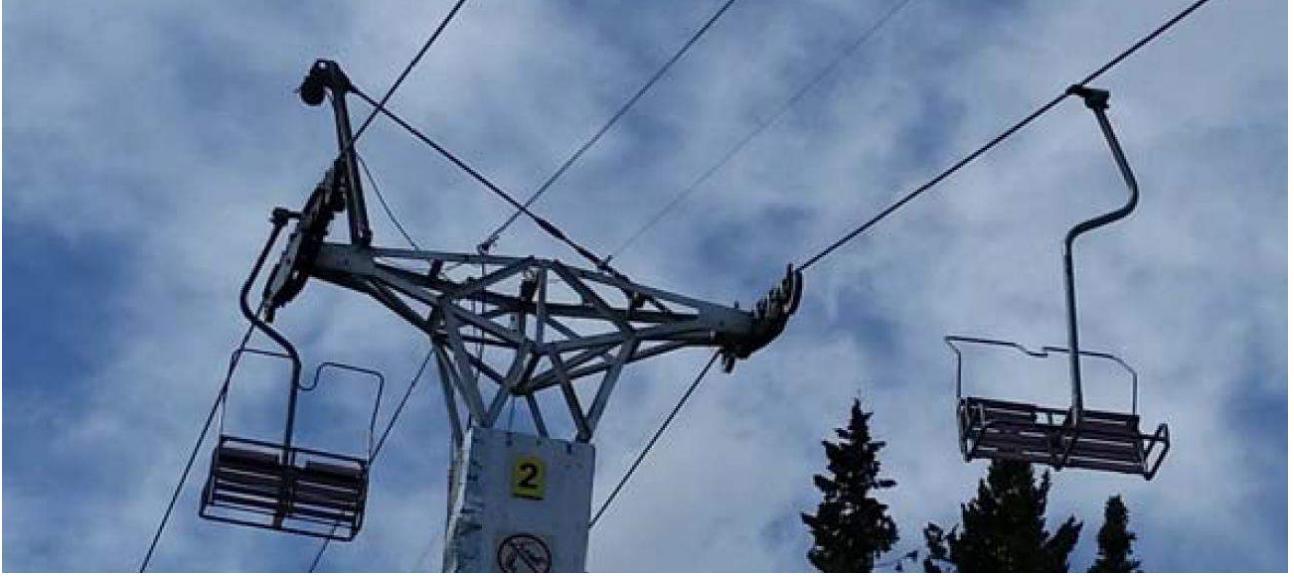
Photograph 9: Double-seat carriers at tower #2 - photo taken June 2014

The deropement occurred at tower #2. The distance between tower #1 and #2 was 65 meters. The spacing between carriers was 19.5 meters, allowing for three carriers to be within the space between towers #1 and #2.

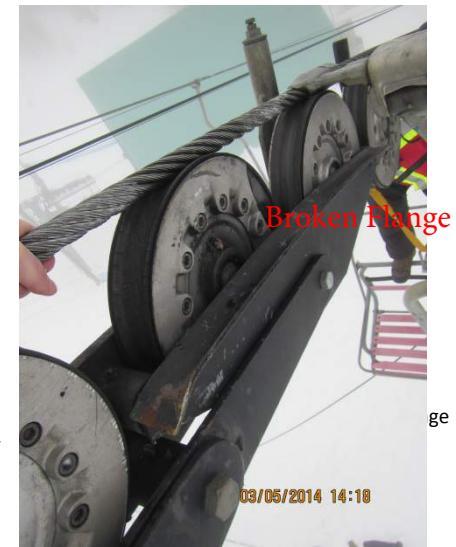
Picture 1 – Tower 2 Upgoing

- 1. The carrier, #15, that contacted the lead-in edge of the cable catcher at tower 2 was empty and was located between two loaded carriers, #14 and #16.
- 2. The resulting complete deropement missed the catchers and sent carriers #13 through #16 to the snow surface.
- Carrier #9 was damaged as a result of the passengers bouncing out of the chair seat and slamming down. The chair seat flipped into the up position during the incident.
- The sheave assembly upgoing at tower 2 was comprised of 10 sheaves. The incoming rope catcher was bent at the outgoing end and the sheave #3 flange was broken on the outside. Reference Picture 1.
- 5. The damage to carrier #15 included a complete tear on the hanger just below the grip; a deformed hanger; indentations on the grip body and rope marks on the arm rest. Reference Picture 2 and 3.

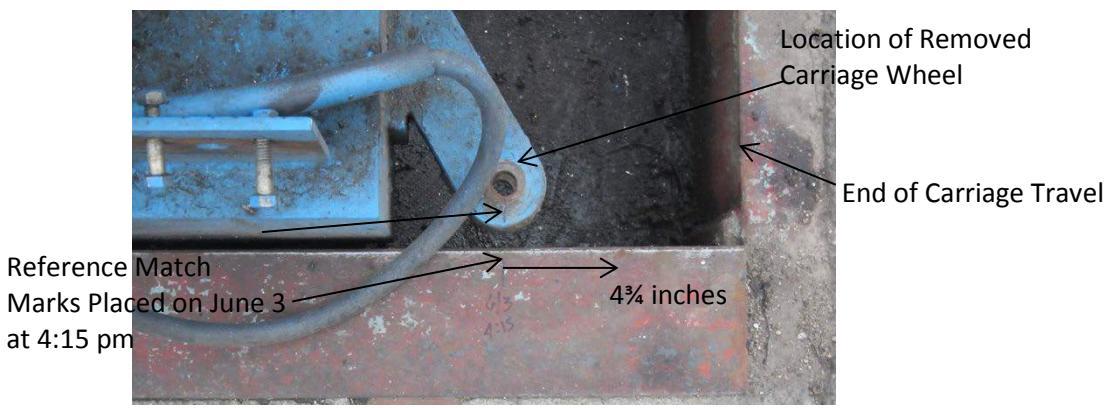
Picture 6 – Downhill End of Carriage

- 9. When the counterweight was lifted and fully supported by the counterweight rope, the carriage moved downhill 4³/₄ inches. This inidcated the lack of the total force of the counterweight being applied to the carriage.

10. After operating the chairlift while the line survey was being completed, the carriage location was measured at 2½ inches downhill from match marks. This is an indication of inherent friction in the counterweight to carriage connection.

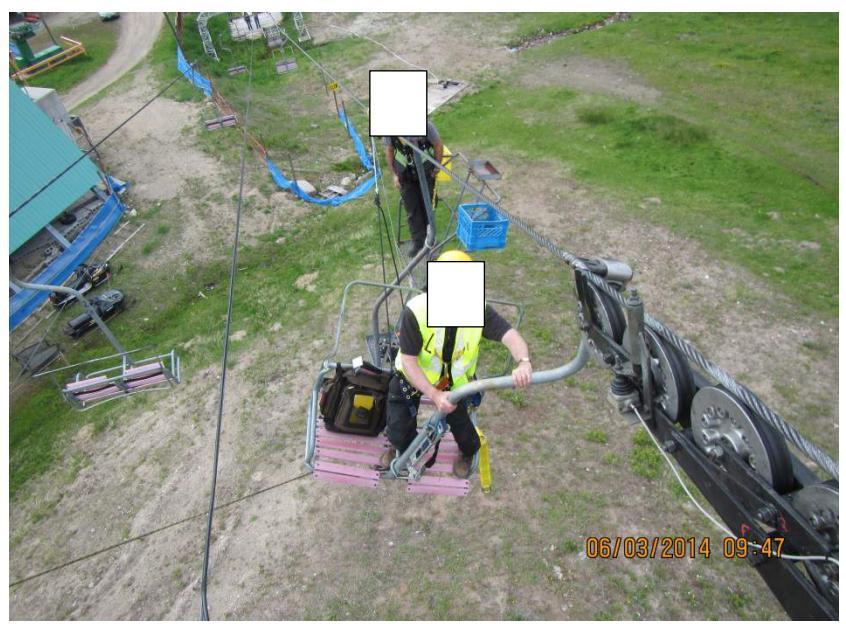
Picture 7 – Tower 2 Measurements Location #1

On June 3rd measurements were taken at tower 2 including verification of sheave dimensions and carrier clearances at various locations and orientations along the sheave assembly. The carriers numbered 13, 14, 15 and 16 that had been damaged during the incident had been removed from the line. Carrier #60 was placed on the line at the location of carrier #15 at the time of the incident. The work carrier was placed 4m behind carrier #60. The first set of measurements was taken with the grip of carrier #60 located one-sheave radius from its entry to the first sheave as shown in the following picture.

These measurements were taken to get a general overall sense of the extent of carrier swing that would produce contact with the tower. The carrier was oriented at 21° back along the line and at 27° inward across the line. At this combination it appeared that the carrier would be well inside the line of the cable catcher.

- 1. Location 1 The grip was located approximately 6 inches before entering sheave 1 (Pic 7).
- 2. Location 2 The grip was located approximately midway between sheaves 1 and 2 (Pic 8).
- 3. Location 3 The grip was located 4 inches downhill from the 10-sheave rotation center (Pic 9).

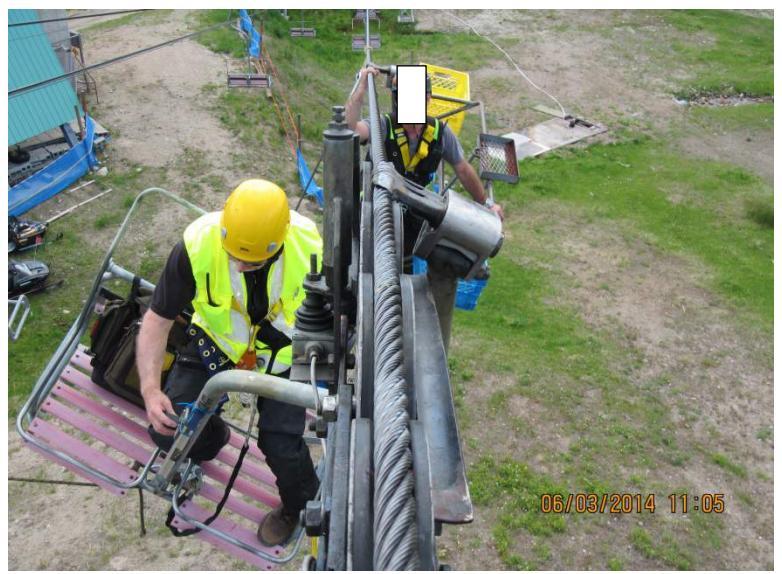
Picture 8 - Tower 2 Measurements Location #2

- 1. With the carrier hanging vertically, 2½-2¾ inches were measured between the hanger and the cable catcher.
- 2. First contact of the hanger with the cable catcher occurred when the carrier was oriented at 21° back along the line and at 18.5°-19° inward across the line.
- 3. With the carrier hanging vertically, first contact of the hanger with the cable catcher occurred when the carrier was oriented at 24° inward across the line.
- 4. A sheave in the assembly was measured: Diameter of the rim=317mm; diameter of the liner=325mm; and width of sheave=60mm.
- 5. For the pair beam the distance from the center of the sheave to center of beam was 20cm.

Various other dimensions of the assembly were recorded such that the as-built conditions would be properly represented when the carrier and assembly were modeled. It was observed that the 2-sheave assembly had a side plate only on the inside of the assembly, thus producing an "overhung" condition for the sheave bearings and pair bushing as well as reducing the stiffness of the 2-sheave assembly.

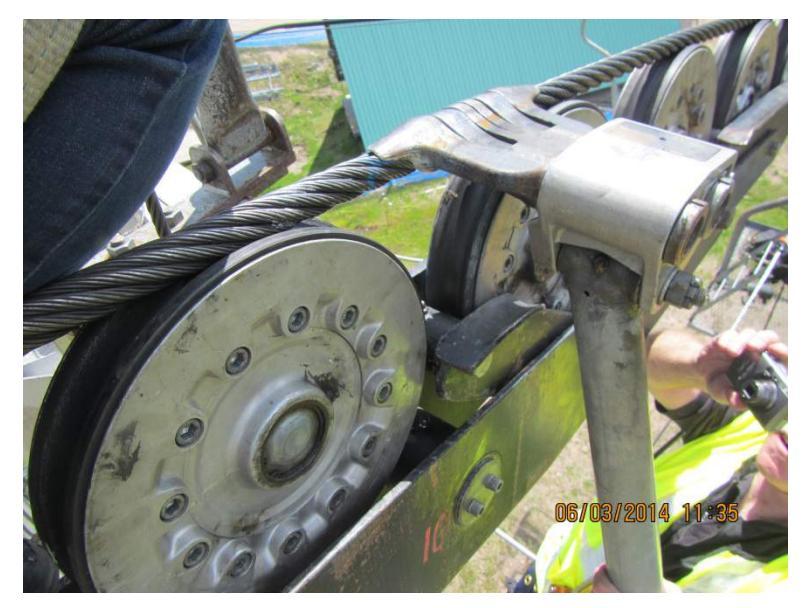
Picture 9 - Tower 2 Measurements Location #3

The third set of measurements was taken with the carrier grip located approximately 4 inches downhill from the center of rotation of the 10-sheave assembly. With the carrier hanging vertically, the distance between the center line of the hanger and face of tower ski tip deflector was measured at 49½ inches. With the carrier hanging vertically, the inward swing of the carrier produced contact of the chair seat support frame at approximately 16°. This location is as shown in the following picture.

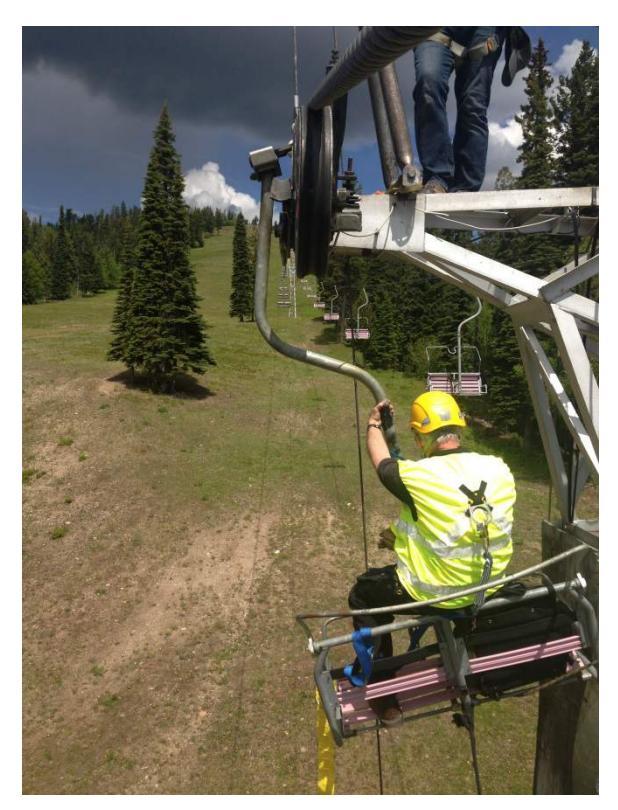
Picture 10 - Tower 2 Measurements Location #3

With the carrier hanging vertically, 2½-2¾ inches were measured between the hanger and the cable catcher which is the same as was measured at the lead-in 2-sheave assembly.

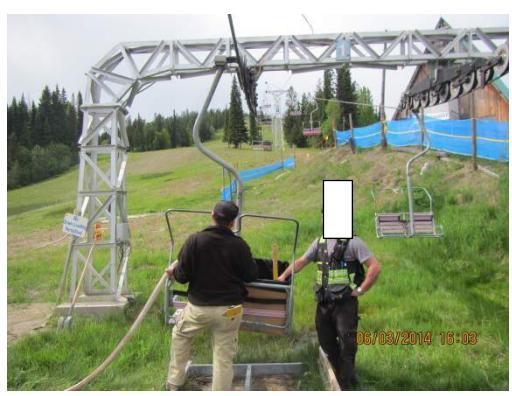
Picture 11 – Simulated Carrier Loads

The initial observations were made on June 3^{rd} with carriers loaded with water to simulate the carriers loaded below Tower 4 at the time of the incident. The following are the carriers that were loaded with $18'' \times 18''$ box filled with water to a height of $14\frac{1}{2}''$:

Carrier #2 loaded both seats. Carrier #3 loaded one seat. Carrier #4 loaded one seat. Carrier #5 loaded one seat. Carrier # 9 position (#40 in place) loaded both seats. Carrier #14 position (#30 in place) loaded both seats. Carrier #15 position (#60 in place) unloaded. Carrier #16 position (#16 in place) loaded both seats.

It was noted before adding the above load that the carriage was located 6¼ inches further downhill than at the time of

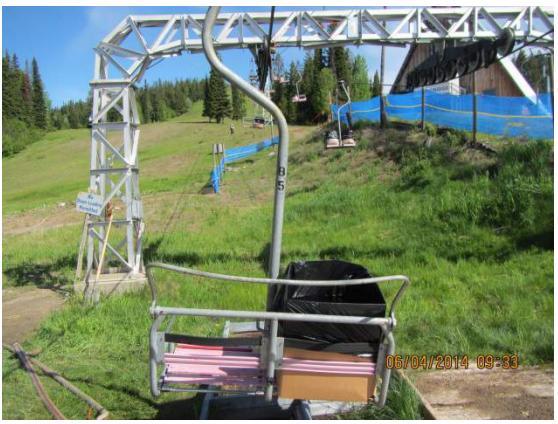
Picture 12 - Simulated Carrier Loads

Carrier #68 loaded both seats. Carrier #69 loaded one seat. Carrier #70 loaded both seats. Carrier #76 loaded one seat. Carrier #77 loaded both seats. Carrier #81 loaded both seats. Carrier #82 loaded both seats. Carrier #83 loaded both seats. Carrier #84 loaded one seat. Carrier #85 loaded one seat.

This loading condition represented the loading condition at the time of the incident. The chairlift was operated and swing was induced into loaded carriers just uphill and downhill of an empty carrier. The swinging at tower 2 of the empty carrier appeared to be similar to that observed on June 3rd, excessive but no contact with the tower or sheave assembly was observed.

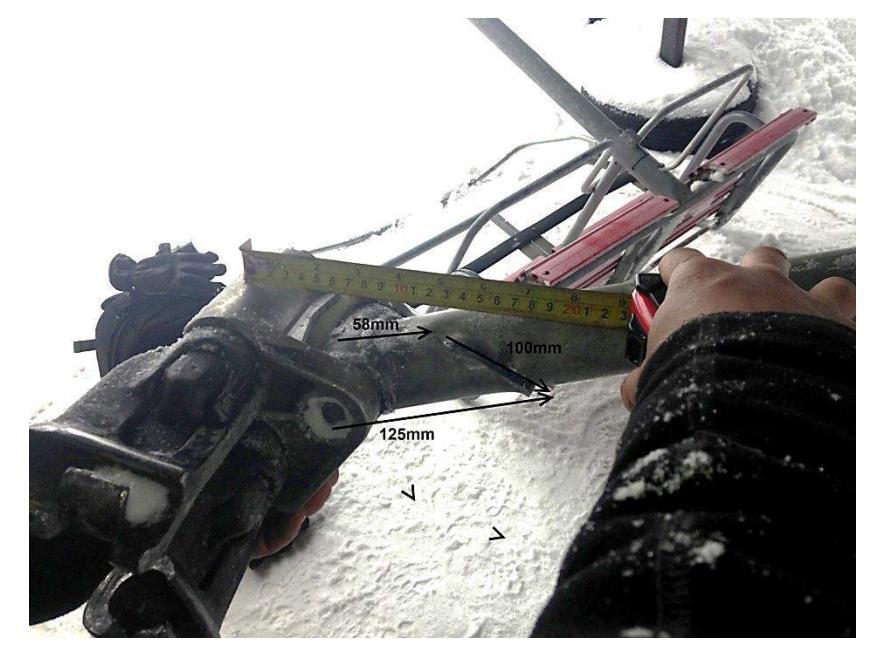
Picture 21 – Detail of Hanger 15 Damage

Reference Appendix D for design details of carrier. During the BCSA investigation, it was noted that carrier hangers #38 and #47 had indications in the location shown in these pictures that would indicate that they had also contacted a cable catcher, most likely the same one involved in the incident. Further it was noted that when carrier 15 was removed from the hauling rope, the rope rotated 180° indicating inherent rope twist.

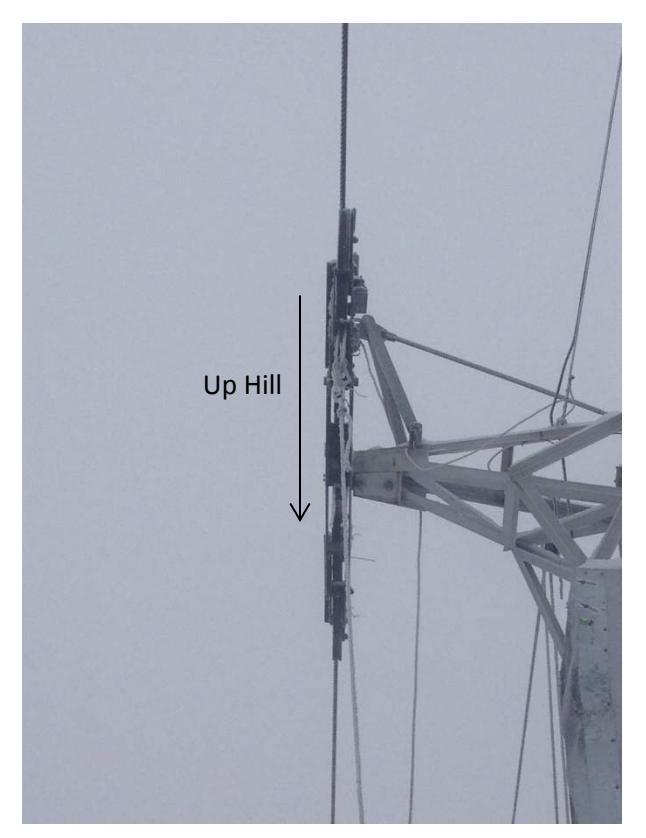
Picture 23- March 2 after Reroping

The following pictures show the misalignment of the 10 sheave, upgoing assembly at tower 2 at different points during the investigation of BCSA.

- 1. The misalignment after the accident was such that if this had been the misalignment prior to the accident, the chairlift would not be recommended for operation.
- 2. When the haul rope is tensioned with the full weight of the concrete counterweight, the sheave assembly is not misaligned such that operation would not be possible.
- 3. The stiffness of the 10 sheave assembly may not be appropriate for the maximum loading.
- 4. The full weight of the concrete counterweight is not tensioning the haul rope in Picture 25, but the assembly is not misaligned as shown Pictures 22 and 23. This is probably due to the work performed in the Mueller Shop on March 7 and 10, 2014.

Relative to misalignment, Picture 25 shows that most if not all of the damage caused by the deropement occurred on the outgoing end of the cable catcher. It would be most probable if misalignment shown in Pictures 22 and 23 had contributed, the rope would have started to derope at sheave number 1 or the lead-in sheave. The markings on the cable catcher at this point appear to be from a secondary contact of the rope after the start of the deropement or most likely from the "slicing" of the chair hanger since they are less severe and toward the outside of the cable catcher. This can be seen in the following picture.

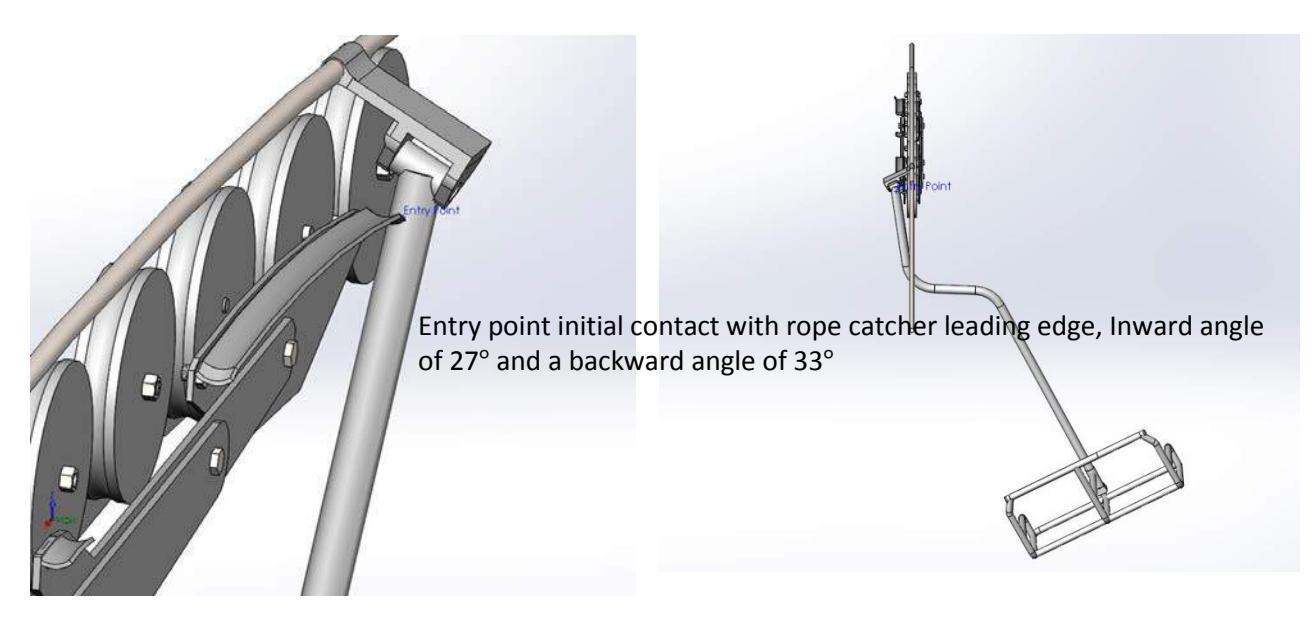
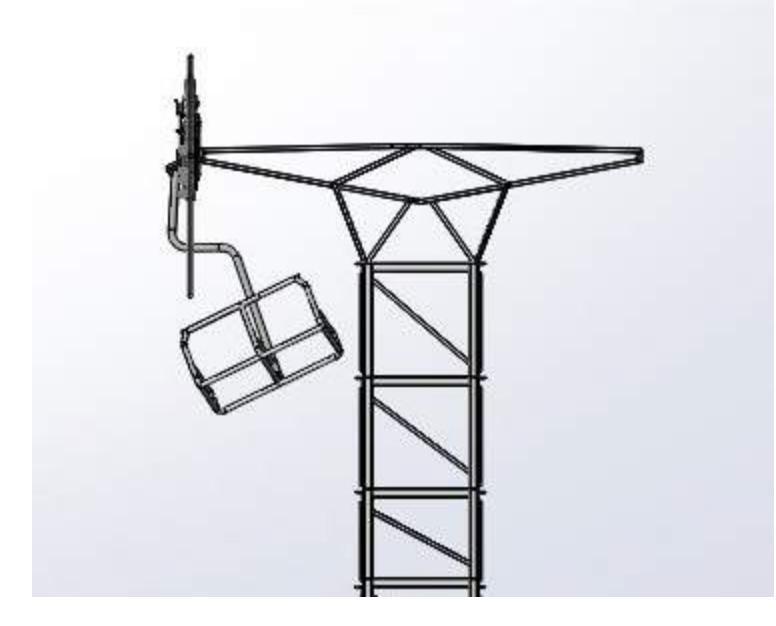
Carrier Contact with Cable Catcher at Initiation of Hanger Tear

Looking Uphill – Carrier at Contact with Cable Catcher

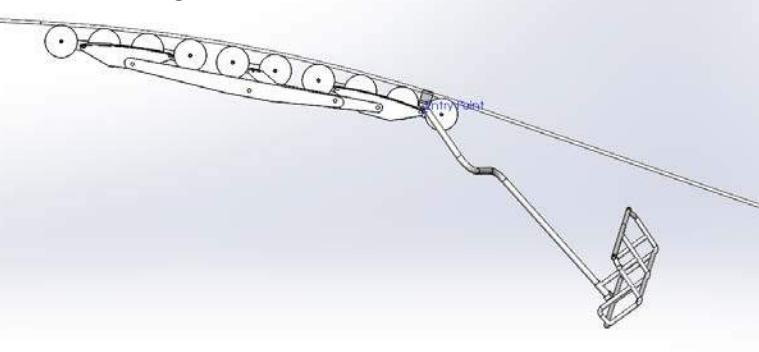
Photo group 6

Initial contact from stem entry point puncture and rope catcher. Chair backward angle: 33.2°

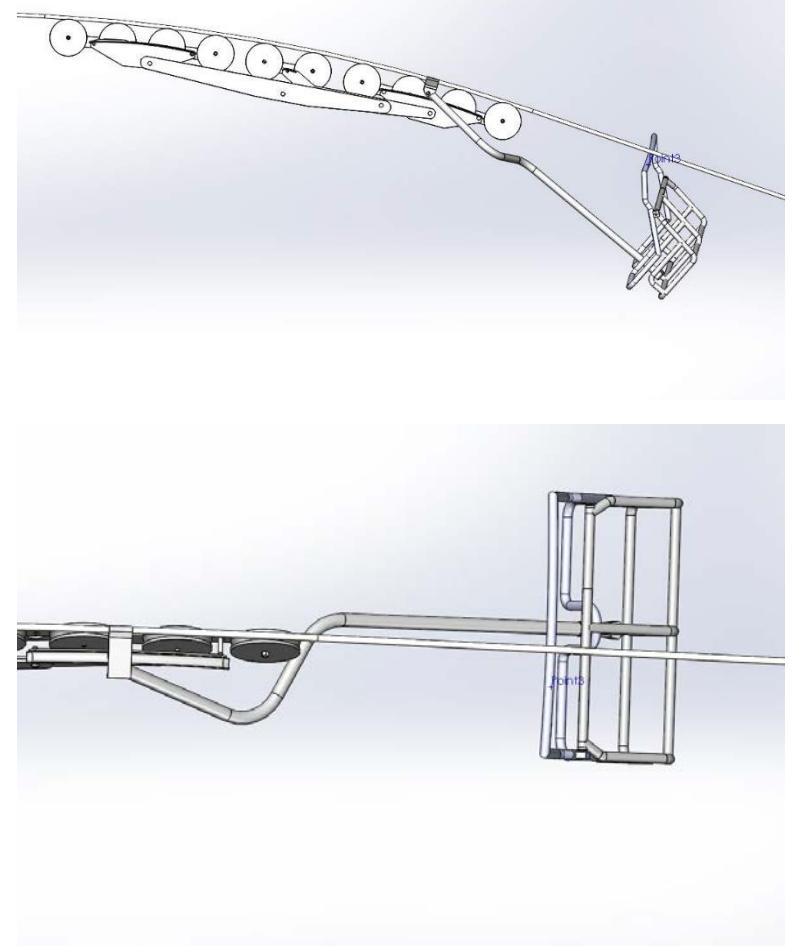
Restrainer bar in the open position making contact with the rope. Inward angle: 9.7° Backward angle: 40.2°
