## Incident Summary #II-964050-2020 (#16298) (FINAL)

| | Regulated industry sector | | Boilers, PV & refrigeration - Boiler and pressure vessel system | |

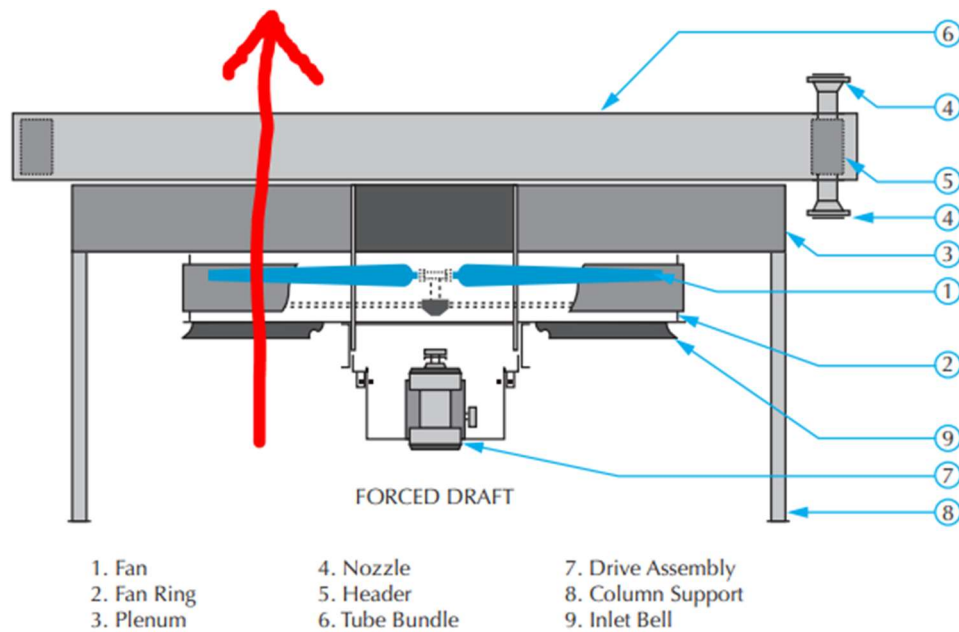
**Side Illustration of Cooler Assembly- Red Arrow- Direction of Airflow with louvers open**

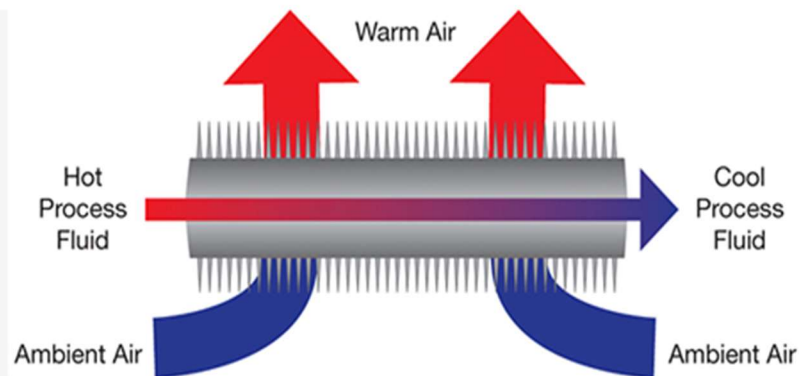
▲ **Figure 1.** In an air-cooled heat exchanger, hot process fluid flows through a finned tube. Ambient air passes over the finned tube, which cools the process fluid.
