## Kicking Horse Gondola Hanger Load Analysis

January 26, 2026 | Revision PA

Submitted to: Technical Safety BC  
Prepared by McElhanney Ltd.

On March 10<sup>th</sup> 2025 a gondola on Kicking Horse's Golden Eagle Express suffered a catastrophic failure of the hanger arm connecting the cabin to the grip assembly as it was leaving the lower station.

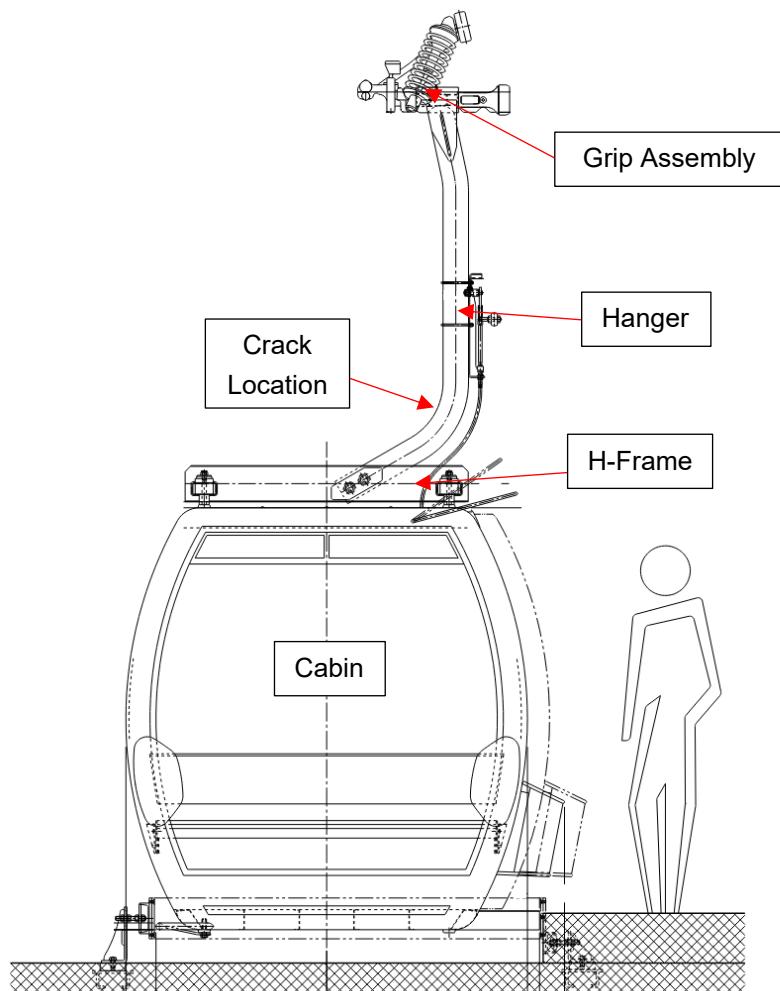
*Figure 4 - Carrier Terminology*

The following figure shows the terminology that will be used in this report and the approximate location where the hanger broke apart. The grip connects the carrier to the steel rope and attaches and detaches at the top and bottom terminals. The hanger connects the grip to the cabin to allow clearances to line equipment. The cabin is connected to the hanger frame via 4 bolts and dampeners.

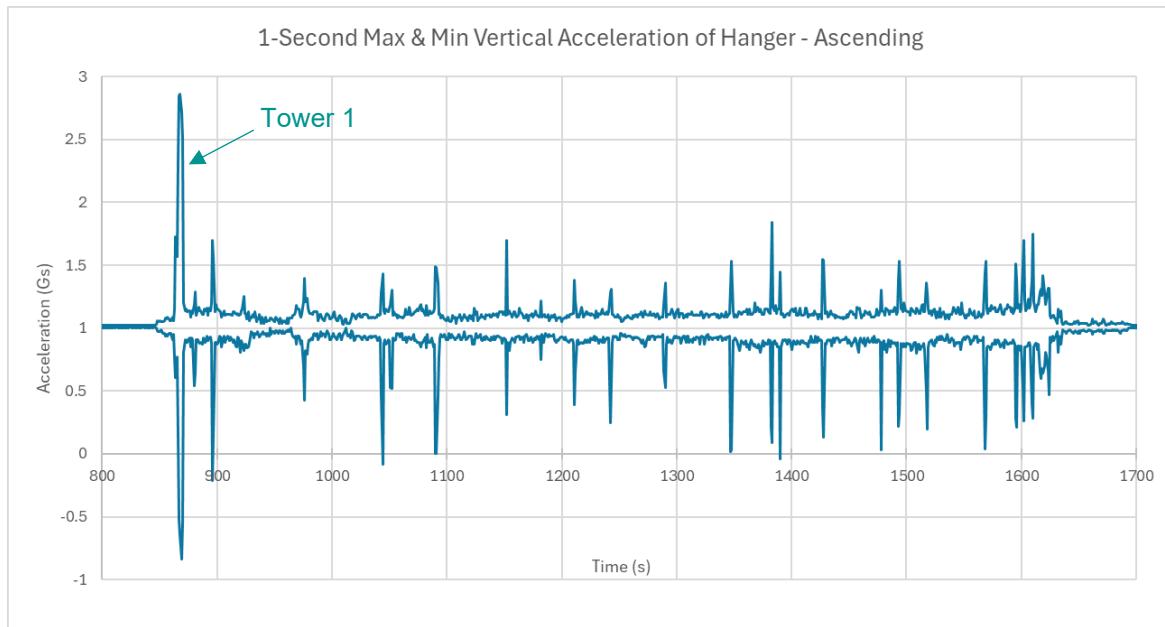
As a gondola passes over a tower, vertical accelerations are imposed, with larger accelerations at the hold down sheave assemblies due to impact of the grip passing under the sheaves. Accelerometer testing was conducted for the gondola on an empty carrier over a full lap of the lift circuit show in Figure 5 and Figure 6. Tower 1 is the only tower on this line with a hold down sheave assembly, and it had the greatest accelerations, with a maximum of 2.8g and minimum of -0.8g. The g-forces from passing over the rest of the support towers ranged from maximums of 1.3g to 1.8g, to minimums of 0g to 0.5g. A representative range of 1.5g to 0.25g was used for these towers in the calculations of this report.

Figure 5 – Max and min acceleration per second while **ascending** located at the top of the cabin

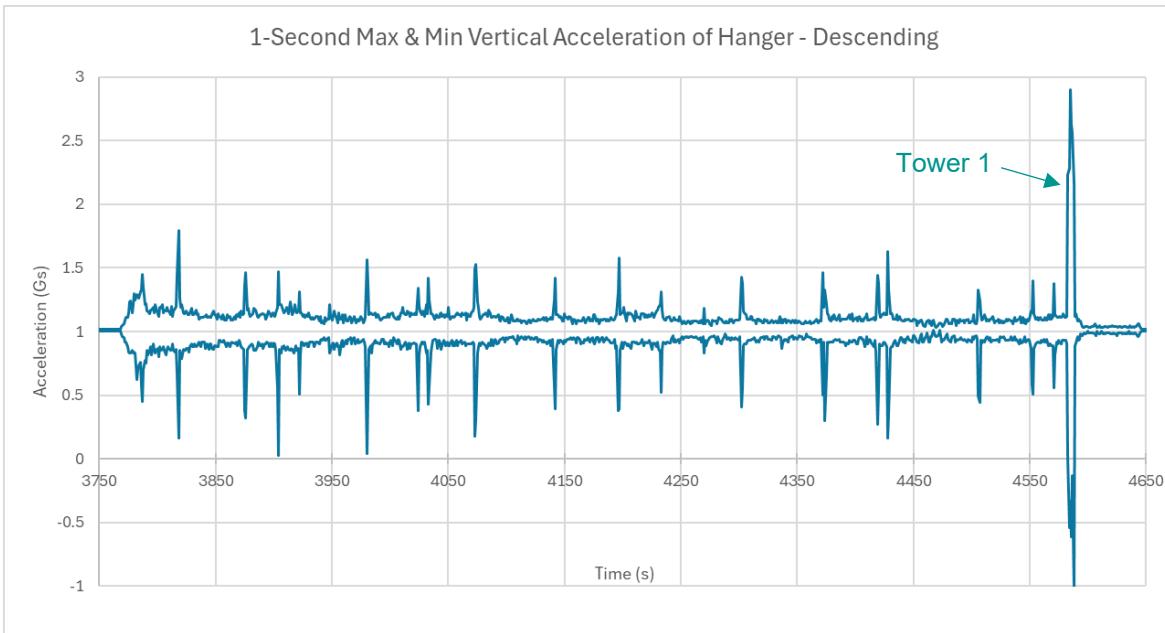
Figure 6 - Max and min acceleration per second while **descending** located at the top of the cabin

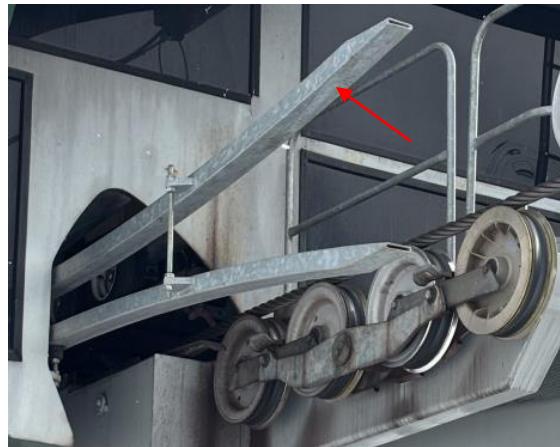
Figure 8 - Lateral rail 'trumpet'

To ensure that all potential positions of the carrier are captured by the terminal, flared rails known as the "Trumpet", are installed as shown in Figure 8.

Based on the documentation provided by LPOA, the installed trumpet assembly should have two spring dampers and two rubber bumpers at gooseneck #1, and two rubber dampers at gooseneck #2. Inspection of the lift in the fall of the 2025 and review of previous photos showed that some of these were missing. It is unclear how long these were missing for.

The missing rubber dampeners would cause the trumpet to be more flexible and cause a couple of issues. The increased flexibility could cause lateral deflection that would result in the carrier missing the trumpet however this is less likely with the additional items added. Additionally, there is potential that the increased flexibility causes a larger rebound acceleration from the spring effect structure.

The trumpet does not have much for lateral adjustment however there is not specification on the dimension to the lateral beam. This could cause issues with missing the trumpet and should be confirmed max and min dimensions.

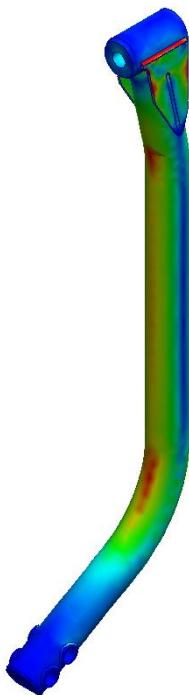
*Figure 16 - Static Stress Analysis Heat Map*

Table 9 lists the calculated static stresses at the crack location and shown in Figure 16 heat map,

Number of Passengers	Static Load (kN)	Direct Stress (MPa)	Bending Stress (MPa)	Total Static Stress (MPa)
0	4.4	1.3	36	38
4	7.4	2.3	61	64
8	10.4	3.2	87	90
8 max	13.2	4.1	110	114

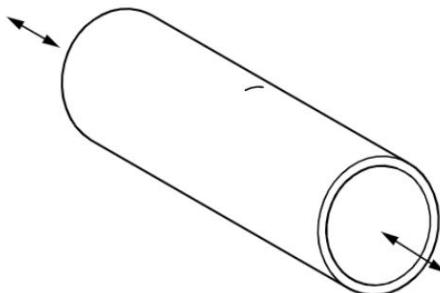
*Figure 17 - Example 1c of detail category A of CSA S16:19's section 26.3 on fatigue design. This closely resembles the geometry of the hanger arm at the crack location*

section of the pipe where cracking propagated is best described as detail category A Figure 17, which has a 'constant amplitude stress range' of 165 MPa. This means for max to min stress ranges of less than 165MPa the steel should theoretically have infinite fatigue life.
