Inciden		December 10, 2019
	Location		Vancouver
z	Regulated industry sector		Elevating devices - Elevator
ATIO		Qty injuries	0
SUPPORTING INFORMATION	st Injury	Injury description	No injuries
INF	Impact	Injury rating	None
RTING	Damage	Damage description	Damage to elevator sling, top of elevator components and an overhead hitch beam. Elevator floor tiles damaged from impact.
Odd	Dan	Damage rating	Moderate
SL	Incident rating		Moderate
	Incident overview		During an annual emergency brake test procedure known as "unintended motion" the emergency brakes failed to deploy. The car continued to ascend until it's counterweight collided with the buffer and the car struck the overhead beam.
Nd INVESTIGATION CONCLUSIONS	Incident overview		 An electric elevator of the roped traction type. This unit uses steel ropes, electric motor and a counterweight to raise and lower the car. Motor has a brake assembly consisting of 2 electromagnetic brakes (automatically activated by a solenoid). 2 brake compression springs to adjust holding force. The electric motor, drive sheave and brakes are one unit mounted in the overhead of the hoistway. A controller in a remote room, located in an underground parkade.

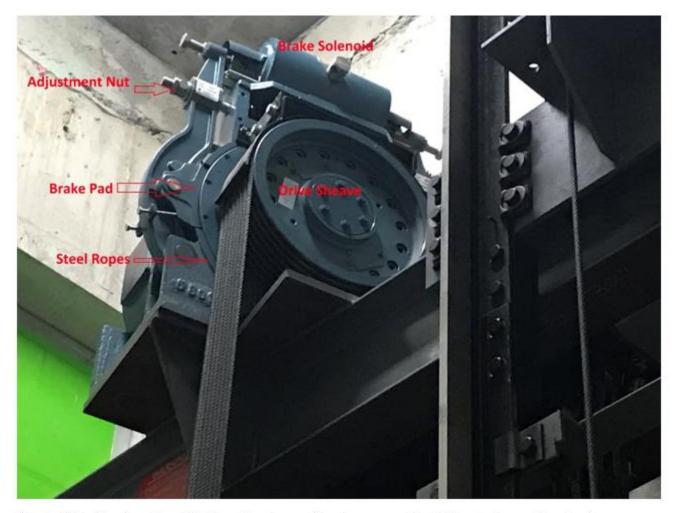
Photo #1- Overhead installation of motor and brake assembly. This pic shows the steel ropes wrapped around the drive sheave. This machine is secured to a beam located in the overhead.
