Incident Summary #II-1639122-2023 (#41742) (FINAL)

SUPPORTING INFORMATION	Incident Date			November 21, 2023
	Location			Chilliwack
	Reg	Regulated industry sector		Gas - Natural gas system
		Injury	Qty injuries	0
			Injury description	NA
	Impact		Injury rating	None
		Jamage	Damage description	An electrical connection just below the plastic air filter overheated, burning off approximately three (3) inches of insulation from the wire and then igniting the plastic air filter.
		Δ -	Damage rating	Moderate
	Inci	cident rating		Moderate
	Incident overview			There was a fire inside an approximately 30-year-old furnace.
				A "push on" electrical terminal connection that is part of the electrical power circuit for the furnace fan became resistive over time, resulting in the wire becoming hot enough to burn away approximately four (4) inches of the wire insulation jacket and then ignite the plastic air filter mounted above the wire on fire. The resulting smoke and fumes from the burning filter entered the living space of residence and was detected by a carbon monoxide alarm which alerted the single resident of a hazardous situation.

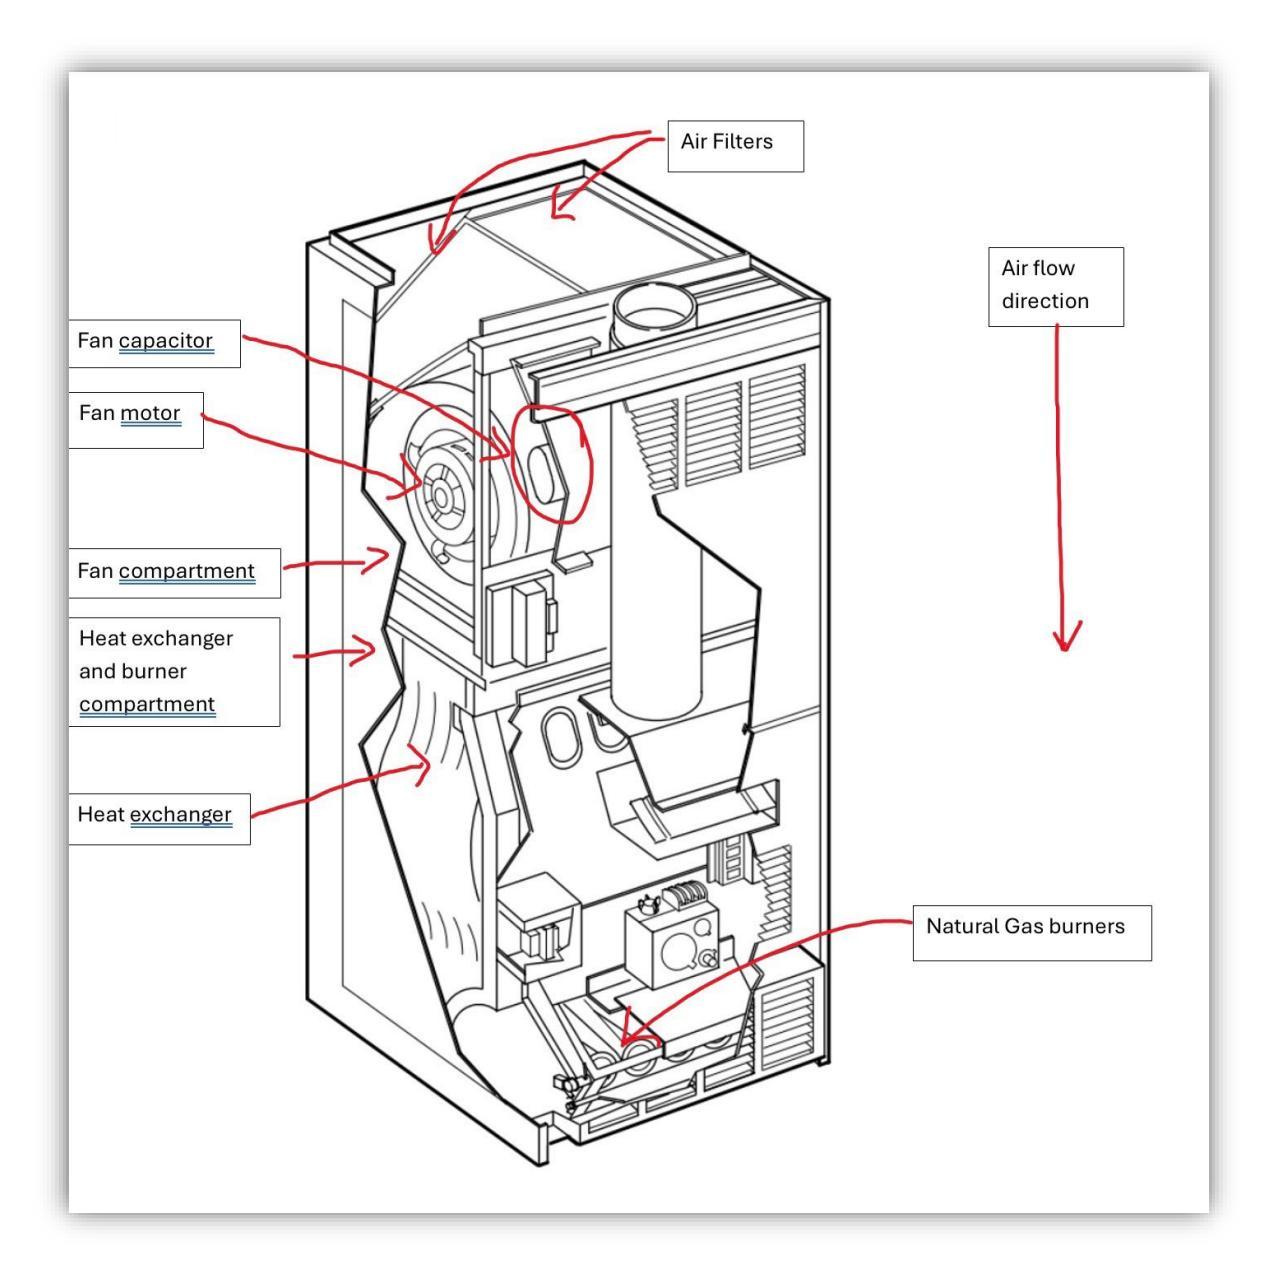
Image 1 – This is a cut away view of the furnace from the installation manual for this model of furnace and shows the parts of the furnace. The cooler air from the home is drawn through the return air duct connecting to the top of the furnace, then down through the air filters, through the fan assembly, and then pushed through the heat exchanger and then down to the supply air duct which distributes the heated air back into the rooms of the home. **This diagram is from the Lennox G20RE service manual.*

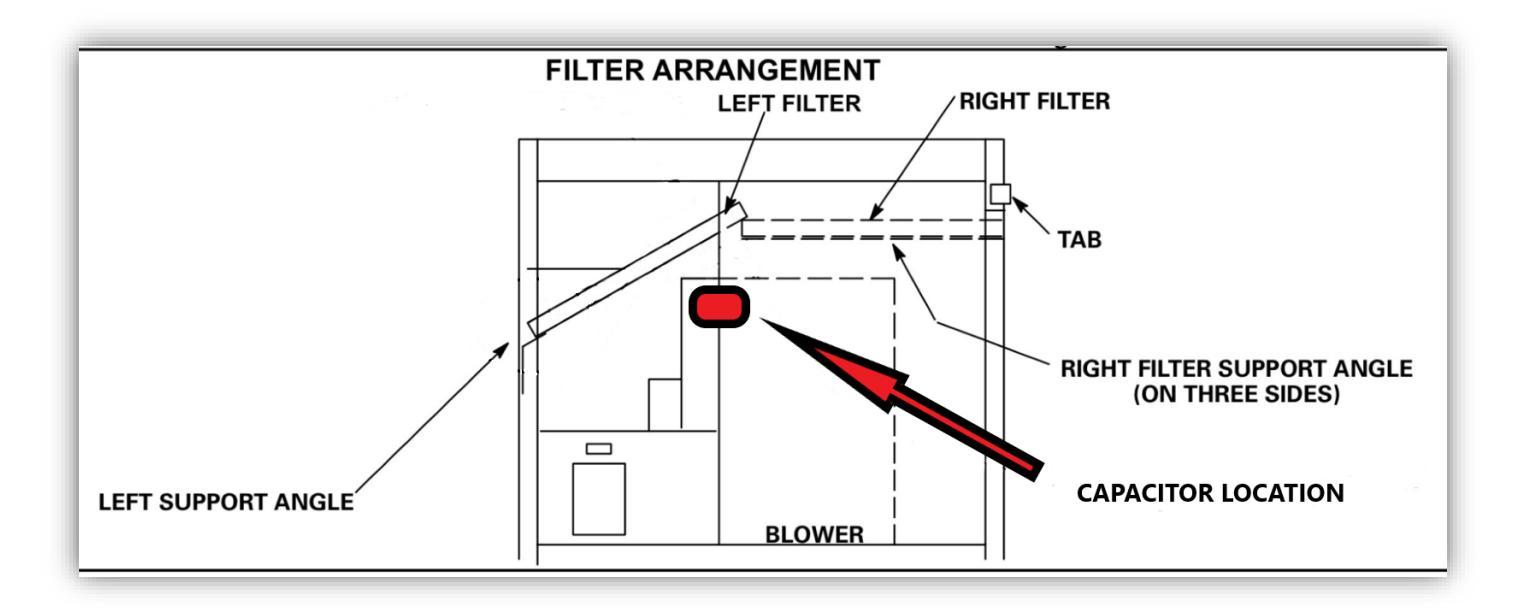
Causes and contributing factors	The resulting fire appears to be a combination of an existing electrical component ongoing failure and a possibility that the left side filter was not placed fully into the lower filter bracket resulting in the plastic filter being drawn down with the airflow to make contact with the heated electrical wire. The design of the filter brackets and fan assembly places the filter in close proximity to the electrical connections of the fan capacitor. An error in properly installing the filters, or poor maintenance resulting in plugged filters can result in the filters being drawn down toward the fan assembly with the airflow and making contact with the energized terminals of the capacitor.

Image 2 - The filters are positioned over top of the fan housing as illustrated in this diagram. There are 2 filters required, one installed horizontally above the fan assembly on the right, and one installed at an angle on the left above the capacitor and the associated wiring. **This diagram is from the Lennox G20RE service manual.*

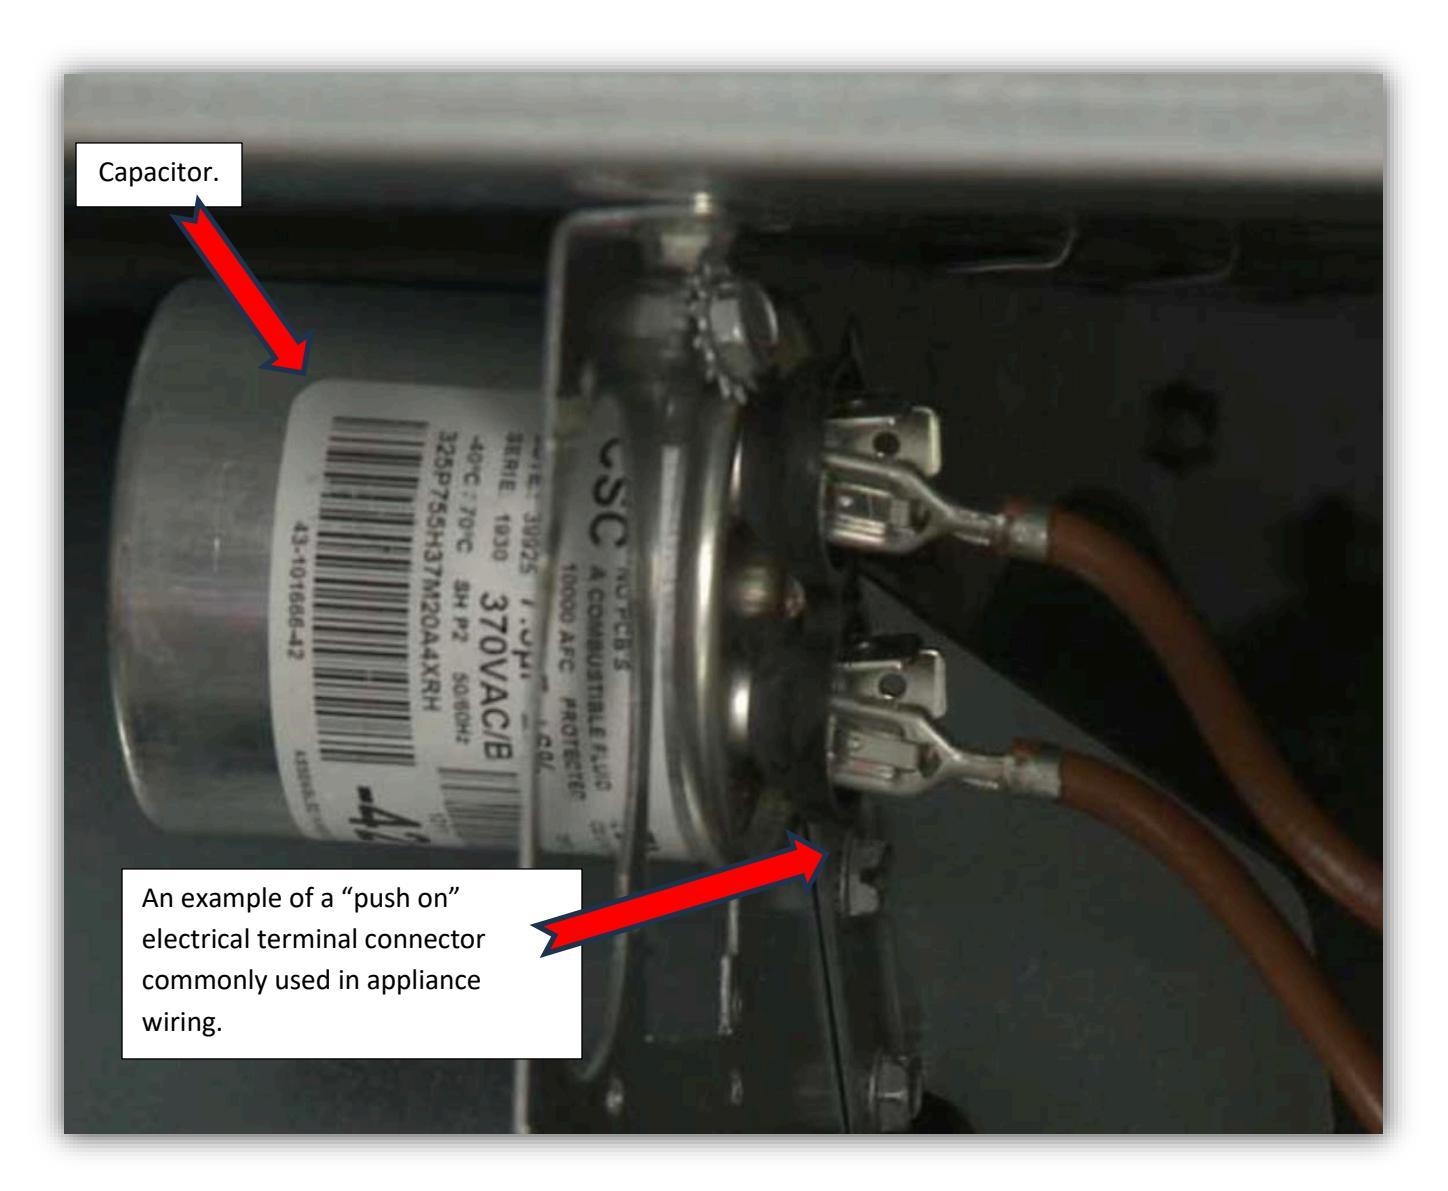
Image 3 – This is a generic view of a fan capacitor installed with the manufacturers wiring method of using "push on" terminal connectors. **This photo is from https://m.youtube.com/watch?v=CXzrSpuLJI0.*
