Incident Summary #II-928694-2019 (#15744) (FINAL)

SUPPORTING INFORMATION	Incident Date		October 25, 2019		
	Location		Abbotsford		
	Regulated industry sector		Boilers, PV & refrigeration - Refrigeration system		
		Qty injuries	0		
	Injury	Injury description	No injury reported		
	act	Injury rating	None		
	lmp amage	Damage description	A shaft seal failure on a compressor in a refrigeration system released approximately 5 lbs of ammonia intended to be contained.		
	Ő	Damage rating	Minor		
	Incident rating		Minor		
	Incident overview		An ammonia release resulted in the temporary shutdown of an ammonia plant in an industrial food processing facility.		
INVESTIGATION CONCLUSIONS	Site, system and components		Ammonia refrigeration systems are designed to operate at 250 pounds per square inch gauge (Psig). The major components of the system like compressors, evaporators, liquid receivers, piping, and fittings etc. are installed in a machinery room. The compressor sucks refrigerant gas into a cavity, gradually reduces the volume of the cavity, and discharges the refrigerant as a high-pressure gas. Lubricating oil is very significant to keep the compressor in a good operating condition. To p

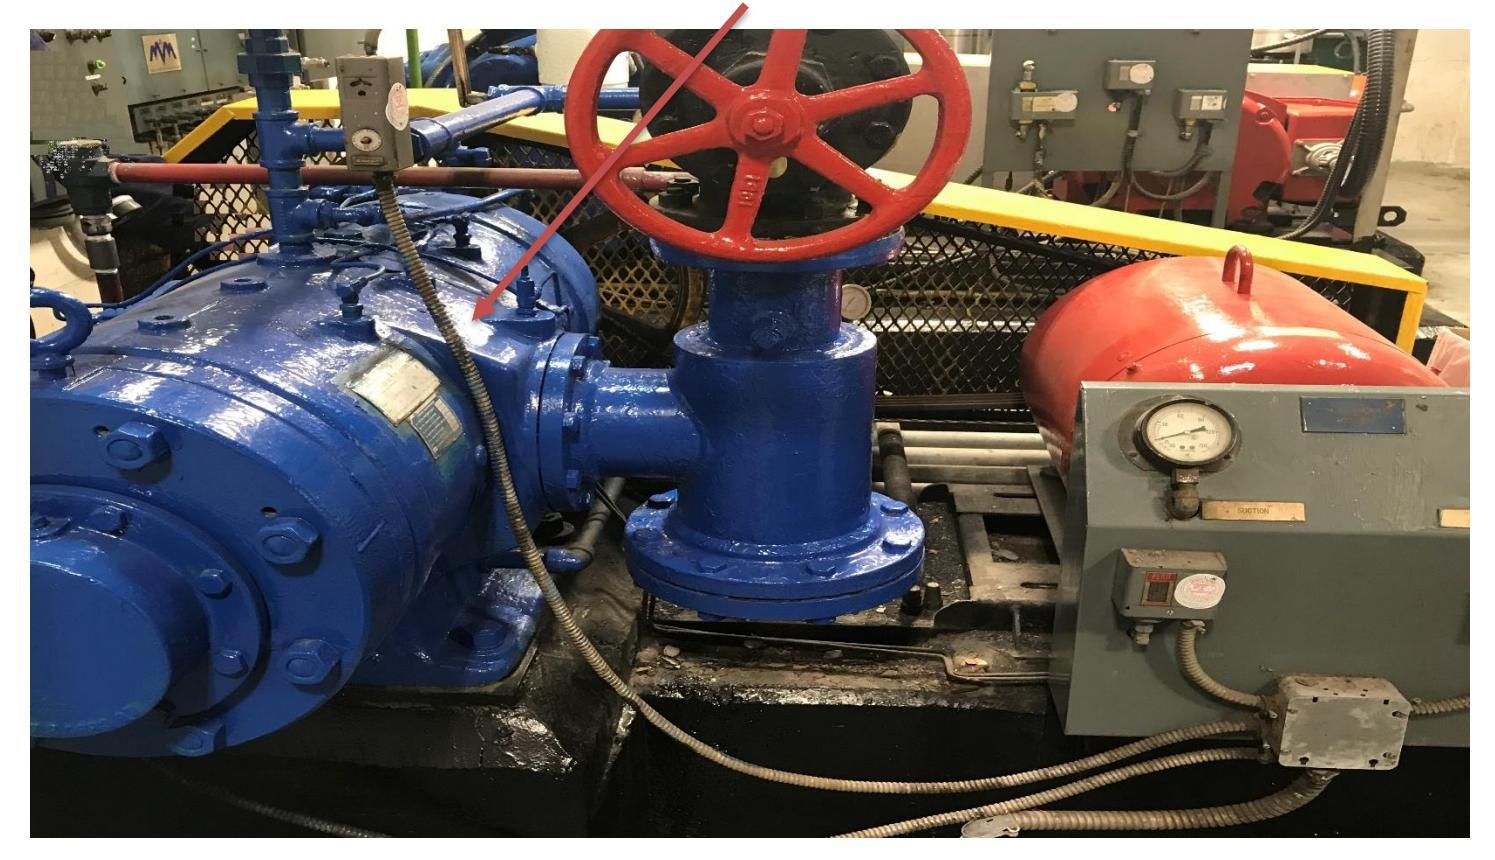
COMPRESSOR

Failure scenario(s)		 In the machinery room, the ammonia from the compressor was released through the shaft seal during the night time, which triggered the audio ammonia alarm. The ammonia monitor located outside the machinery room initially showed 500ppm and then suddenly dropped to 98ppm, this could happen as the ammonia detector was just above the compressor and a sudden release like a cloud of ammonia may have triggered the detector to the highest reading. A refrigeration maintenance contractor was contacted. The refrigeration contractor's personal monitor was showing 3ppm.

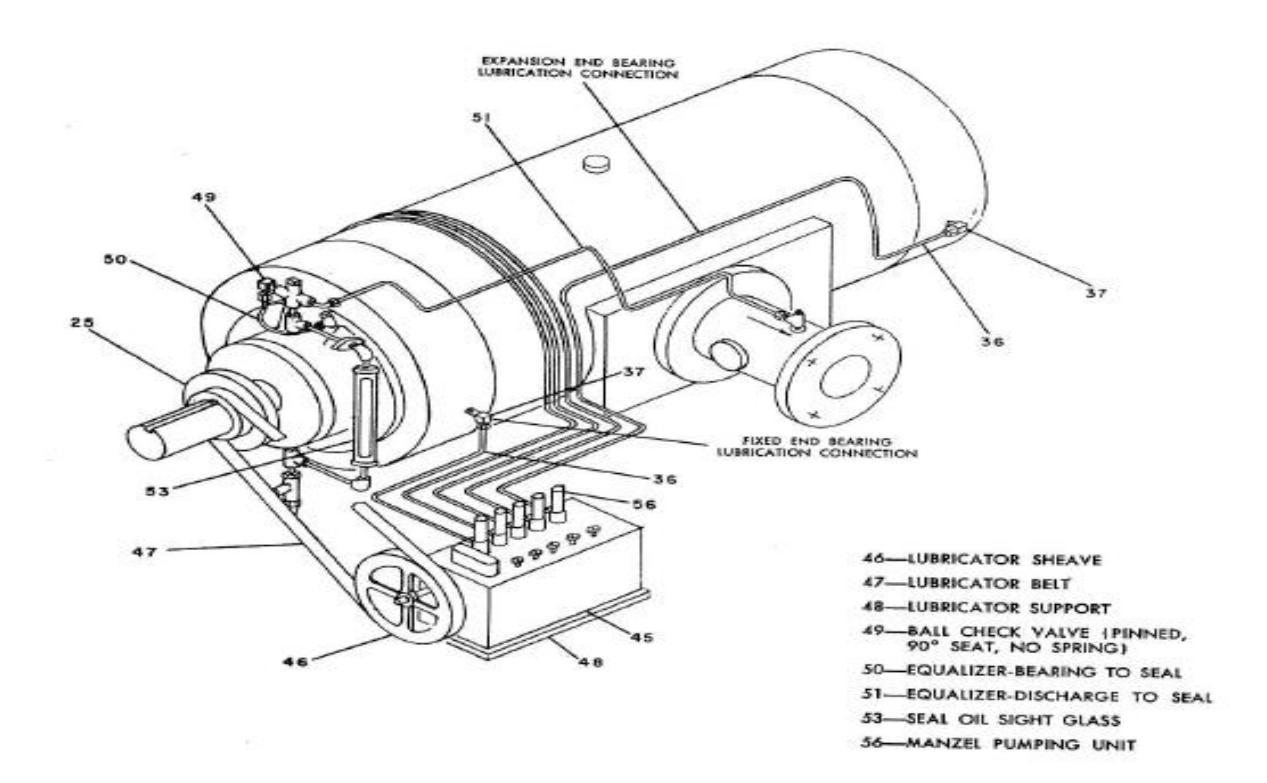
Compressor (sectional view – shaft seal assembly location)

Causes and contributing factors	The cause of the ammonia release was very likely due to a lack of lubrication between the compressor shaft seal faces. This caused the seal to fail allowing ammonia to be released through the micron class gap between the seal faces. The lack of seal lubrication was due to a low oil level condition within the compressor seal reservoir. A contributing factor was that there was no monitoring system in place for the seal reservoir oil level.
