Incident Summary #II-1806066-2024 (#55151) (FINAL)

SUPPORTING INFORMATION	Incident Date		September 3, 2024
	Location		West Vancouver
	Regulated industry sector		Gas - Natural gas system
	Impact	Qty injuries	6
		Injury description	Several people residing and working in a residential home experienced illness symptoms related to carbon monoxide exposure.
		Injury rating	Minor
	Damage	Damage description	Dangerous concentrations of carbon monoxide were being produced by a heating boiler and migrated indoors causing exposure to the occupants.
		Damage rating	Moderate
	Incident rating		Moderate
Incident overview		A wall hung condensing boiler installed in a large residential home, produced high concentrations of carbon monoxide (CO). The venting system for the boiler allowed the flue gasses to enter the home and expose the occupants to levels of CO that resulted in illness symptoms over a two-year period.	
INVESTIGATION CONCLUSIONS	Site, system and components		<p>The 13,359 square foot residential home was built in 2009. The radiant heating and domestic hot water system for the home was designed to use a geothermal heat pump system as the primary source for heat, with a gas fired condens

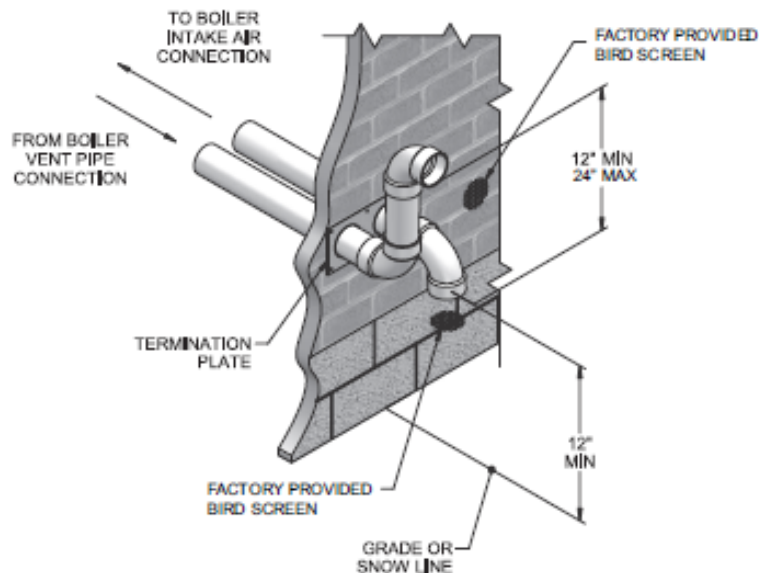
Figure 4-1 Field Supplied Fittings with Vent Termination Elbow

- Material for the vent shall be S636 certified stainless steel, PVC, CPVC, or Polypropylene.
- The vent size for the model of boiler (199) shall be 3" with max equivalent length of 100 feet (4" is only used for larger models 285 or 399).
- All PVC vent pipes must be glued, properly supported, and the exhaust must be pitched a minimum of a 1/4 inch per foot back to the boiler (to allow drainage of condensate).
- When using a sidewall termination, maintain clearances as shown:

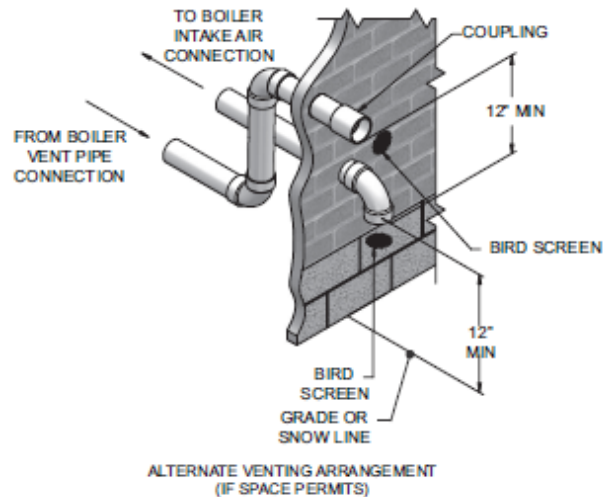
Figure 4-5B Field Supplied Fittings with Vent Termination Coupling

WARNING A gas vent extending through an exterior wall shall not terminate adjacent to a wall or below building extensions such as eaves, parapets, balconies, or decks. Failure to comply could result in severe personal injury, death, or substantial property damage.
