## Incident Summary #II-875227-2019 (#14105) (FINAL)

SUPPORTING INFORMATION	Incident Date		July 4, 2019	
	Location		Abbotsford	
	Regulated industry sector		Boilers, PV & refrigeration - Refrigeration system	
	Impact	Injury	Qty injuries	0
			Injury description	No injury reported
			Injury rating	None
		Damage	Damage description	A safety feature (flanged connection) failure in a refrigeration system released 10 to 20 lbs of ammonia intended to be contained.
			Damage rating	Minor
Incident rating			Minor	
Incident overview		An ammonia release resulted in the evacuation and temporary shutdown of an ammonia plant in an Industrial food processing facility.		
INVESTIGATION CONCLUSIONS	Site, system and components		Ammonia refrigeration system is designed to operate at 250 Psig. The system uses welded or flanged connections to connect components such as compressors, condenser, evaporators, and liquid receivers. Piping and fittings including flanges, different types of valves, elbows, tee's etc., makes the system complete. Gaskets are installed between the mating surfaces of the fittings to ensure a proper seal so that the refrigerant will not leak out into the atmosphere. When bolts on fla

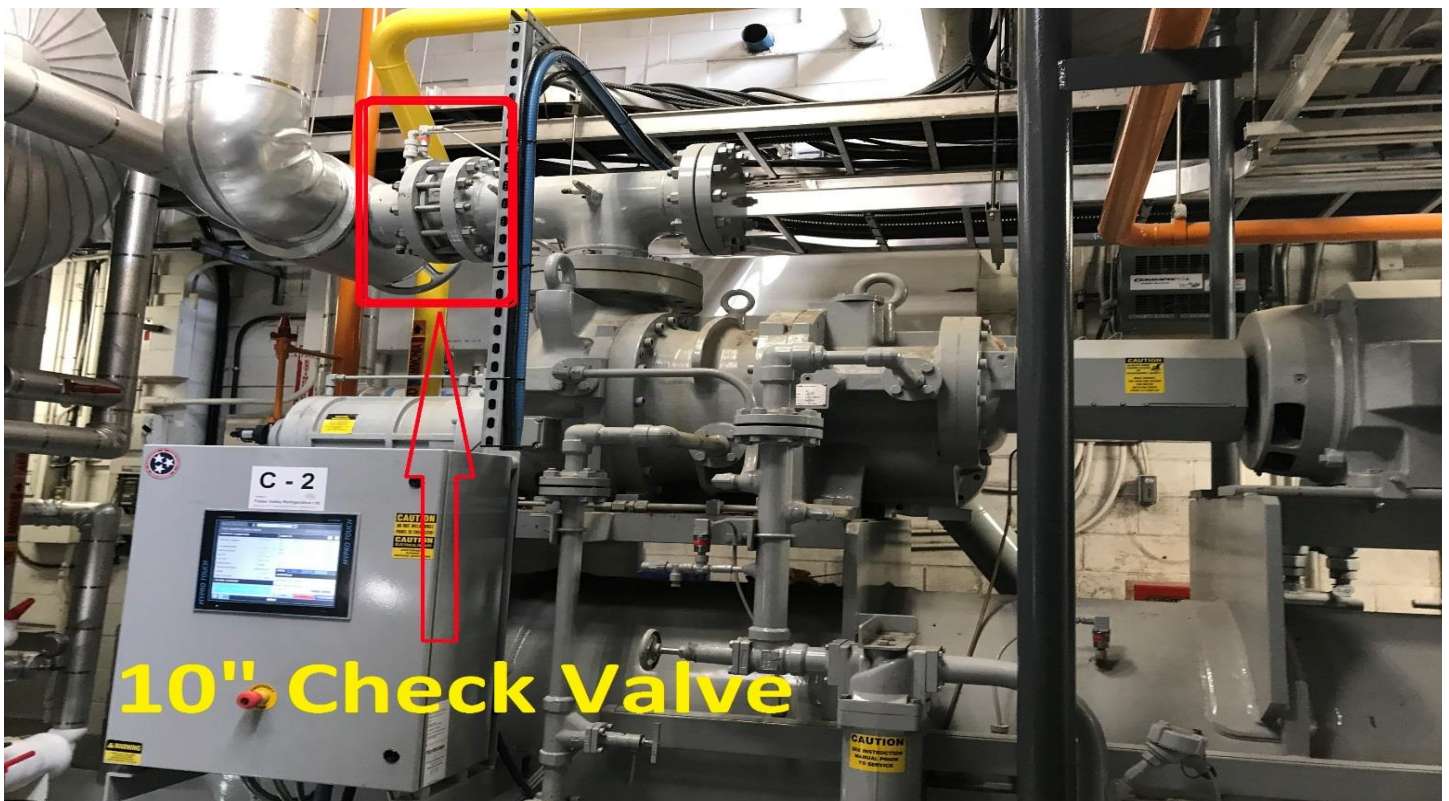
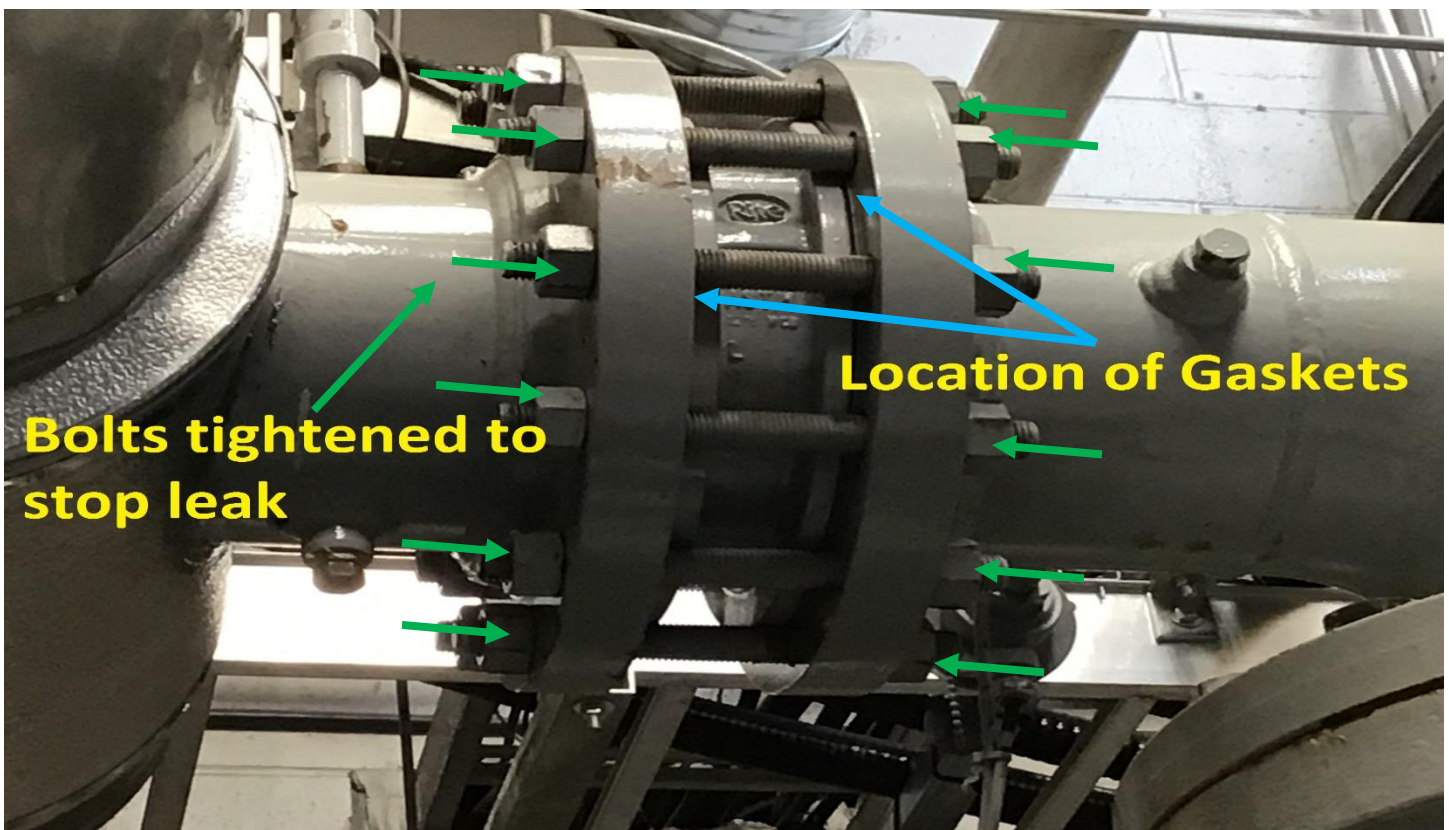
**COMPRESSOR**

<p>Leak detections:</p> <ul style="list-style-type: none"><li>• Maintenance contractor detected ammonia leak through litmus test</li><li>• The leak was found on flanged connection of 10" check valve at the suction side of compressor</li><li>• Maintenance contractor tightened the flange bolts which stopped the leak</li><li>• The ammonia concentration came down to zero in the room</li><li>• The compressor was shut down and isolated for inspection of flanged connection</li></ul> <p>Assessment of Flanged connection:</p> <ul style="list-style-type: none"><li>• The flanged connections were dismantled to assess the condition of the gasket and faces of the flanges.</li><li>• The Gasket was found a little off centered but had no signs of physical damage</li><li>• Flange faces were normal</li><li>• Gasket was replaced</li></ul>
<b>Causes and contributing factors</b>	<p>It is very likely that frequent start-up and shutdown of the plant caused thermal expansion and contraction of the piping, flange, and bolts. This combined with vibration occurring while the compressor is running caused the nuts on the bolts of the suction check valve flange to loosen which resulted in an ammonia release.</p>
