## Incident Investigation Report

# Carbon Monoxide Release From Boiler Exhaust Venting

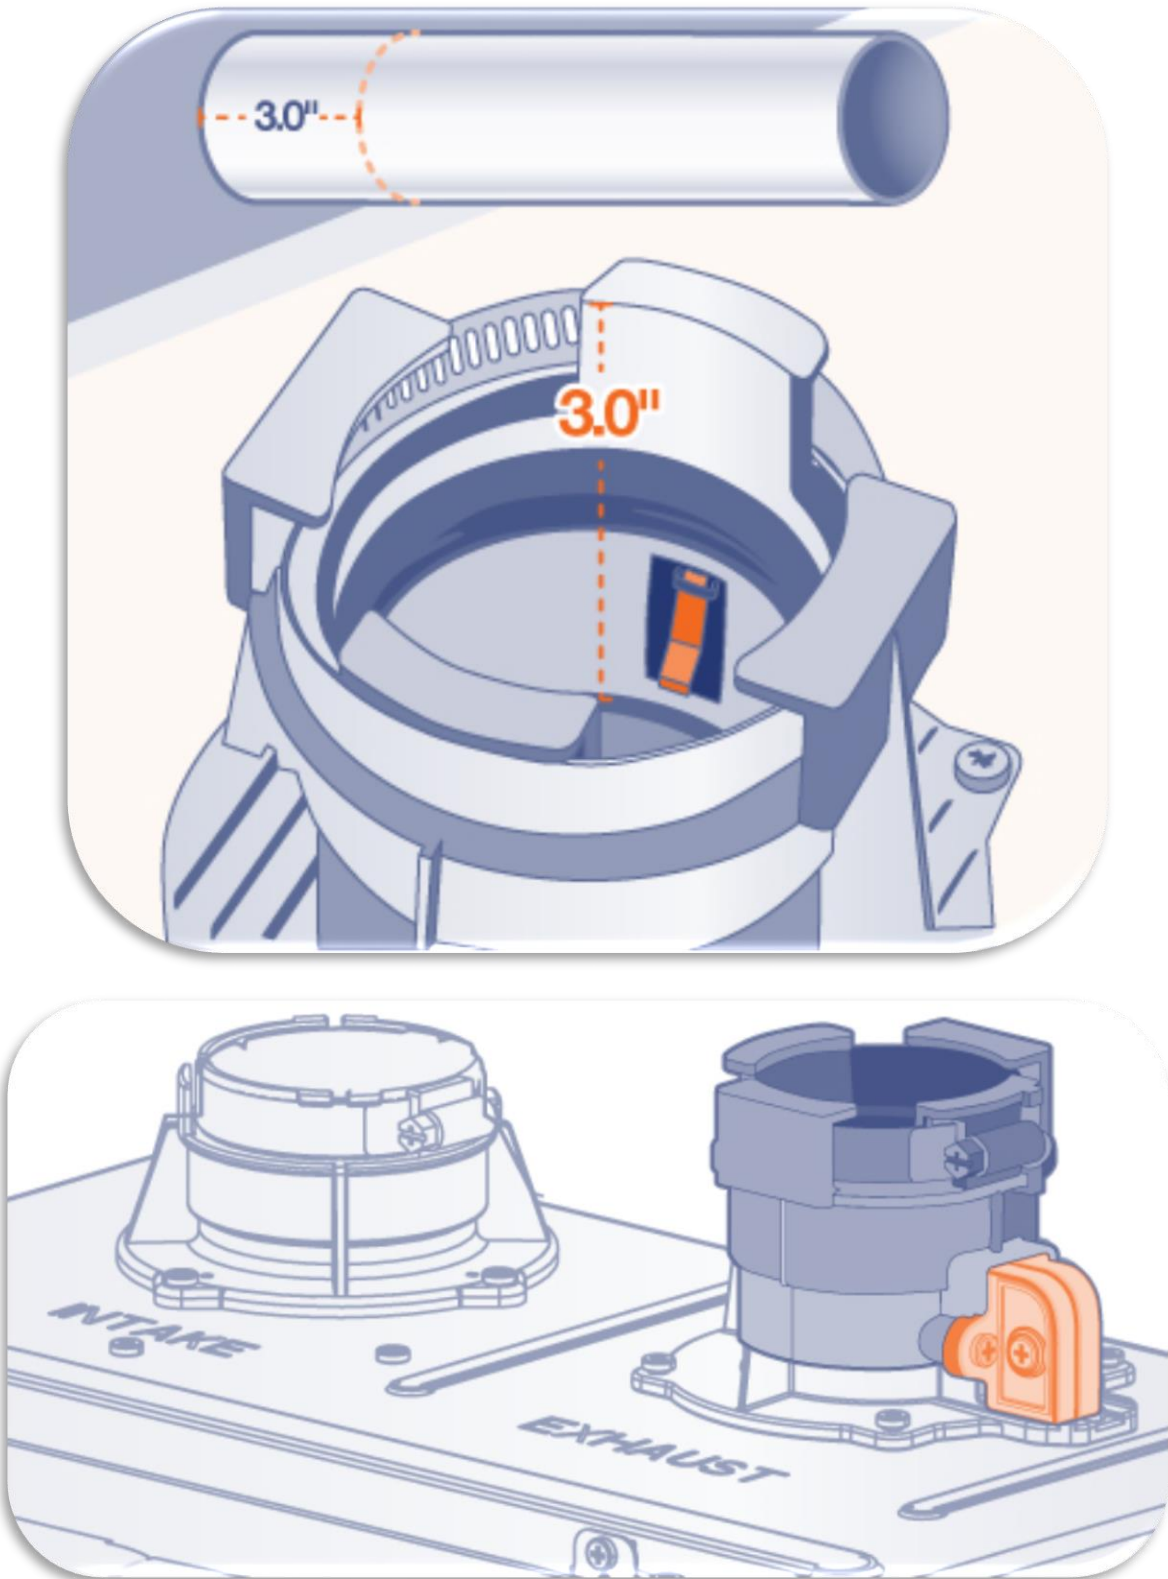
Image 14 – Example of boiler vent installation detector safety switch \*(Source: [www.navieninc.ca/blog/notice/innovation-by-design-vent-installation-detector](http://www.navieninc.ca/blog/notice/innovation-by-design-vent-installation-detector)).
