Incident Summary #II-1892563-2025 (#57220) (FINAL)

SUPPORTING INFORMATION	Incident Date	April 9, 2025			
	Location	Vancouver			
	Regulated industry sector	Elevating devices - Elevator			
	Impact	Qty injuries	0		
		Injury description	N/A		
		Injury rating	None		
	Damage	Damage description	An elevator collided with the passenger car during the elevator operation. The counterweight guide assembly was bent and broken, and the metal frame of the car was bent and torn. Two 50lb balancing weights from underneath the car dislodged and fell down the elevator shaft into the pit from the 17 th floor.		
		Damage rating	Major		
	Incident rating	Major			
	Incident overview	The counterweight for a freight elevator in a 32-floor high-rise office building came off of the guide tracks. While the elevator was traveling downward without any passengers, the rising free-swinging counterweight collided with the bottom of the passenger car. The collision damaged the counterweight guide wheel assembly and the metal c-channel structure on the bottom of the car. The collision tripped the elevator overspeed safety circuit, stopping the operation of the elevator.

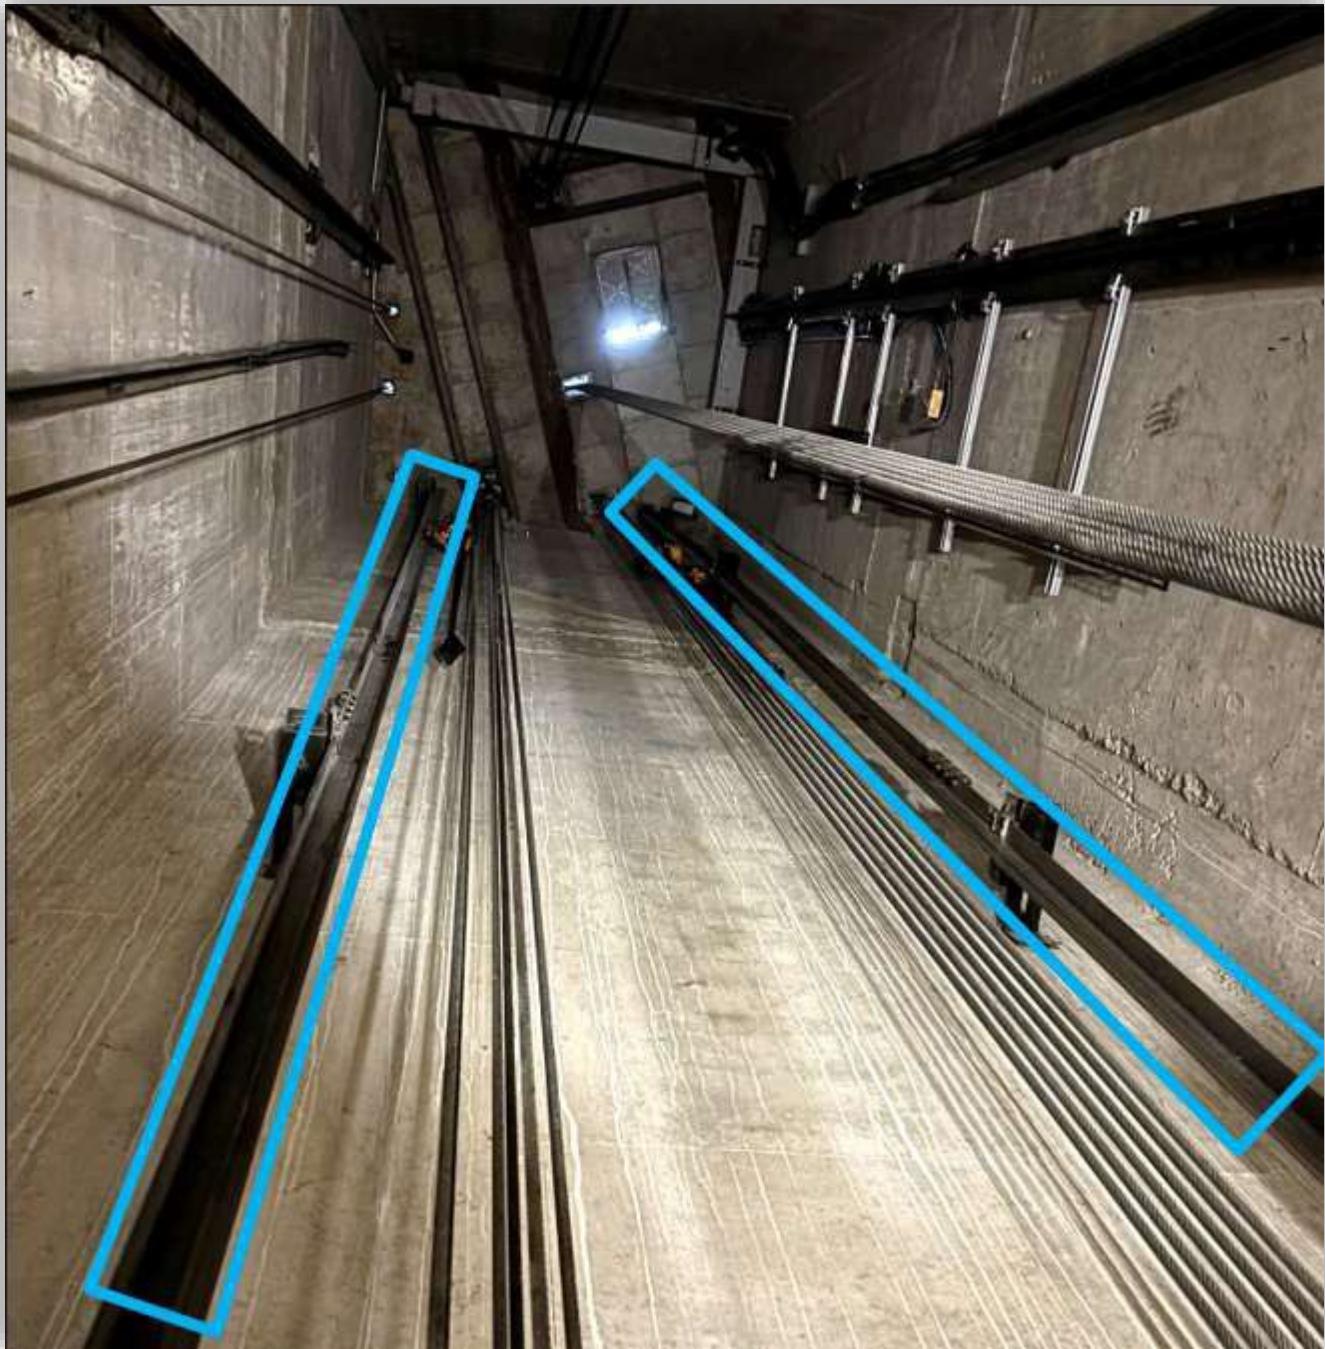
Image 1 – Top of hoistway. [Boxes] The counterweight guide rails.

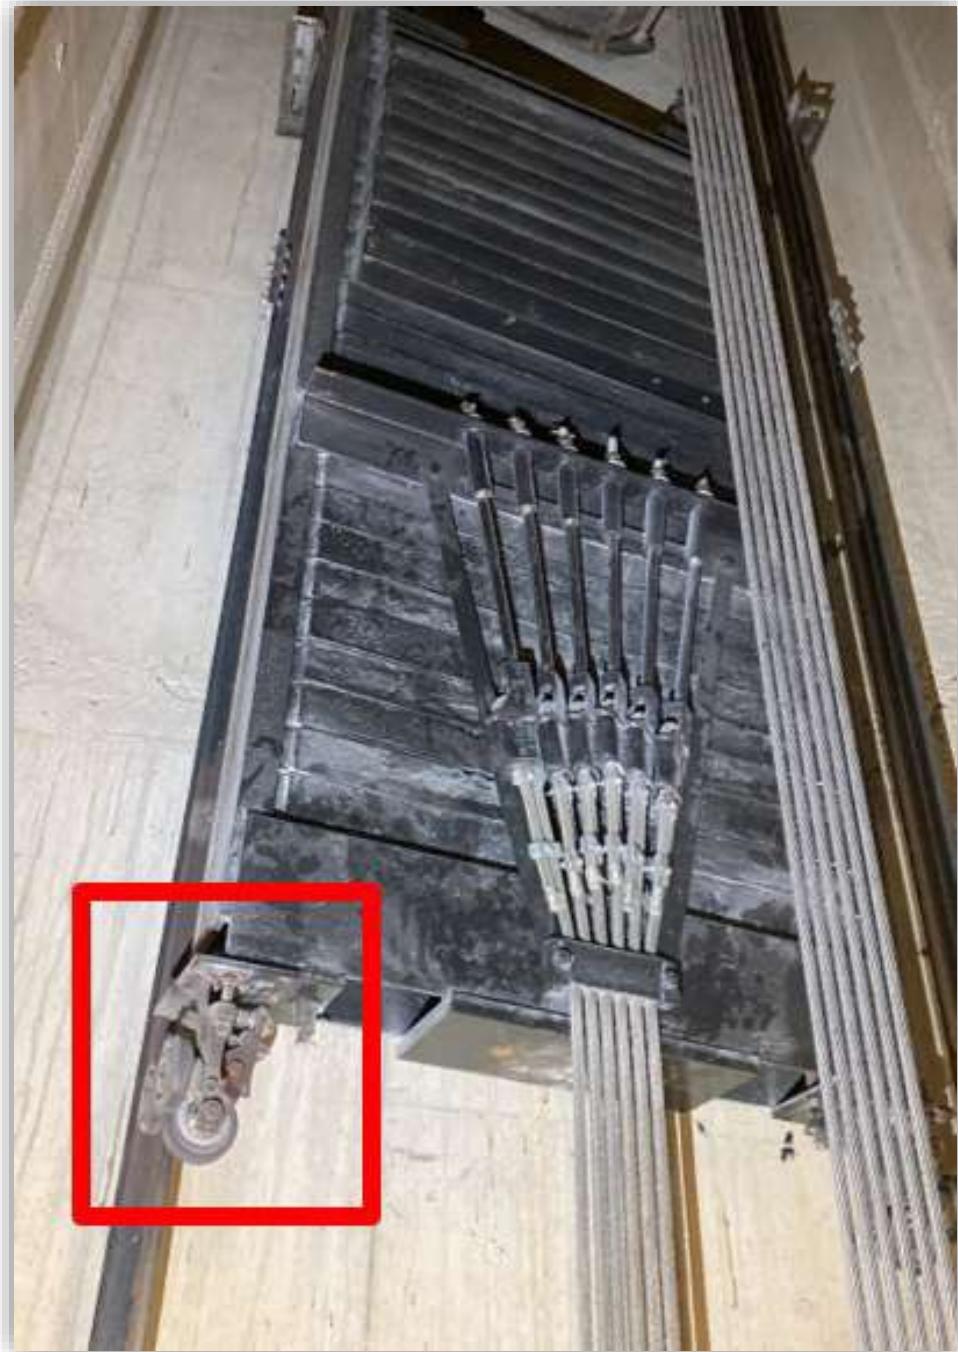
Image 2 – Elevator counterweight. [Box] An undamaged counterweight guide assembly off of the guide rail. The counterweight typically utilizes a guide assembly on the bottom and top of the counterweight for each guide rail.

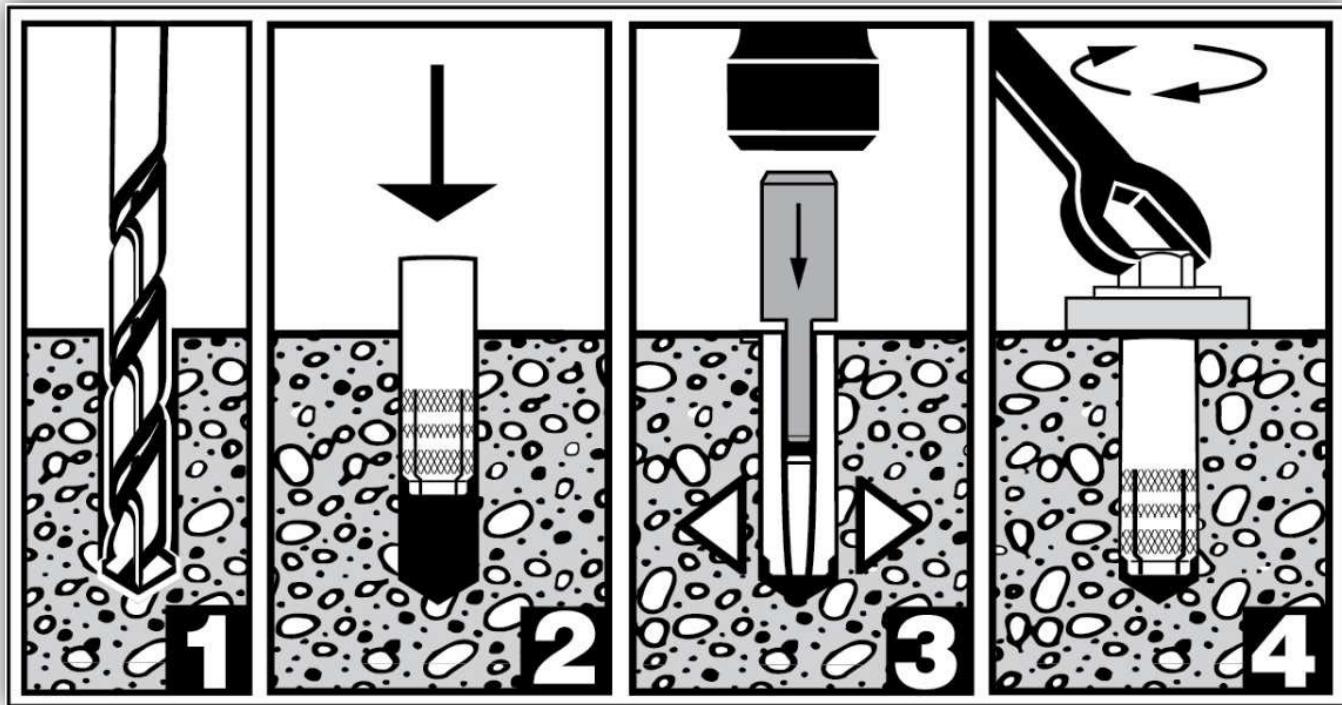
Image 15 – Illustration of the use of a drop-in style concrete anchor system (<https://cobraanchors.com/en/drop-in-stainless-steel-11789.html>).
