## Incident Summary #II-1286980-2021 (#25031) (FINAL)

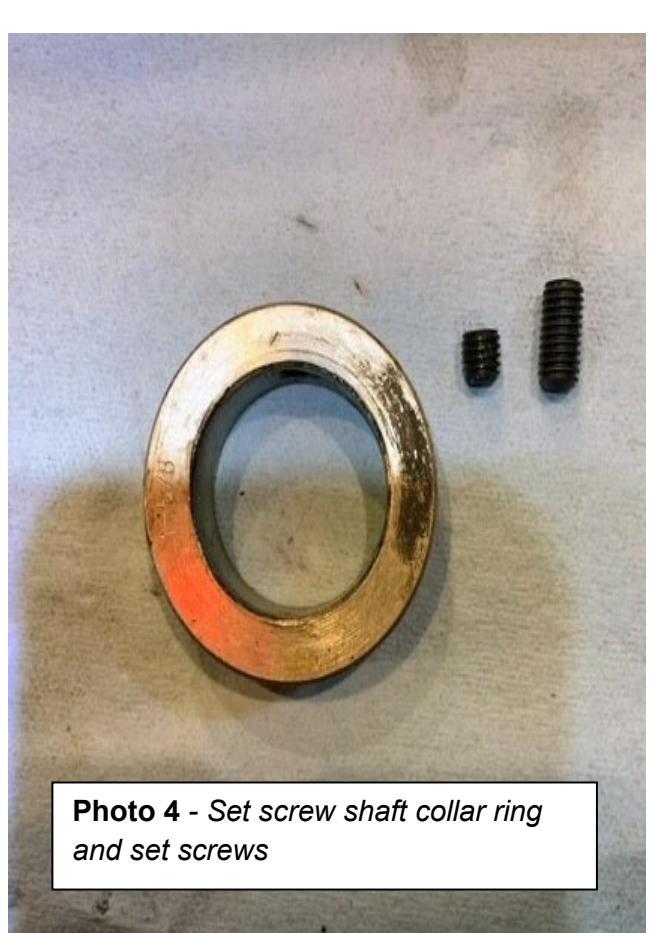
Failure scenario(s)		A set screw shaft collar ring installed on one side of the pulley failed to keep the pulley from rotating out of alignment. The clearance between the roller guides and pulley was reduced as a result. The hex fasteners that keep the roller guides from falling off the track, wore off from the continuous contact with the edge of the pulley. (Photos $5$ , $6$ and $7$ )

**Photo 3** - Set screw shaft collar ring installed on one end of the pulley shaft.
