SUPPORTING INFORMATION	Incident Date		July 1, 2020
	Location		Prince George
	Regulated industry sector		Electrical - Low voltage electrical system (30V to 750V)
	Impact Damage Injury	Qty injuries	0
		Injury description	None
		Injury rating	None
		Damage description	Fire and smoke damage to recreational vehicle. Most structural damage contained to the area where the fridge was located.
		Damage rating	Moderate
	Inciden	t rating	Moderate
	Incident overview		On the day of the incident, the owner of a Jayco recreational vehicle was preparing for a weekend of camping. They were packing the Recreational vehicle and decided to get some items from the store. The recreational vehicle was plugged into the home exterior receptacle and then they turned on the fridge and left. It was at the store they got a call from a neighbour stating the recreational vehicle was on fire. The fire was quickly extinguished.
INVESTIGATION CONCLUSIONS	Site, system and components		The Jayco recreational vehicle was located in the driveway of the owner's single family dwelling. The unit was purchased with a three way refrigerator, meaning it can operate on propane, 12 Volts DC or 120 volts AC. The fridge is a typi

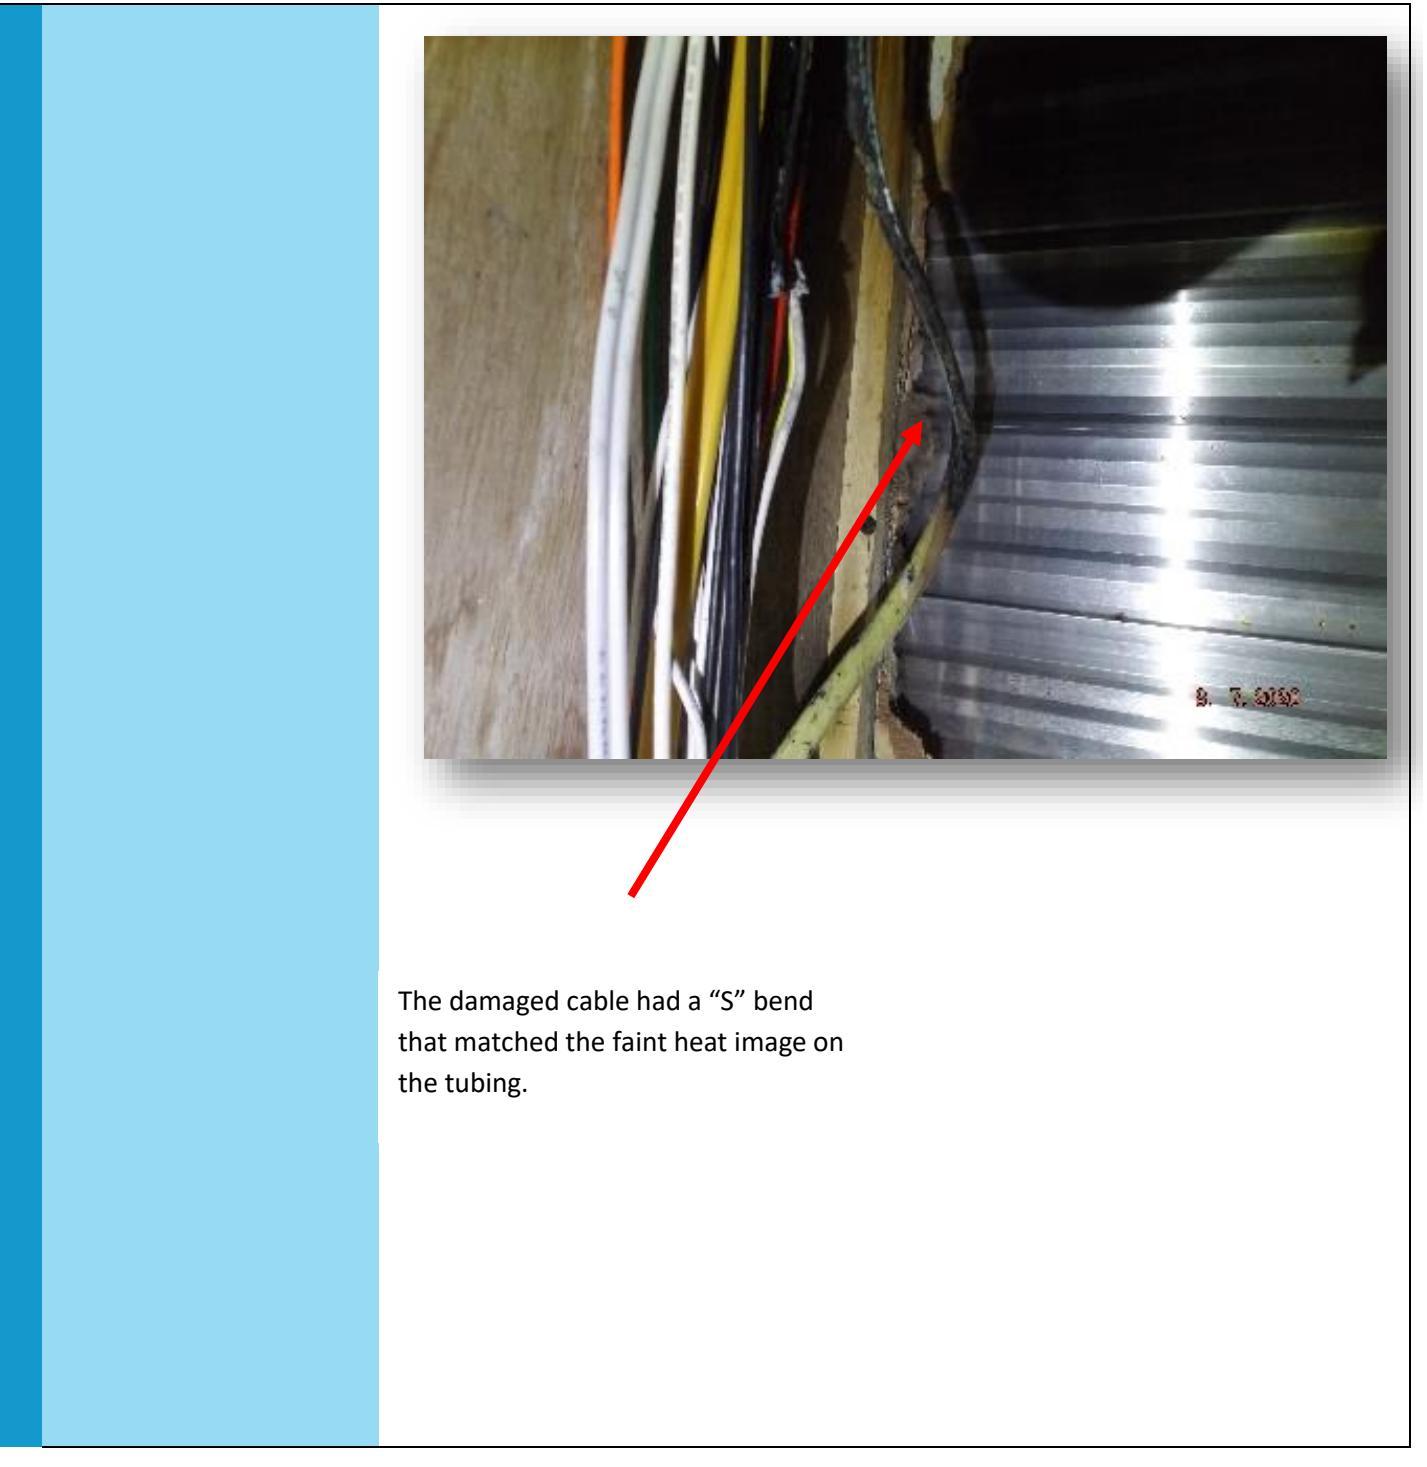
This fire did not burn hot enough to melt copper, and there was one conductor that had been severed. Here is arcing damage to the conductor. This must have been exposed to the bonded tubing of the refrigerator cooling system.

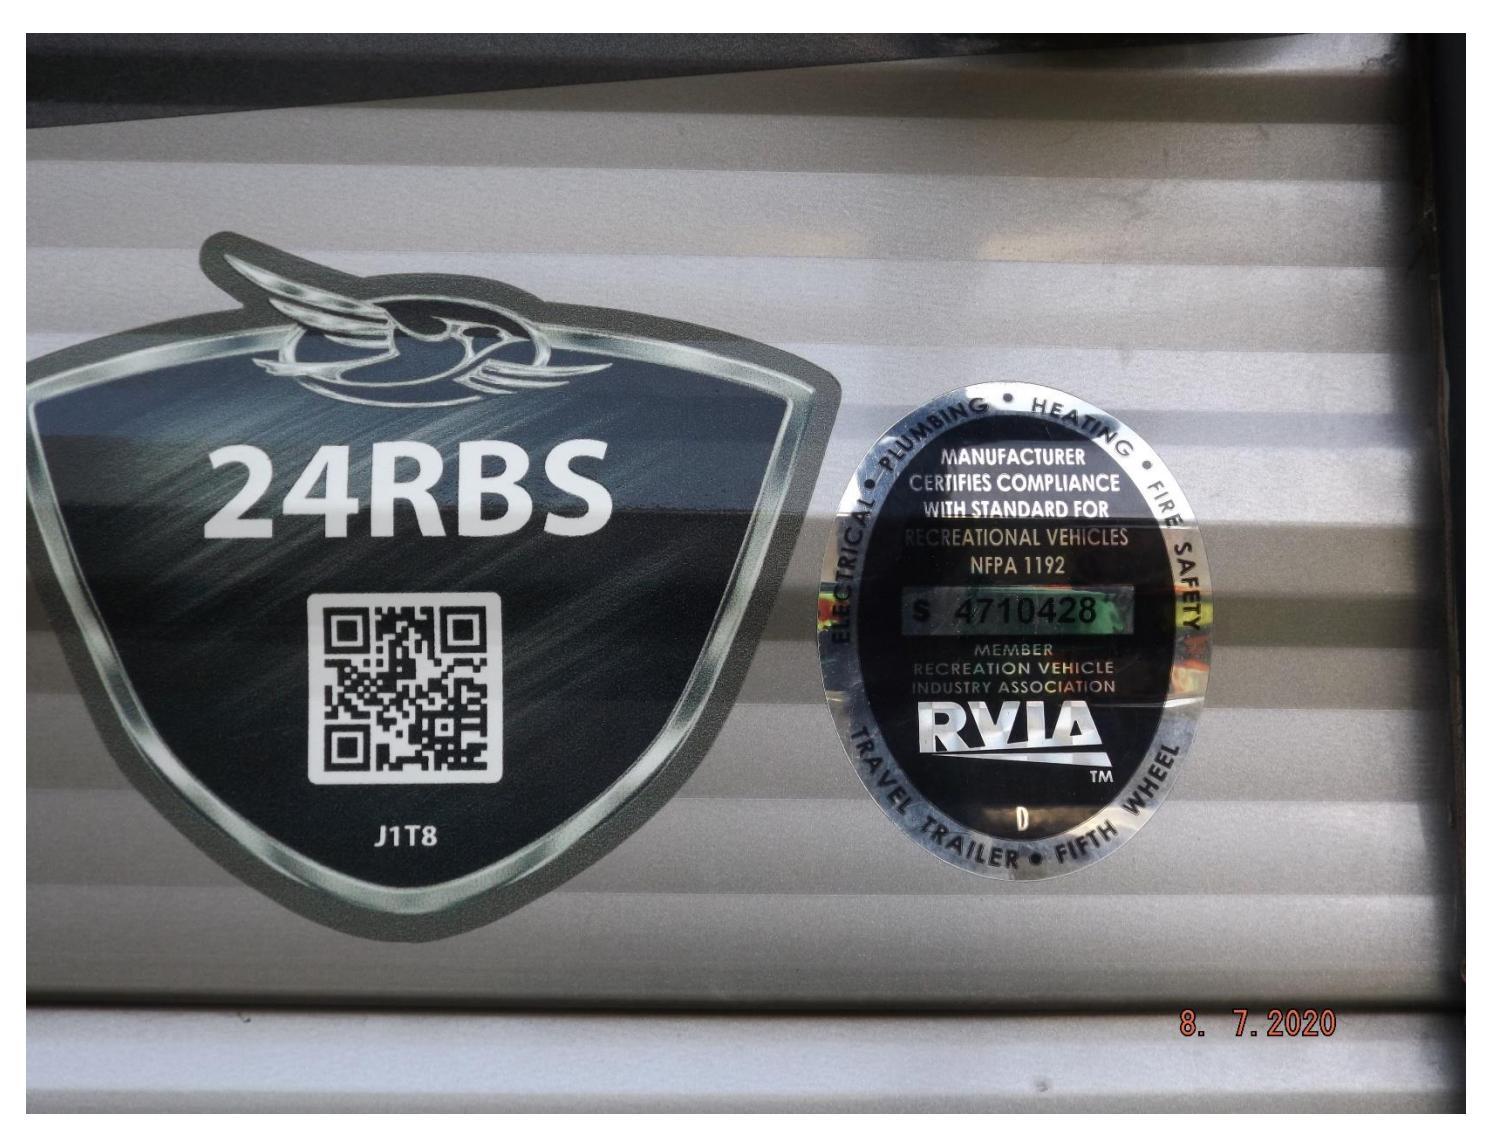
This is the data that can be used to find out which factory made the unit
