Incident Summary (#5610850)

SUPPORTING INFORMATION	Incident Date			January 9, 2016
	Location			Panorama Mountain
	Regulated industry sector			High Voltage Electrical System
	Impact	Injury	Qty injuries	None
			Injury description	N/A
			Injury rating	N/A
		Damage	Damage description	Three 65E High Voltage fuses blew at the Main High Voltage Switch. The 500KVA 25/14.4KV to 120/208V pad mounted transformers oil pressure relief valve discharged, signalling an internal fault.
			Damage rating	Minor
		Incident rating		
Incident overview			A fault occurred in the 500KVA Transformer which caused the overpressure in the transformer oil tank to operate the oil pressure relief valve, also at the same time the High Voltage Primary 65E Fuses ahead of this transformer blew in the High Voltage Switch Gear de-energizing the electrical system.	
INVESTIGATION CONCLUSIONS	Site, system and components			When there is an internal fault on an oil filled transformer the operation of the pressure relief valve signals an internal mechanical failure. The draw-out bay-o-net 18C fuses at the transformer would not react as fast as the 65E primary fuses, these primary fuses would blow or react protecting the syst

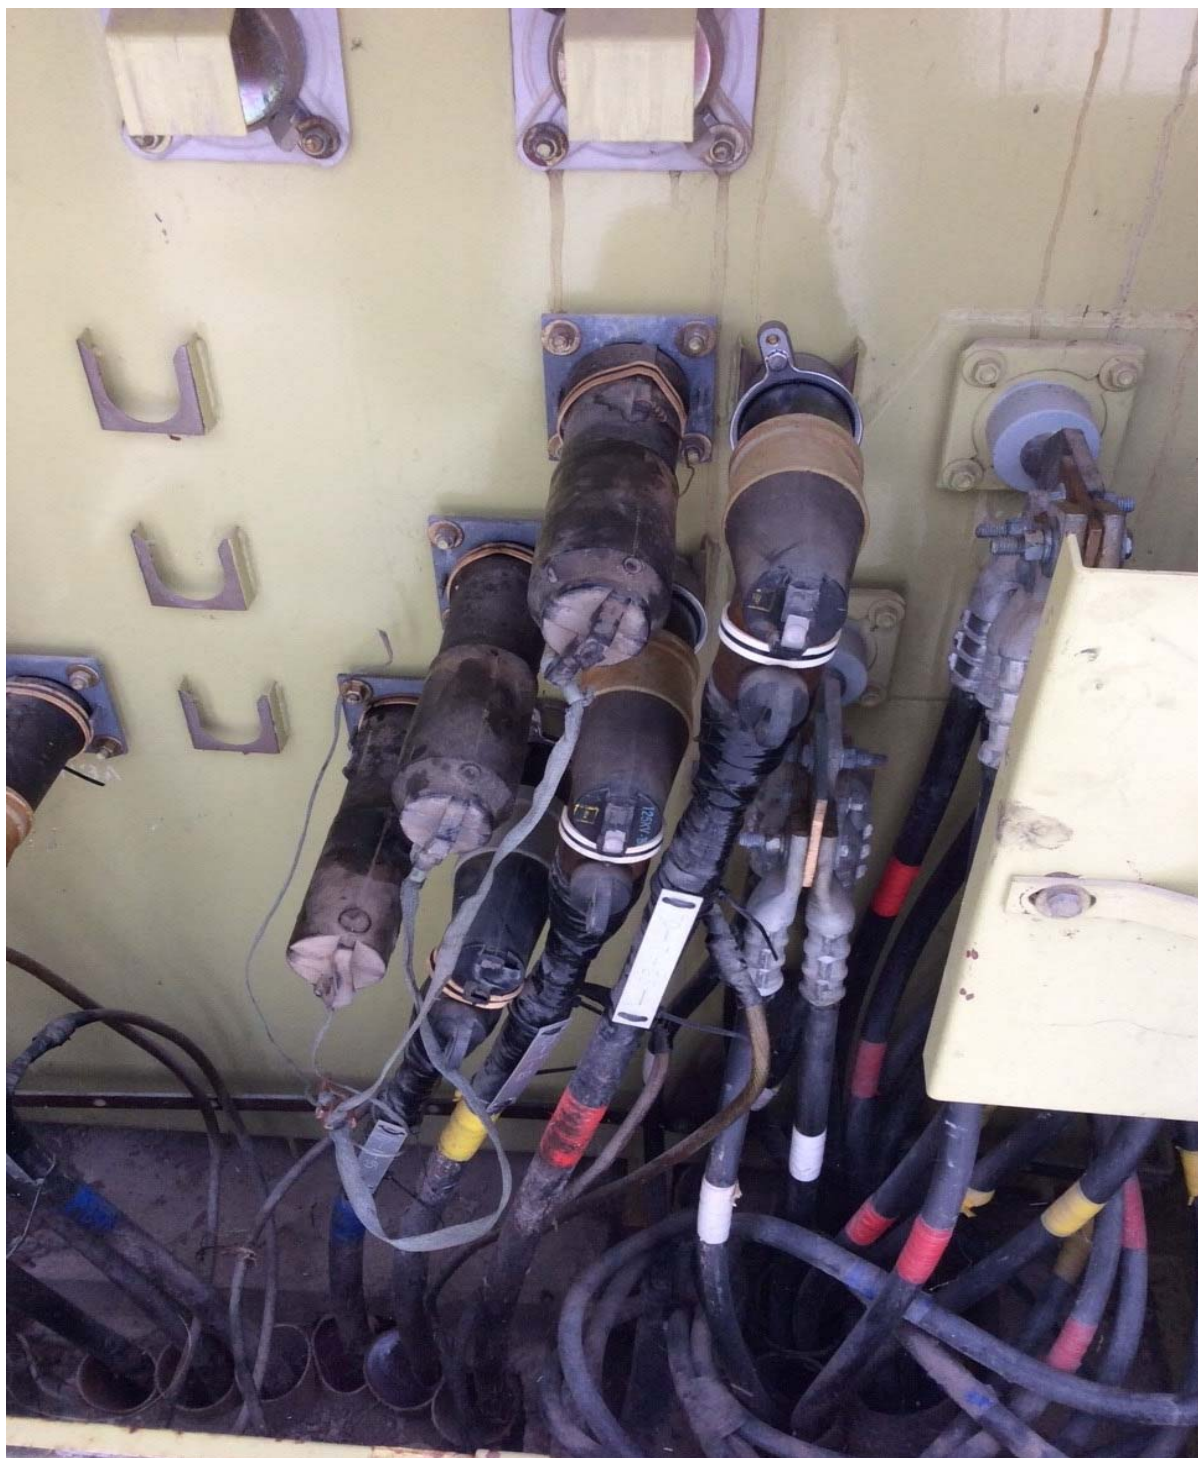
High Voltage connection parked in approved location at the 500KVA Transformer upstream from the blown 500KVA Transformer.
