# LEITNER-POMA SERVICE BULLETIN

Re: Omega lift Lateral rail entrances

## **SERVICE BULLETIN**

**Re:** Terminal entrance lateral rails

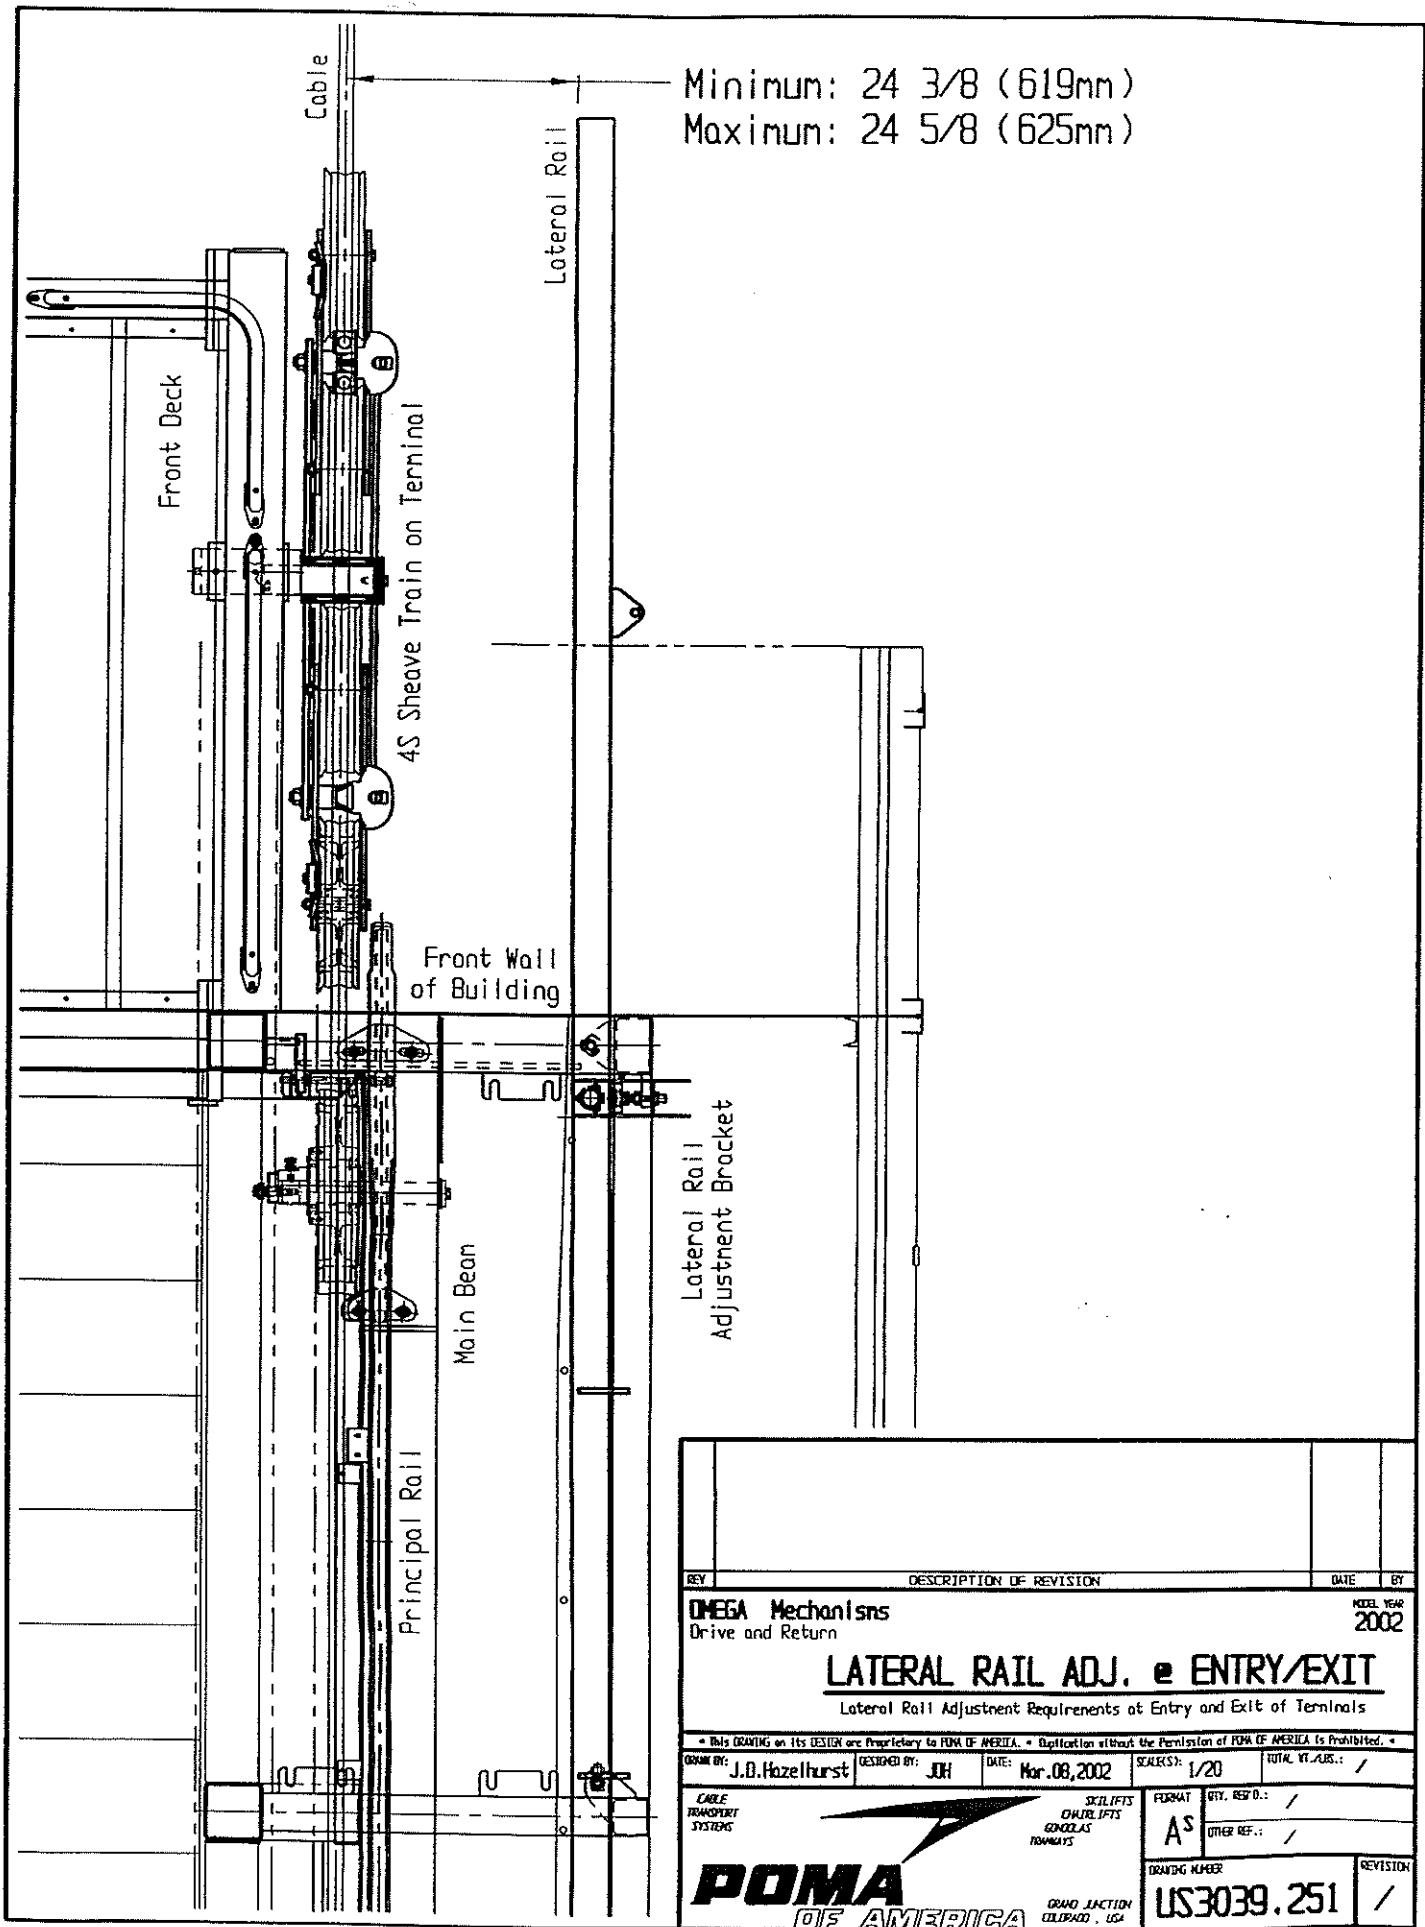
The root cause of this incident was the lateral rail was found to be too far from the haul rope. With this service bulletin is a copy of drawing number US3039251. This drawing shows the optimum distance between the center of the haul rope and the inside edge of the lateral rail. We request that you check this dimension on all your terminals; if your rail is not at the proper dimension please adjust it to the correct position.
