Incident Summary (Reference # II-624127-2017)

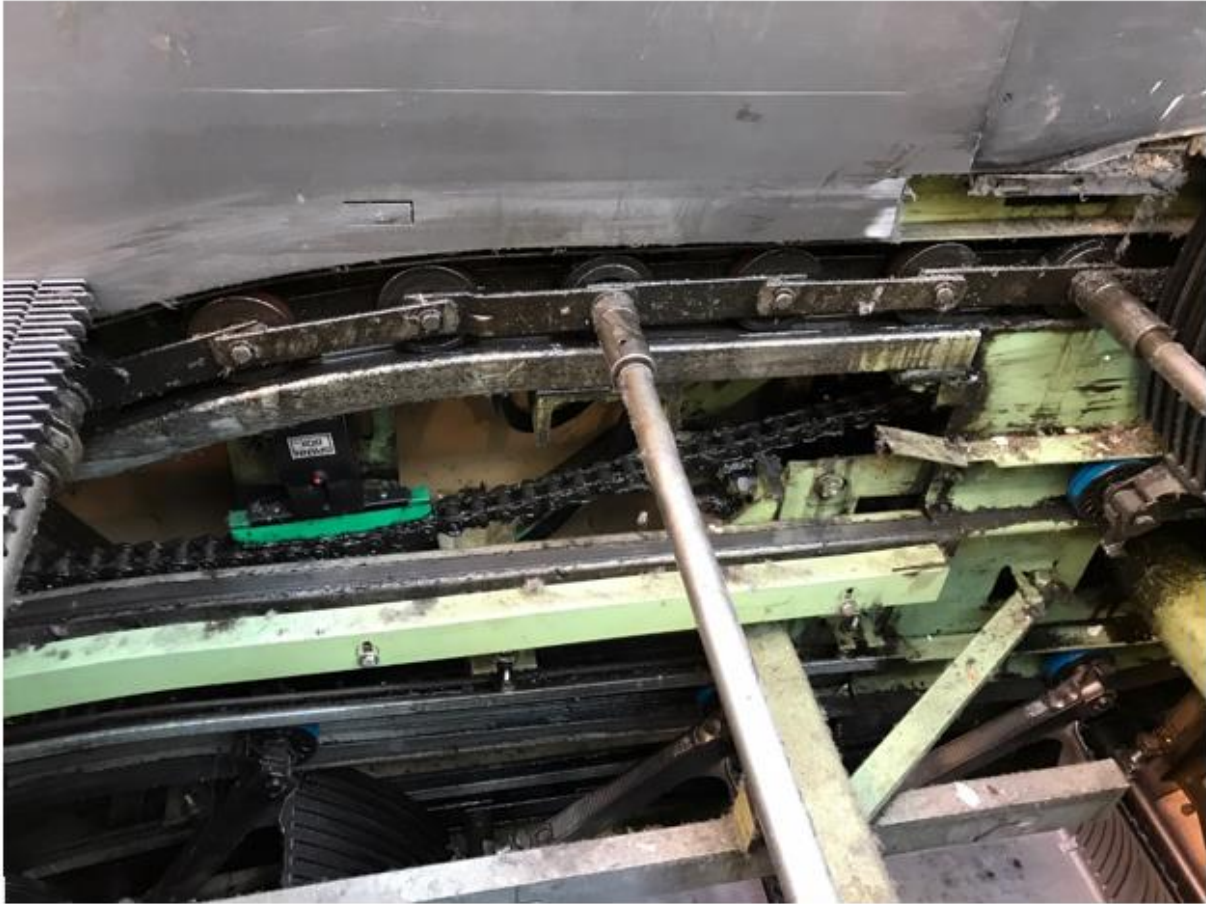
Facts and evidence	<p>All records indicate that the steps were replaced in July of 2017. The C-shaped step clamp was reported to be not locked into the step axial rotatable bushing.</p> <p>See photo's attached.</p>
	Causes and contributing factors	<p>It is highly likely that the incident was a result of a securing pin not being fully engaged into the step axle bushing at the time of installation.</p> <p>A person riding the escalator step caused further misalignment of the step and which might have contributed to the incident.</p> <p>Worn step and chain rollers may have contributed to the incident.</p>

Step axial, step bushing, step chain and step track system.
