Incident Investigation Report

Tube Slide Injury

**TECHNICAL
SAFETY BC**

February 2025

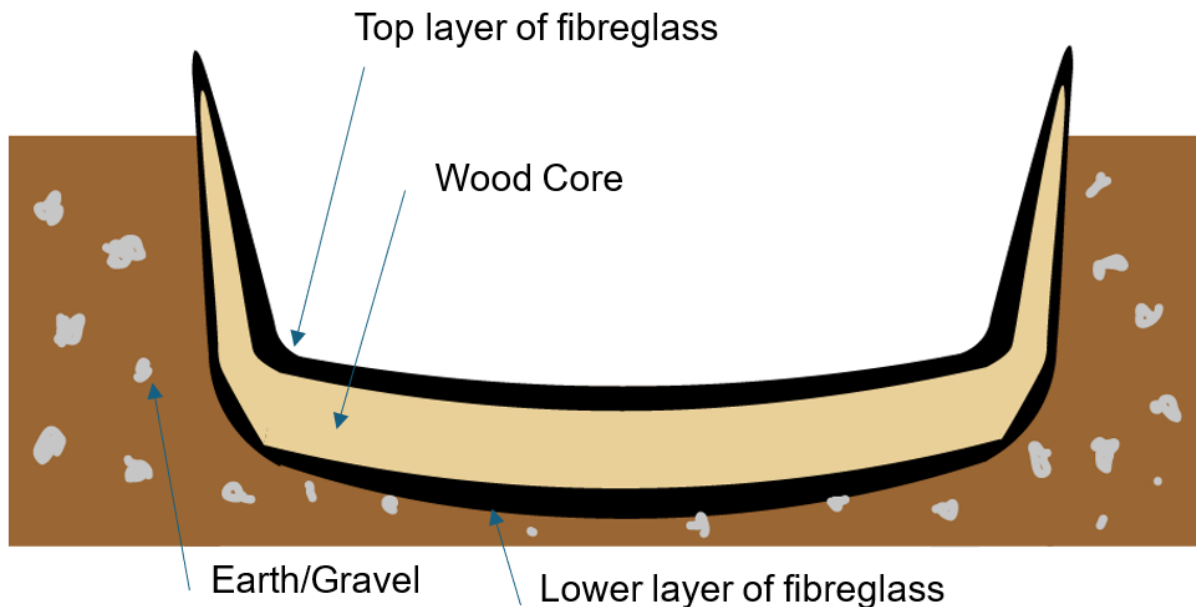
Figure 2 - Representation of the slide cross section at the time of the incident

The Tube Slide is built into the ground and therefore the ground is used as the support structure. In some areas, wood blocking was located between the slide and the ground for additional support. Since the slide was not raised on a traditional support structure, the bottom fibreglass surface could not be visually inspected without specialized tools and/or excavation. In addition, the support provided by the ground was uneven, and subject to change over time. If areas washed out and created voids beneath the slide, they were not typically visible.
