Incident Investigation Report

Kicking Horse Gondola

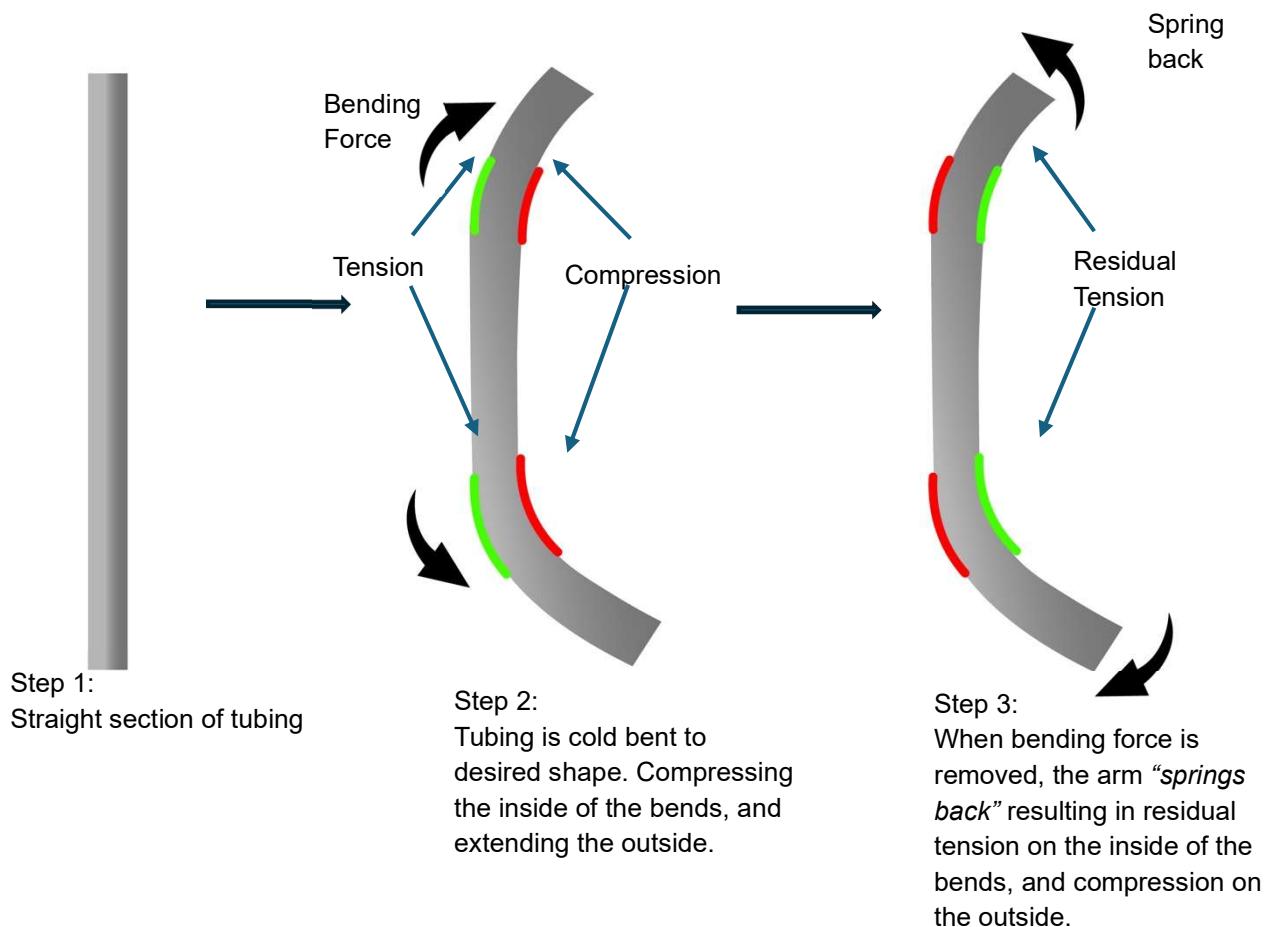
Figure 2 - Manufacturing Process for bending the gondola arms to the desired shape

2. The tubing was shipped to a third-party contractor (specific contractor unknown) in order to bend the tubing as LPOA does not have the capability in house to complete bending on a tube of that size. The tubing was cold bent. This would result in residual tensile stresses at the interior of the bend (See figure 2 below).

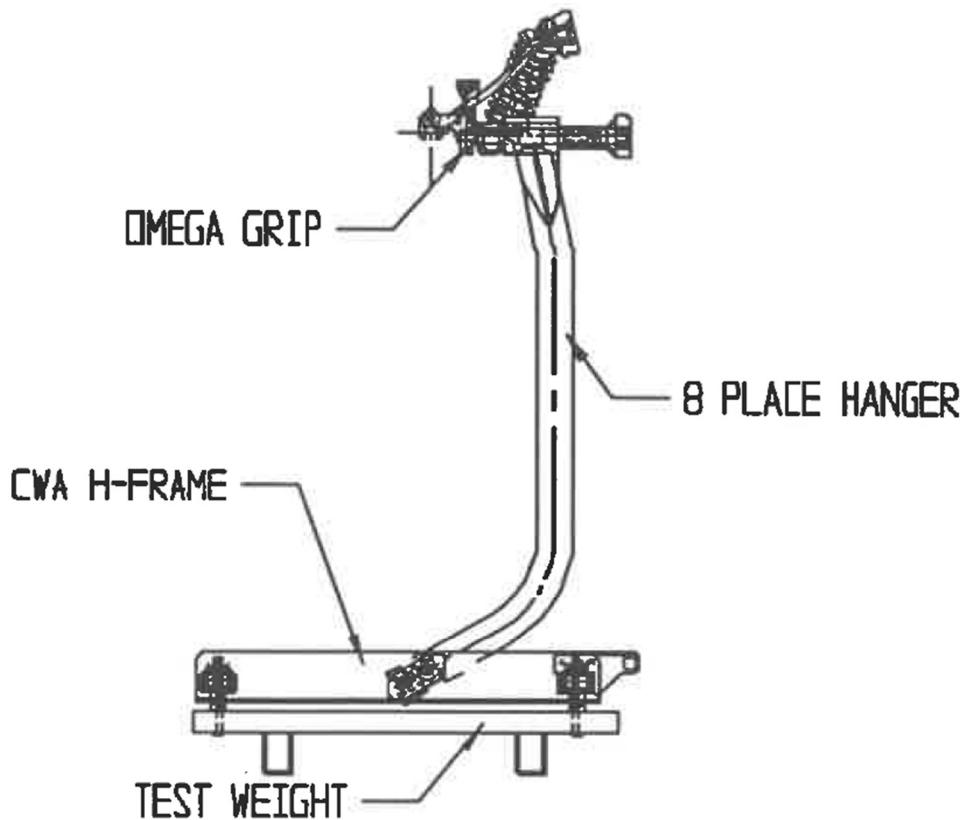
Figure 3 - Diagram of fatigue test apparatus for the GEE Gondola hanger arm (from 1999 LPOA Omega Hanger Arm fatigue test report)

Throughout the manufacturing process for the GEE Gondola, LPOA completed various forms of quality control including regular visual and dimensional checks. In addition, the hanger arm designs were required to be certified according to the CSA Z98 code for fatigue by performing cyclic testing under load on a sample arm. LPOA has a custom fatigue testing machine which is used to create a simulated cyclic load for five million cycles in both loaded (with passengers) and unloaded (weight of the arm and cabin alone) states. The hanger arm design was originally certified in September 1999 for use for up to eight persons. It was later re-certified in 2001 and 2006 for 10-person applications and for use as a freight carrier. At each of those times, an

additional fatigue test was conducted on the arm with the additional expected weight. It was not documented if these tests were done pre or post galvanizing, and LPOA representatives indicated they did not have a consistent practice at the time. However, images that were included in the testing reports from 2001 showed the arm had external corrosion, indicating it was not galvanized at the time of the test. This was confirmed in an interview with LPOA's senior design engineer. Photographs of the hanger arms during other tests completed in 2006 did not have corrosion, indicating they may have already been galvanized.

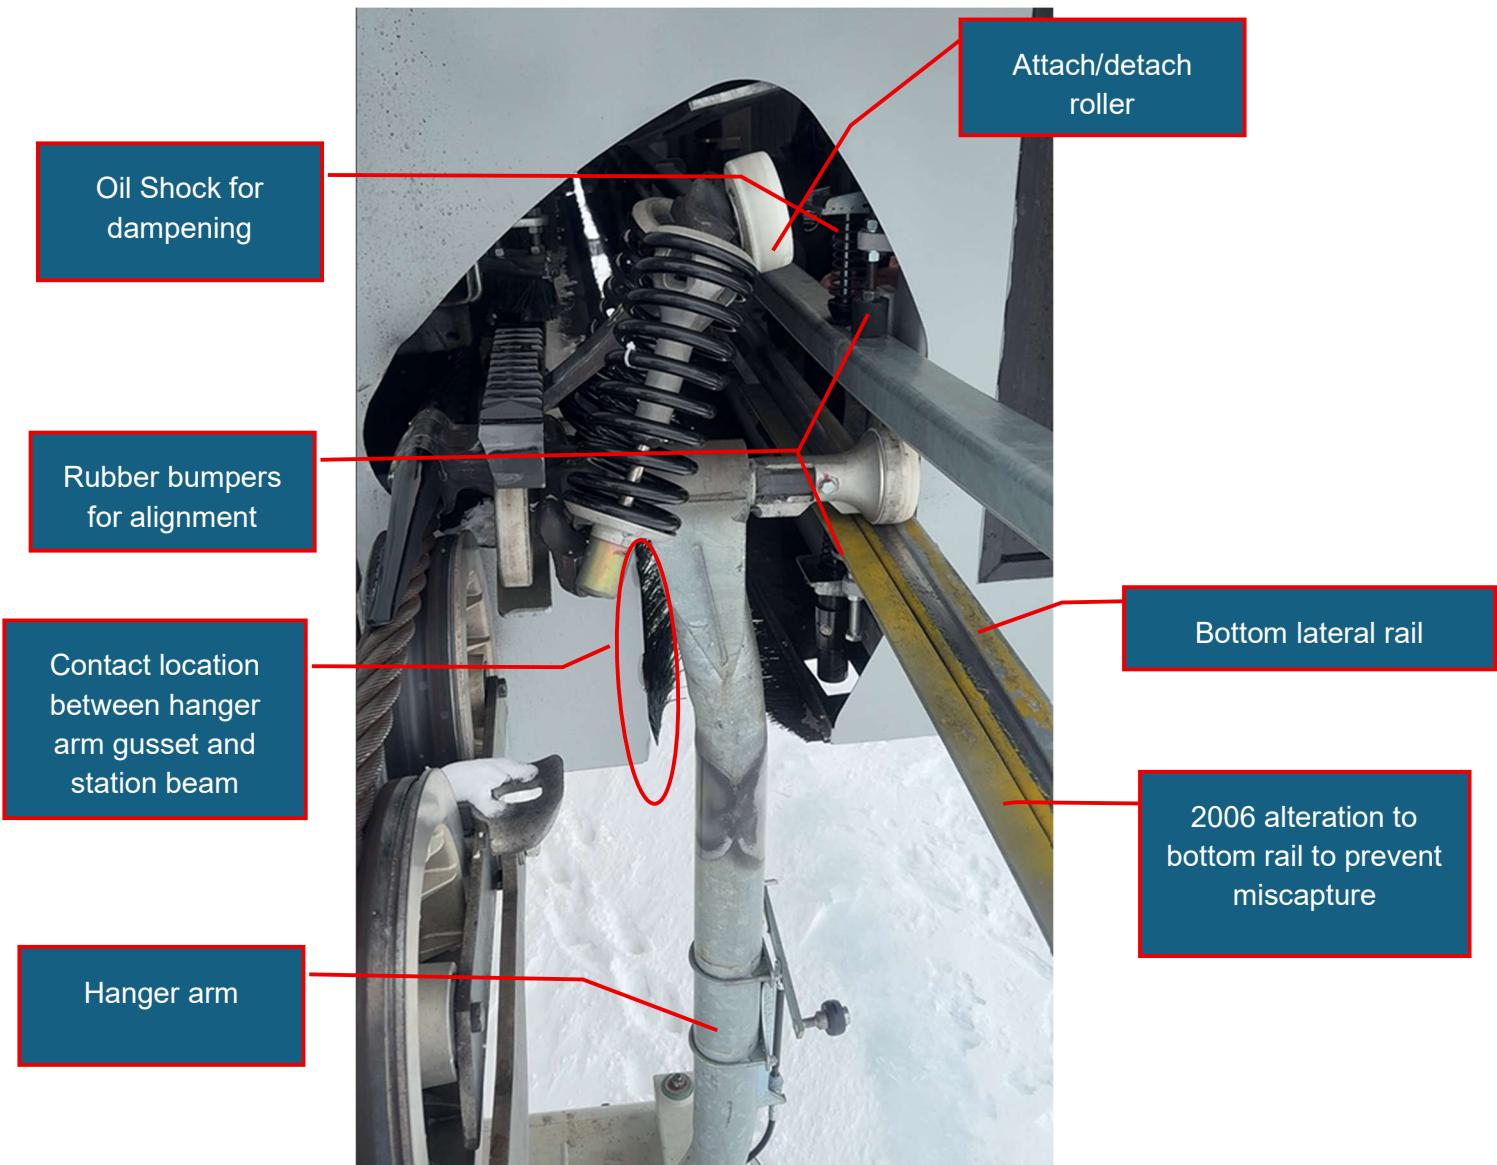
Figure 4 - Lateral rails and associated dampening and modifications for GEE Gondola.

The lateral (or guide) rails are supported by a combination of springs and/or dampers mounted to the station structure. Adjustable rubber cylinders on threaded rods are used for adjustment of the lateral rails and are intended to absorb impacts and vibrations. Additional oil shocks, located just behind them assist in dampening.

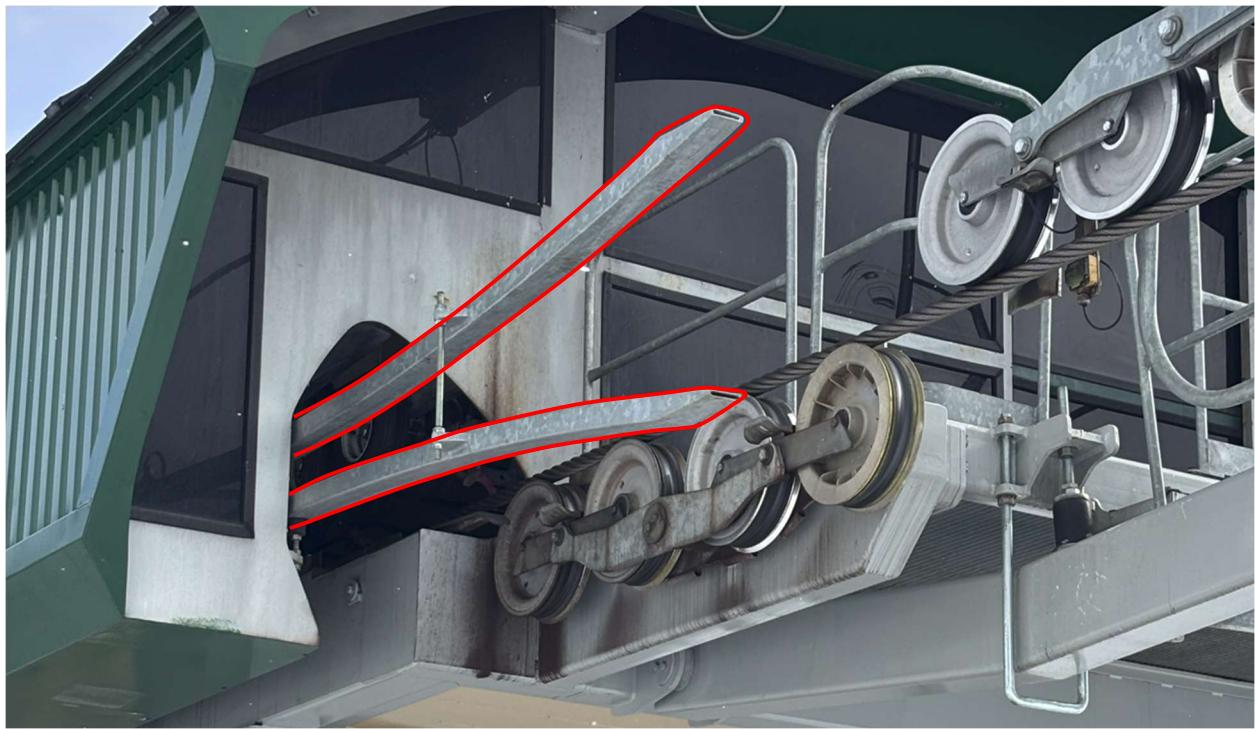
Figure 5 - The guide (lateral) rails on the GEE Gondola Return Station

The lateral rails of the GEE Gondola are the components that stabilize and align the gondola cabin as it enters the top and bottom stations. Several factors, including wind or asymmetrical loading (e.g. all passengers sat on one side), can cause gondola cabins to come into the station at an angle. When this happens, the lateral rails exert force on a grip mounted roller to push the cabin back into alignment. This creates forces on both the hanger arm and lateral rail. The amount of force transmitted through the hanger arms is directly affected by the alignment and

dampening of the lateral rails accomplished through the rubber bumpers and shocks described above.

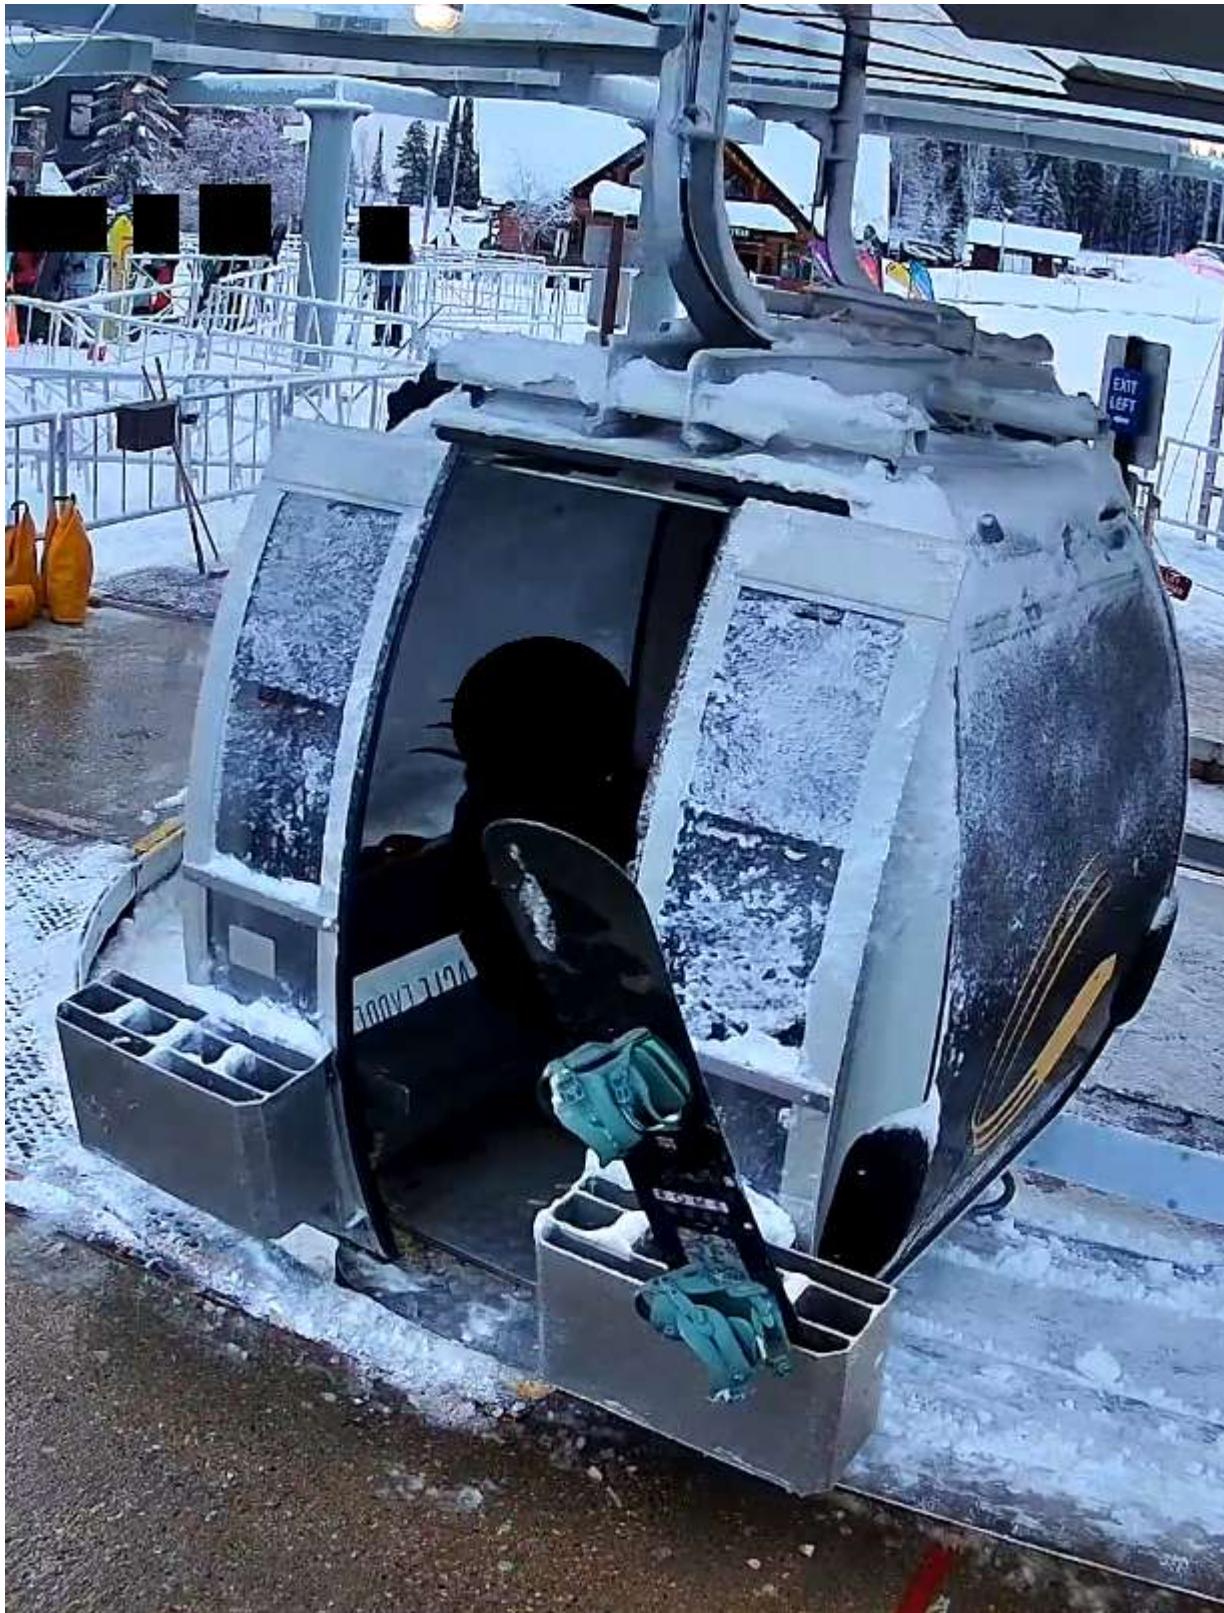
On the day of the incident, at 8:32 am, cabin 15 first came through the lower (return) station (Image 7). At that time, one member of the operations staff boarded the cabin and was successfully brought to the top of the mountain. The cabin went around again several times before the first passengers entered cabin 15 at approximately 9:27 am (Image 8). At that time eight passengers entered the gondola and three snowboards, and five pairs of skis were placed in the cargo compartments on the doors (Image 9). Cabin 15, and a few cabins on either side of it, were covered in snow. The area on the hanger where the crack existed was also coated in snow and/or ice, obscuring any view of the crack. A few seconds later, as the gondola left the station, it fell to the ground. (image 10).

Image 7 – The first time that cabin 15 (the incident cabin) was loaded with a staff member on the day of the incident. Snow covered the inside of the hanger arm. (From resort CCTV footage)

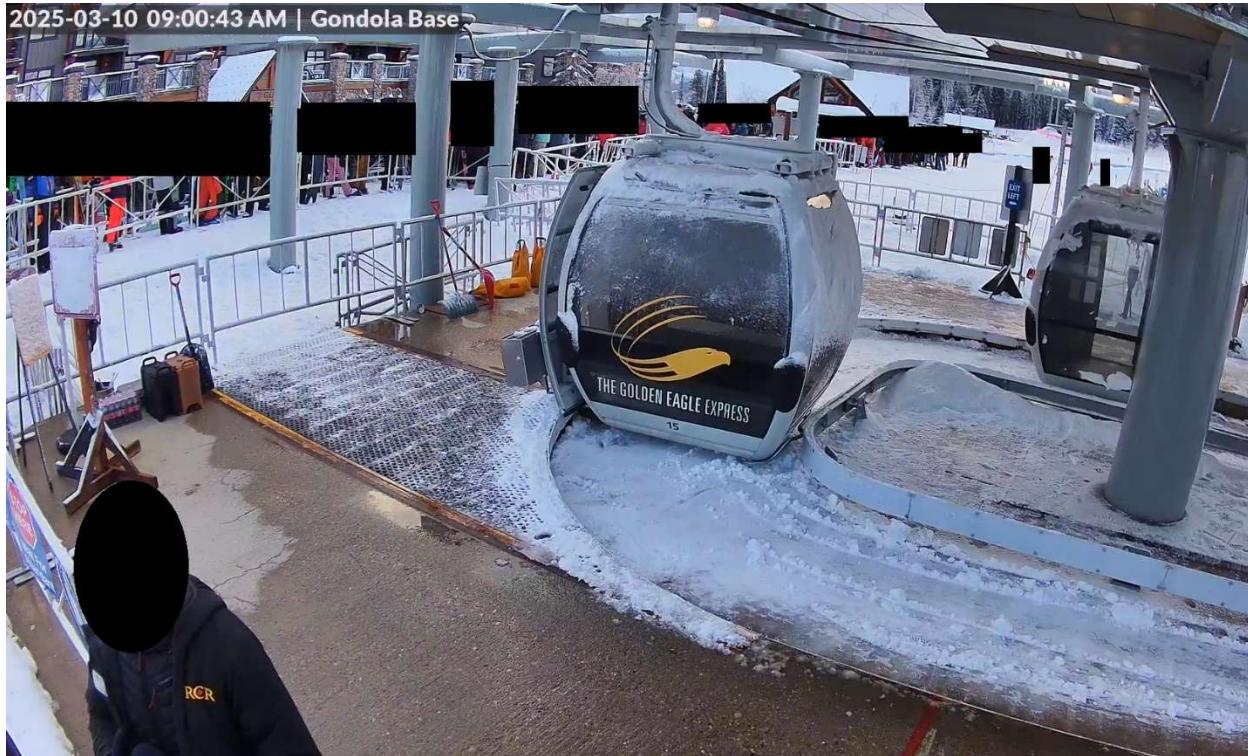
Image 8 – Cabin 15 going around the station prior to the first load of customers. Note the inside of the hanger arm is still covered in snow (from resort CCTV footage).

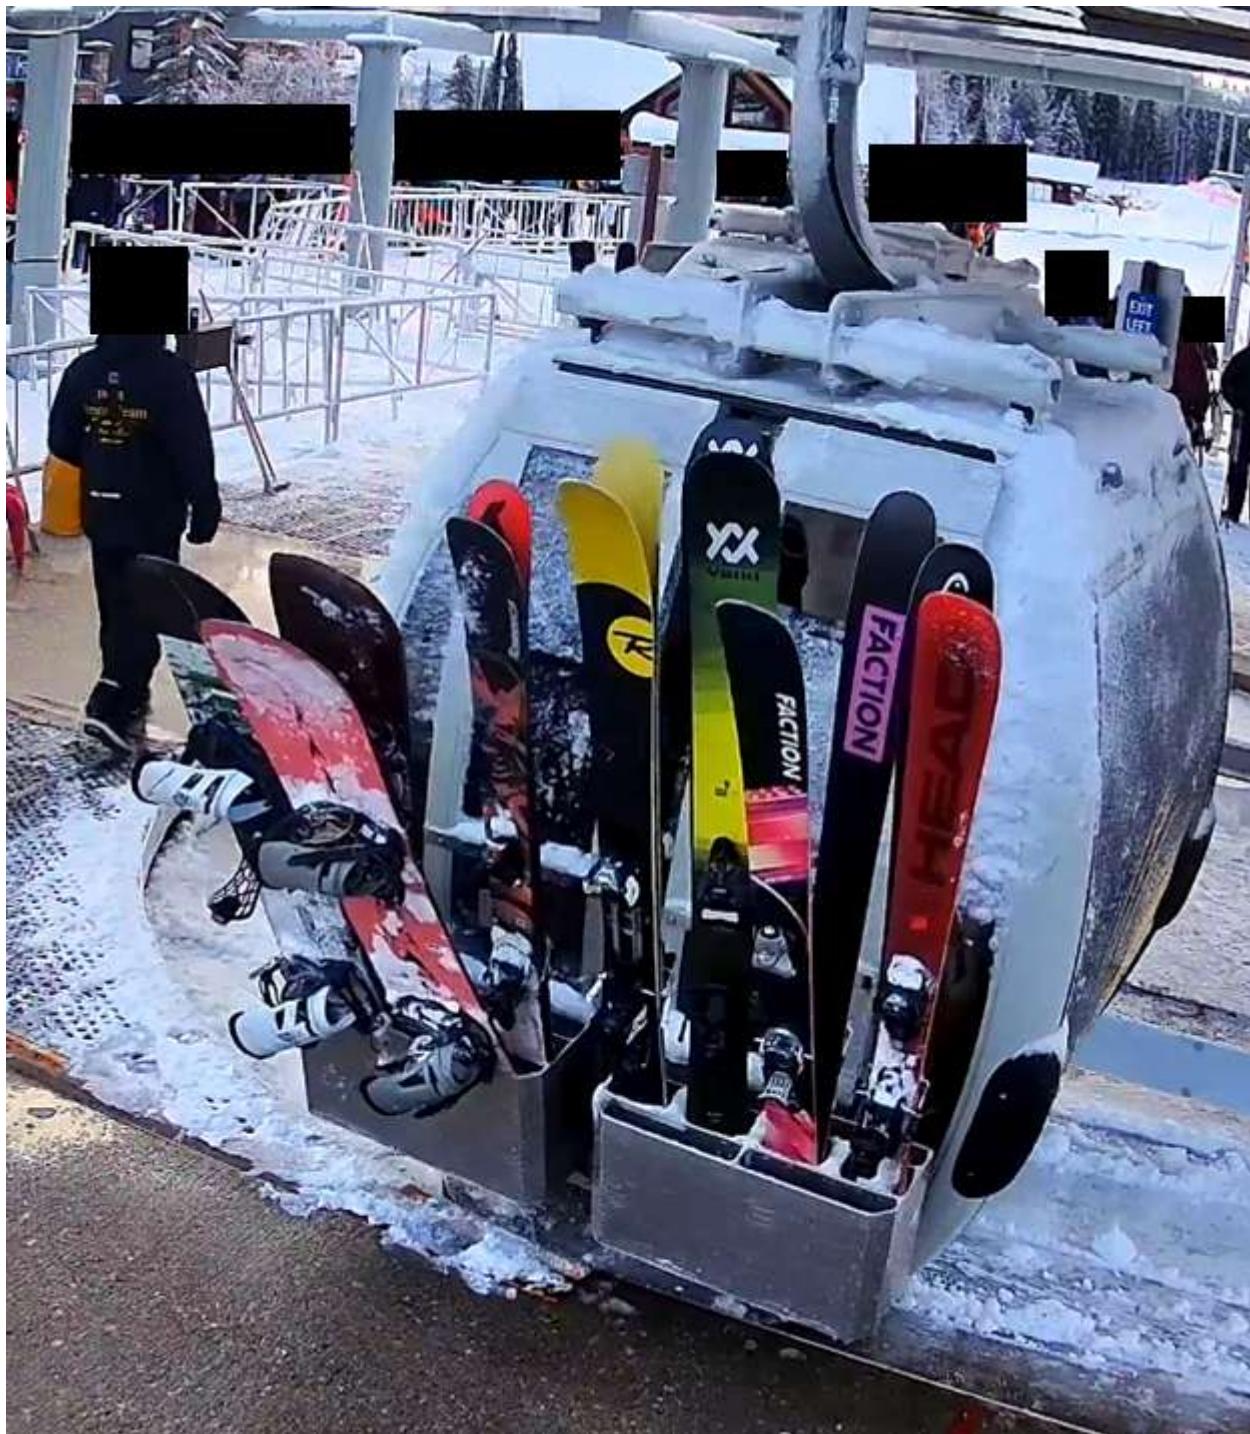
Image 9 – The fully loaded cabin with 8 adult passengers and equipment, just prior to failure (from resort CCTV footage).

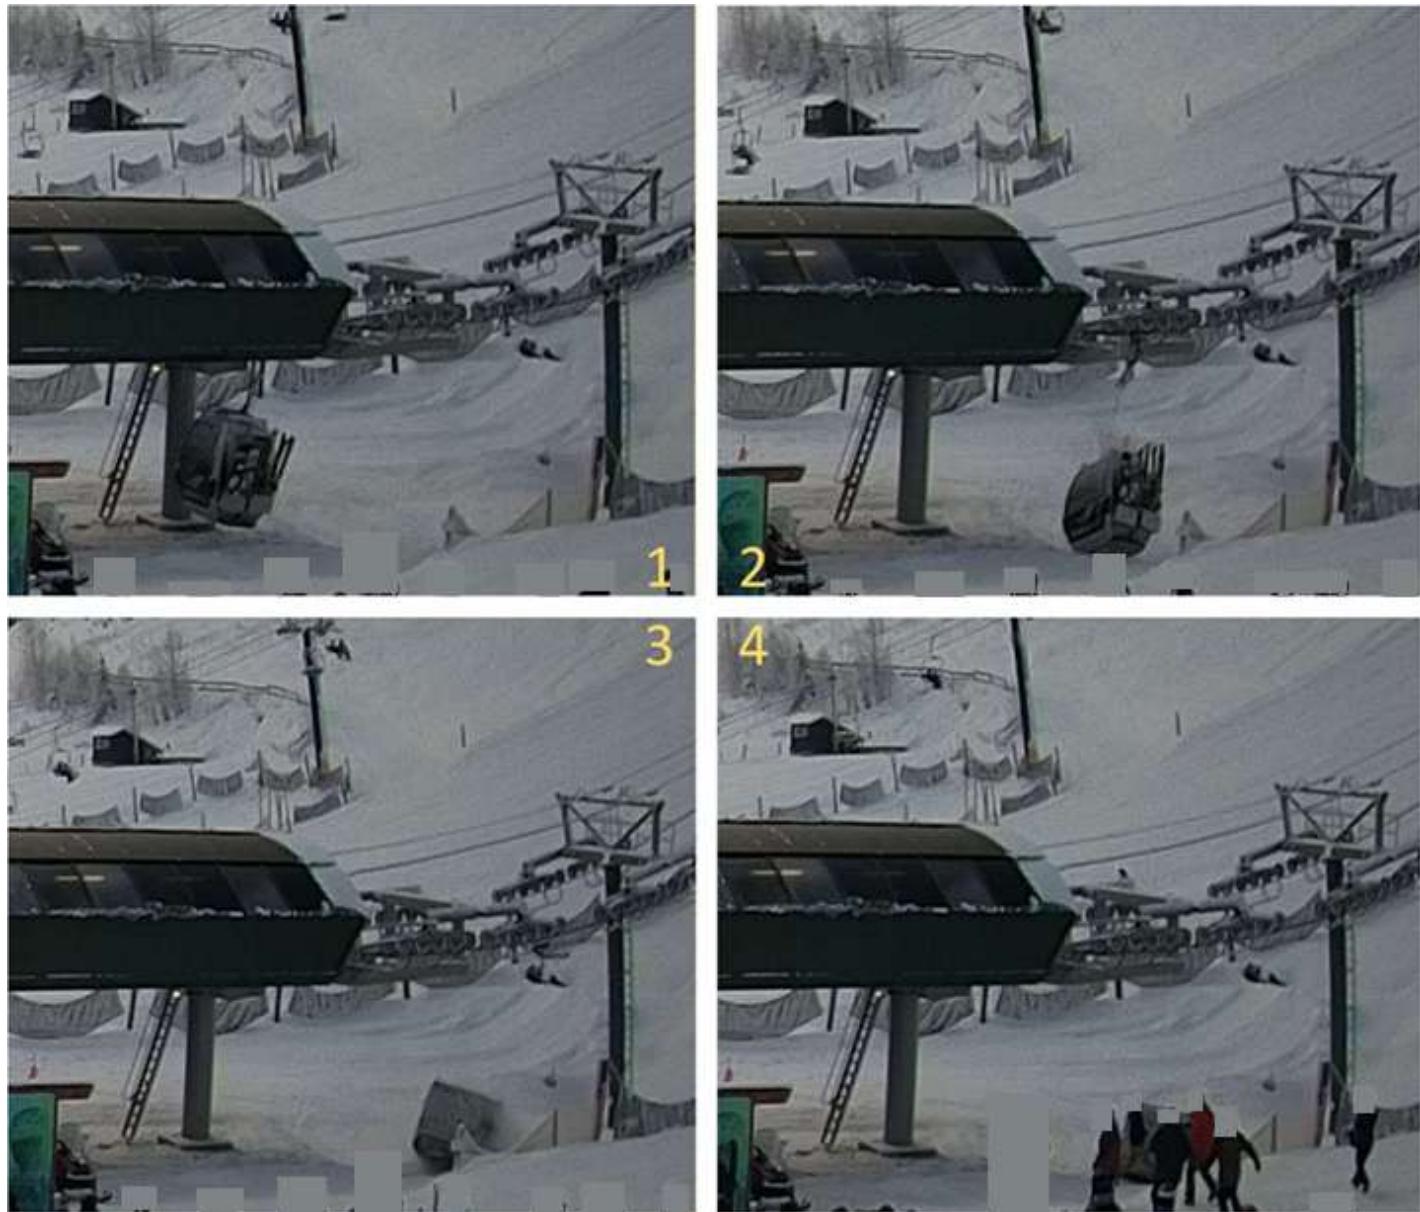
Image 10 – A different camera angle showing the hanger arm fracturing and the cabin falling as it passed under the compression sheaves leading to tower 1 (from resort CCTV footage).

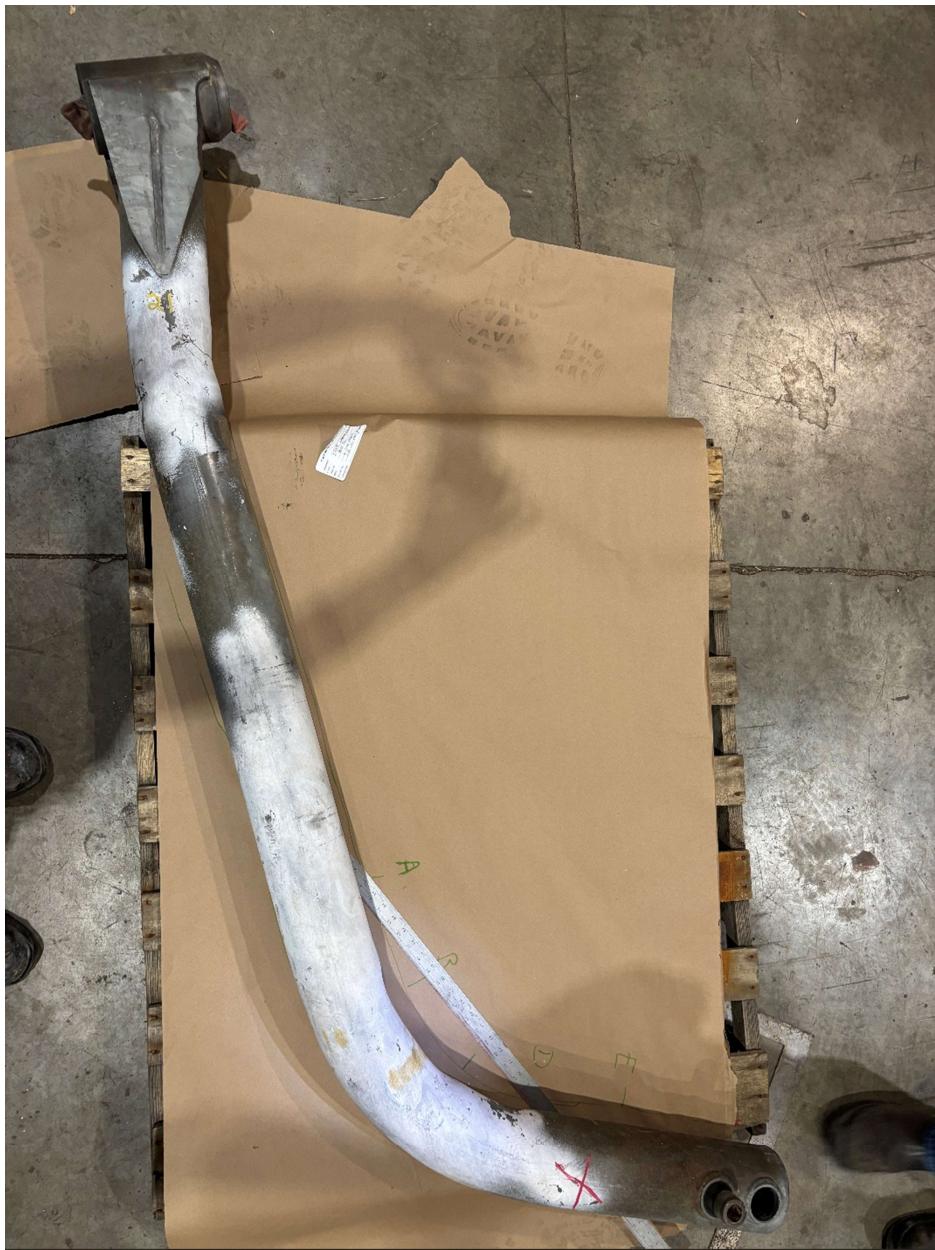
In addition to the in-situ testing, the failed hanger arm (15), as well as several exemplar arms (3, 16, 21, and 47) were brought to the Acuren laboratory for a more in depth and controlled analysis (Image 18). Acuren performed a full suite of tests including (Image 19):

Image 18 – Example of an arm located I the Acuren facility after undergoing extensive MPI testing and documentation.
