Incident Summary (5617800) (Final)

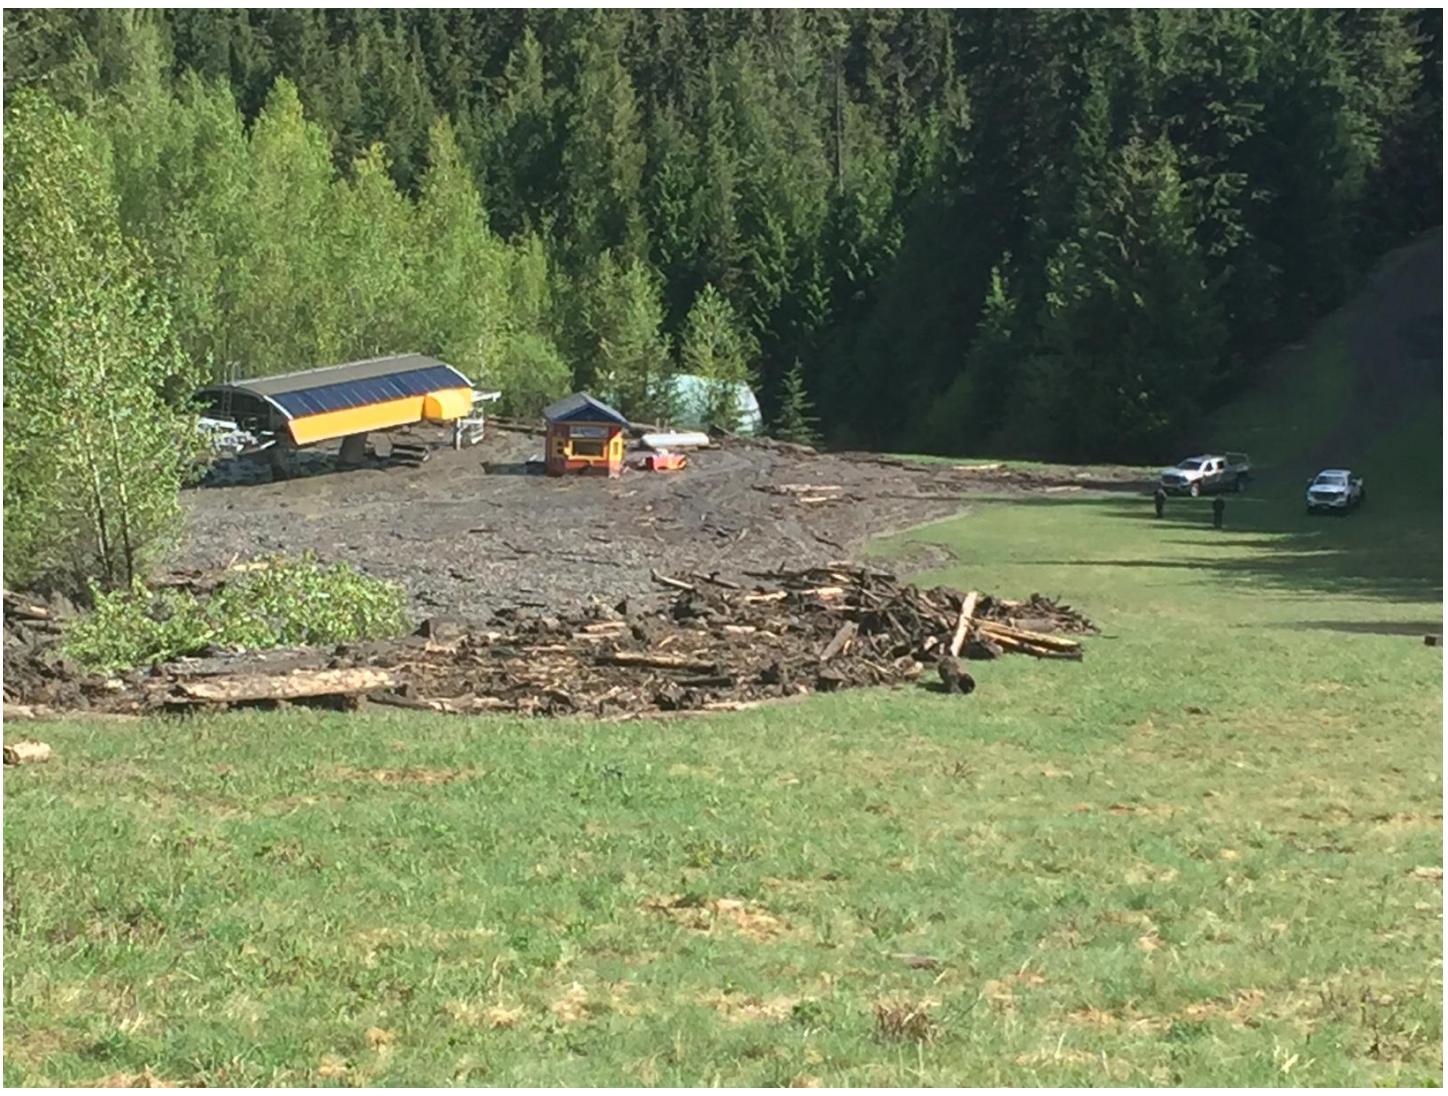
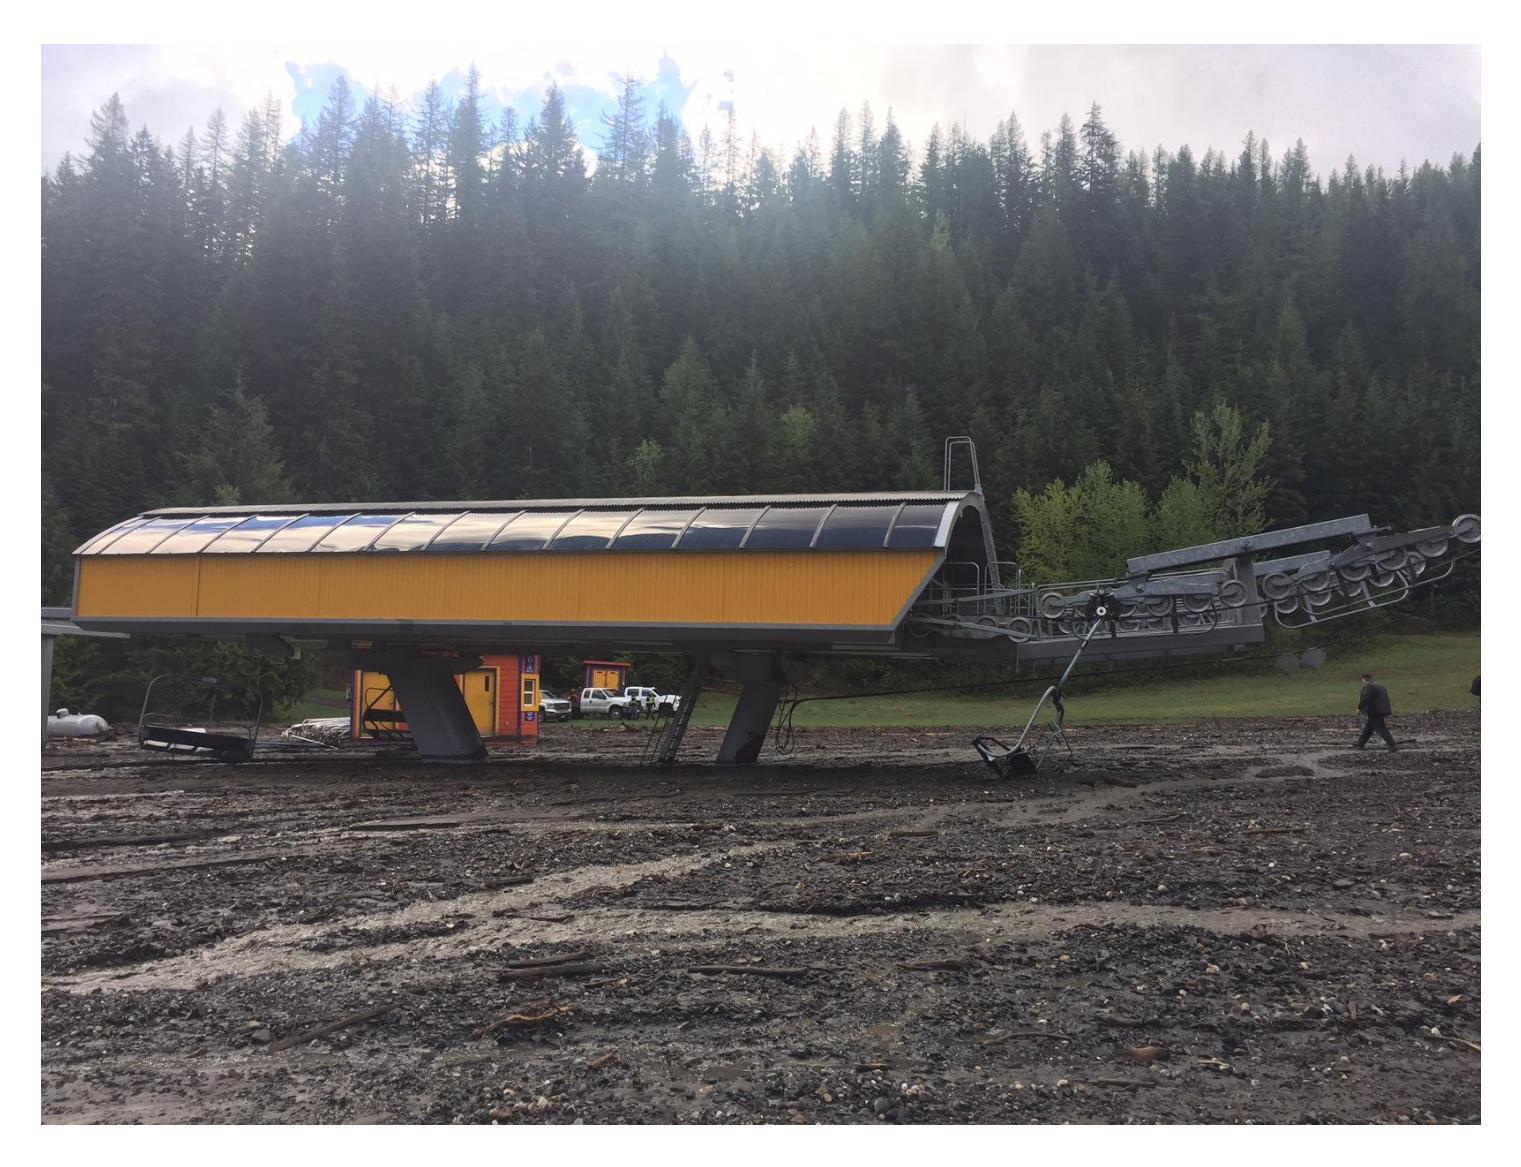
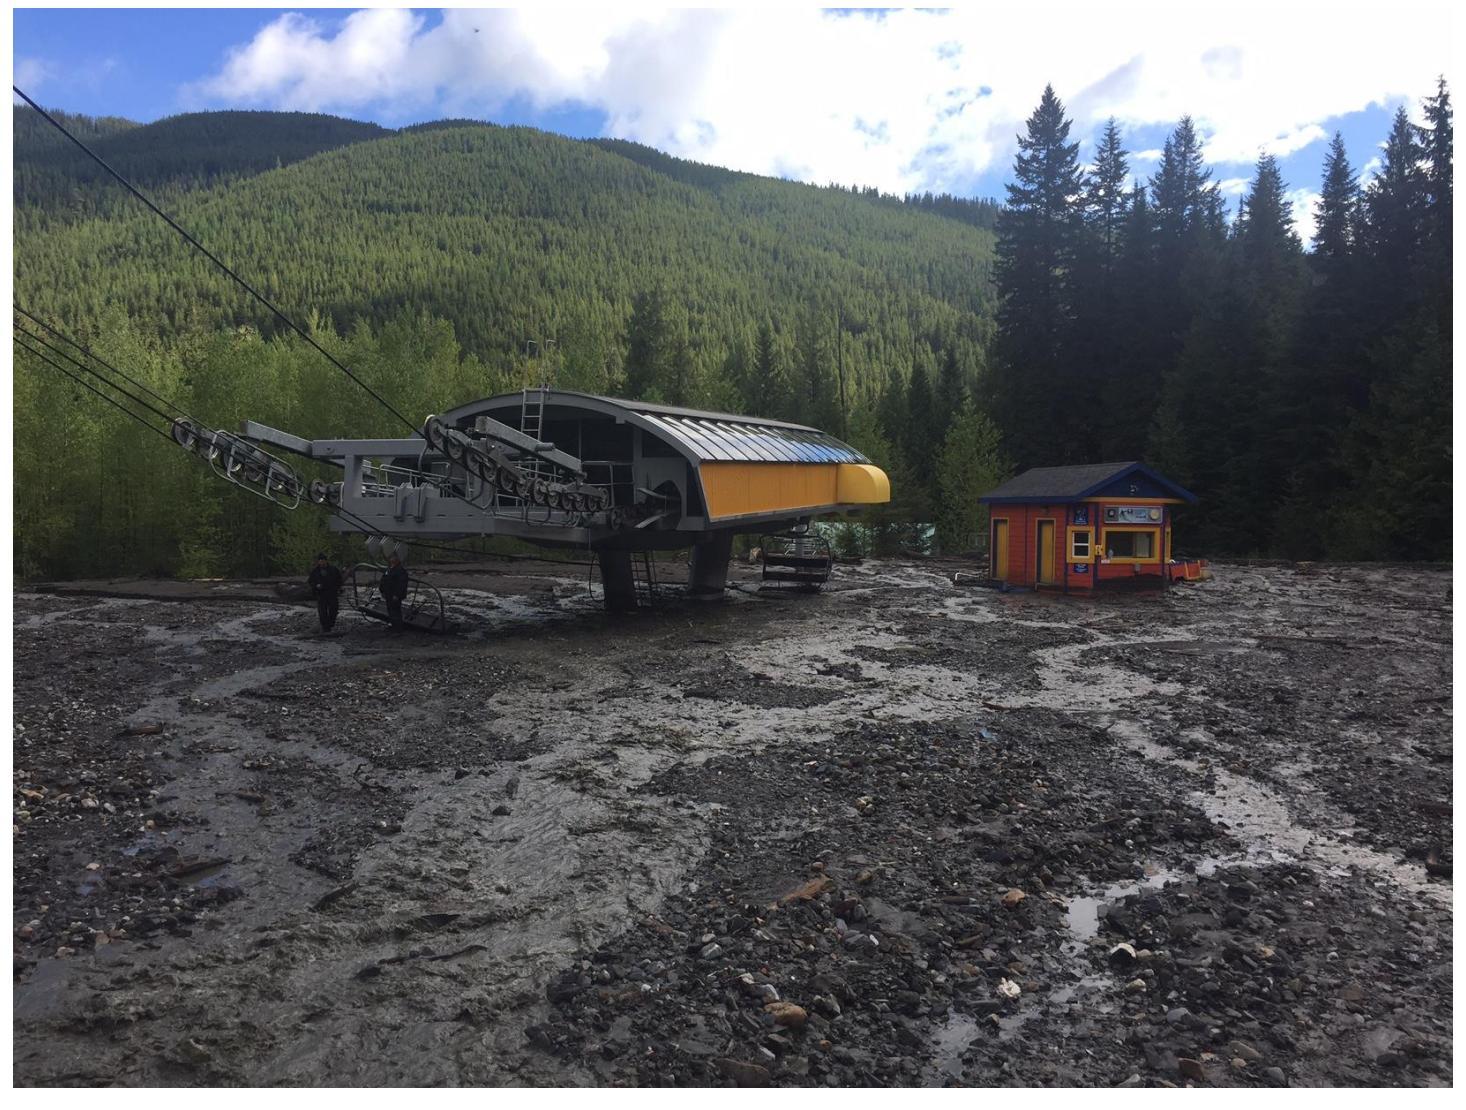
SUPPORTING INFORMATION	Incident Date		Date	June 2, 2017
	Location			Vernon
	Regulated industry sector			Passenger Ropeway – above surface lift
	Impact	Injury	Qty injuries	None
			Injury description	None
			Injury rating	None
		Jamage	Damage description	The wiring between operator controls (Lift hut) and the Return station became separated. The loading gates and carriers in the machine were pushed away from their fixed position.
			Damage rating	Minor
	Incident rating		rating	Minor
	Incident overview			Water saturated earth and debris, started the mudslide about 500m uphill and to the left of the lift alignment. The bottom terminal was the only area of the passenger ropeway that was affected by the mudslide. Bottom terminal surrounded by 1.2m to 1.8m of dirt, silt and small rock. The lift operator hut was turned 130 degrees and pushed off its foundation. The load gates were pushed back about 25m directly behind the terminal over an embankment. Three carriers in the terminal were lifted/pushed in the bottom terminal.

INVESTIGATION CONCLUSIONS	Site, system and components		em and ents	The bottom terminal, which consists of a machine room, operator hut, loading ramp (with loading gates) and carriers that may be in the machine room as they are spaced evenly along the entirety of the lift. The lift operator hut houses the operating controls and safety systems for the bottom terminal and towers. The load gates are used to control passengers loading on the chairs. The carriers are the chairs used to carry passengers.
	Failure scenario(s)			Significant rainfall and large patches of snow creating a water diversion. Resulting in earth becoming saturated and sliding.
	Facts and evidence			Heavy rainfall has been reported this Spring. Slow melting of snow leaving large patches snow, will divert water and create a washout of earth debris.
	Causes and contributing factors			The combination of a rainy spring and potentially blocked drainage ditches and culverts most likely caused the mudslide.
