Incident Summary #II-1068404-2020 (#19252) (FINAL)

SUPPORTING INFORMATION	Incident Date		September 16, 2020
	Location		Burnaby, British Columbia
	Regulated industry sector		Gas - Propane system
	Impact Damage Injury	Qty injuries	0
		Injury description	None
		Injury rating	None
		Damage description	Camper van badly burnt (Image 1). Propane auto dispenser badly burnt. No damage to building or other areas, the fire was contained to the island dispensing area.
		Damage rating	Major
	Incident rating		Major
	Incident overview		A Propane dispensing attendant was refueling a camper van at a card lock auto dispenser. The vehicle had a typical under belly mounted propane tank that is used for the appliances in the camper. Filling of the tank required the fixed liquid level gauge (Spit Valve) to be opened during filling. Propane vapor is released from the open fixed liquid level gauge and once the liquid level of the tank reached the legal limit, liquid vented from the spit valve indicating the tank was full to the required 80% level. The propane vapour found a source of ignition and set the dispenser and vehicle on fire.

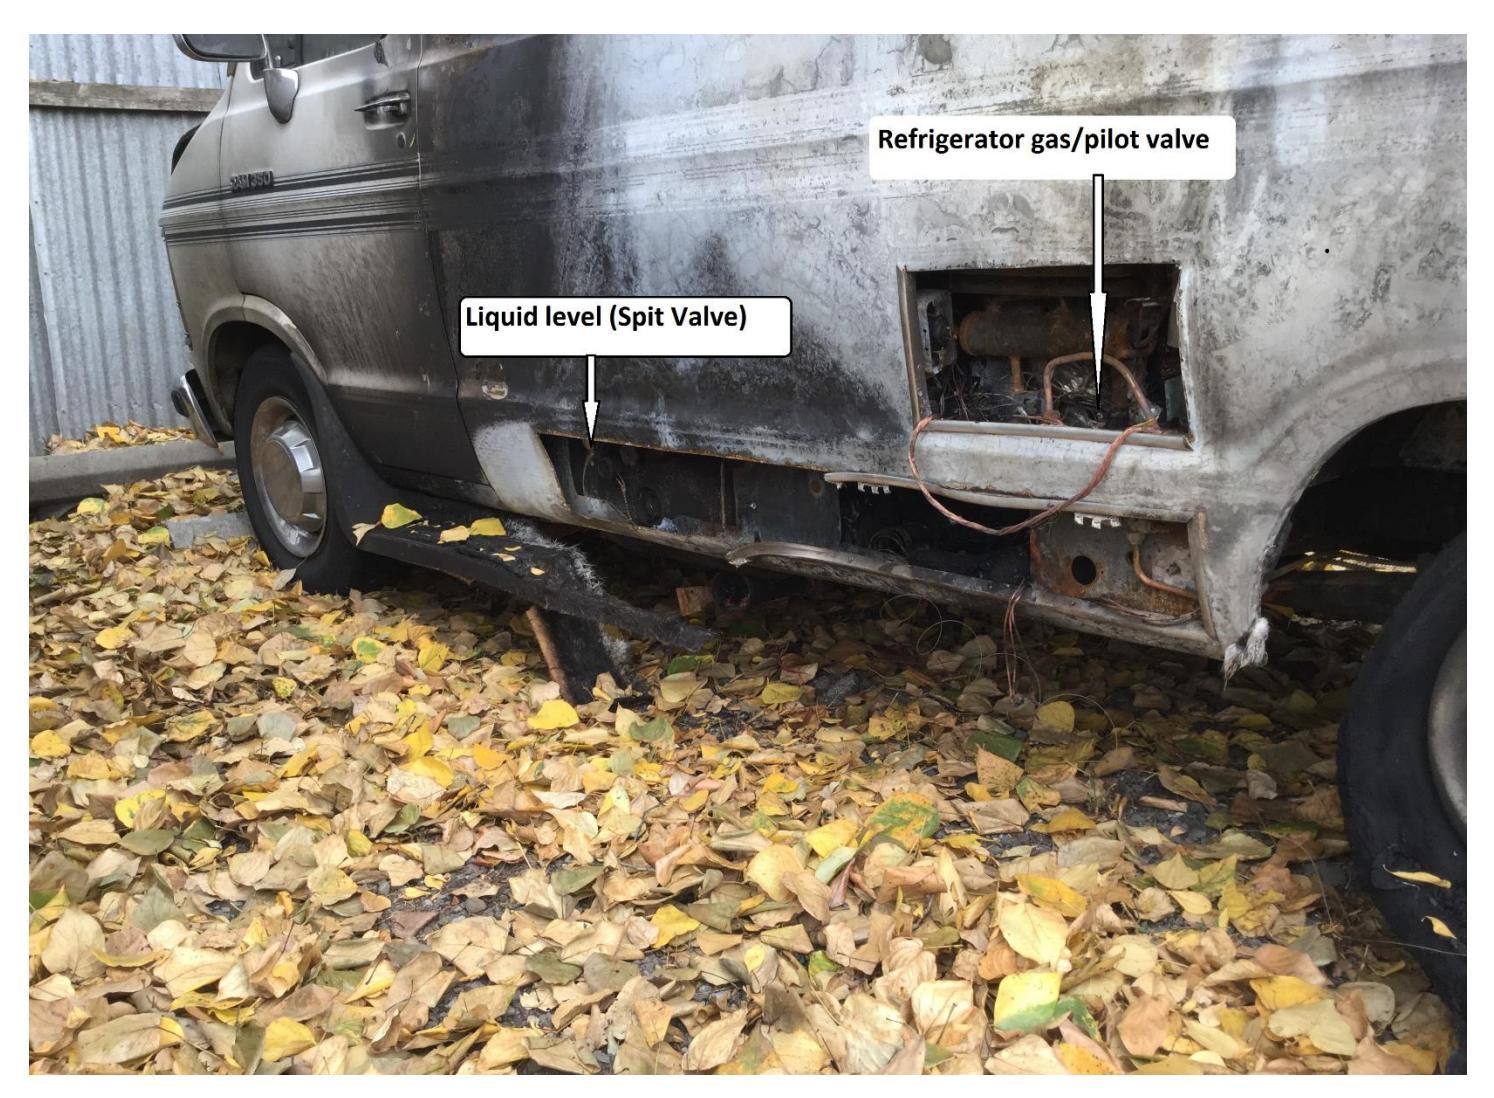
Image 2 - Cylinder fill point and refrigerators standing pilot

reach a source of ignition located within the vehicle that had not been extinguished by either the owner of the vehicle nor the propane attendant prior to filling.
