Incident Summary (# 5615530)

Incident Date			December 30,2016
SUPPORTING INFORMATION	Loca	ation		Surrey
	Regulated industry sector		d industry sector	Refrigeration system
	Impact	Injury	Qty injuries	1
			Injury description	Heavy head ache ; Burning nose
			Injury rating	Moderate
		Damage	Damage description	None
		Da	Damage rating	None
	Incident rating		rating	Moderate
	Incident overview			Ammonia was purged by air to do a maintenance work on a refrigeration system. A worker moved the hose used for purging and became exposed to ammonia.
INVESTIGATION CONCLUSIONS	Site, system and components			Ammonia is a refrigerant used in refrigeration system. It needs to be removed from system to do the maintenance work. Large amount of ammonia is isolated in the system. Only small amount of residual ammonia is purged under 5 PSI through a hose to water filled tote with lid. Hose is weighed and dipped into water to absorb purged vapour ammonia. All new employees received orientation which includes ammonia awareness training.

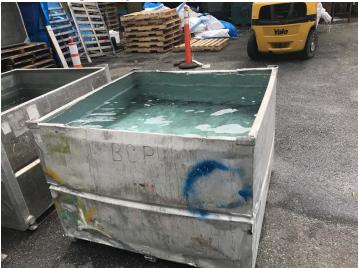
Water filled tote(similar to the plastic tote used)
