Incident Summary Report II-654915-2018 (Incident ID #5698) Final

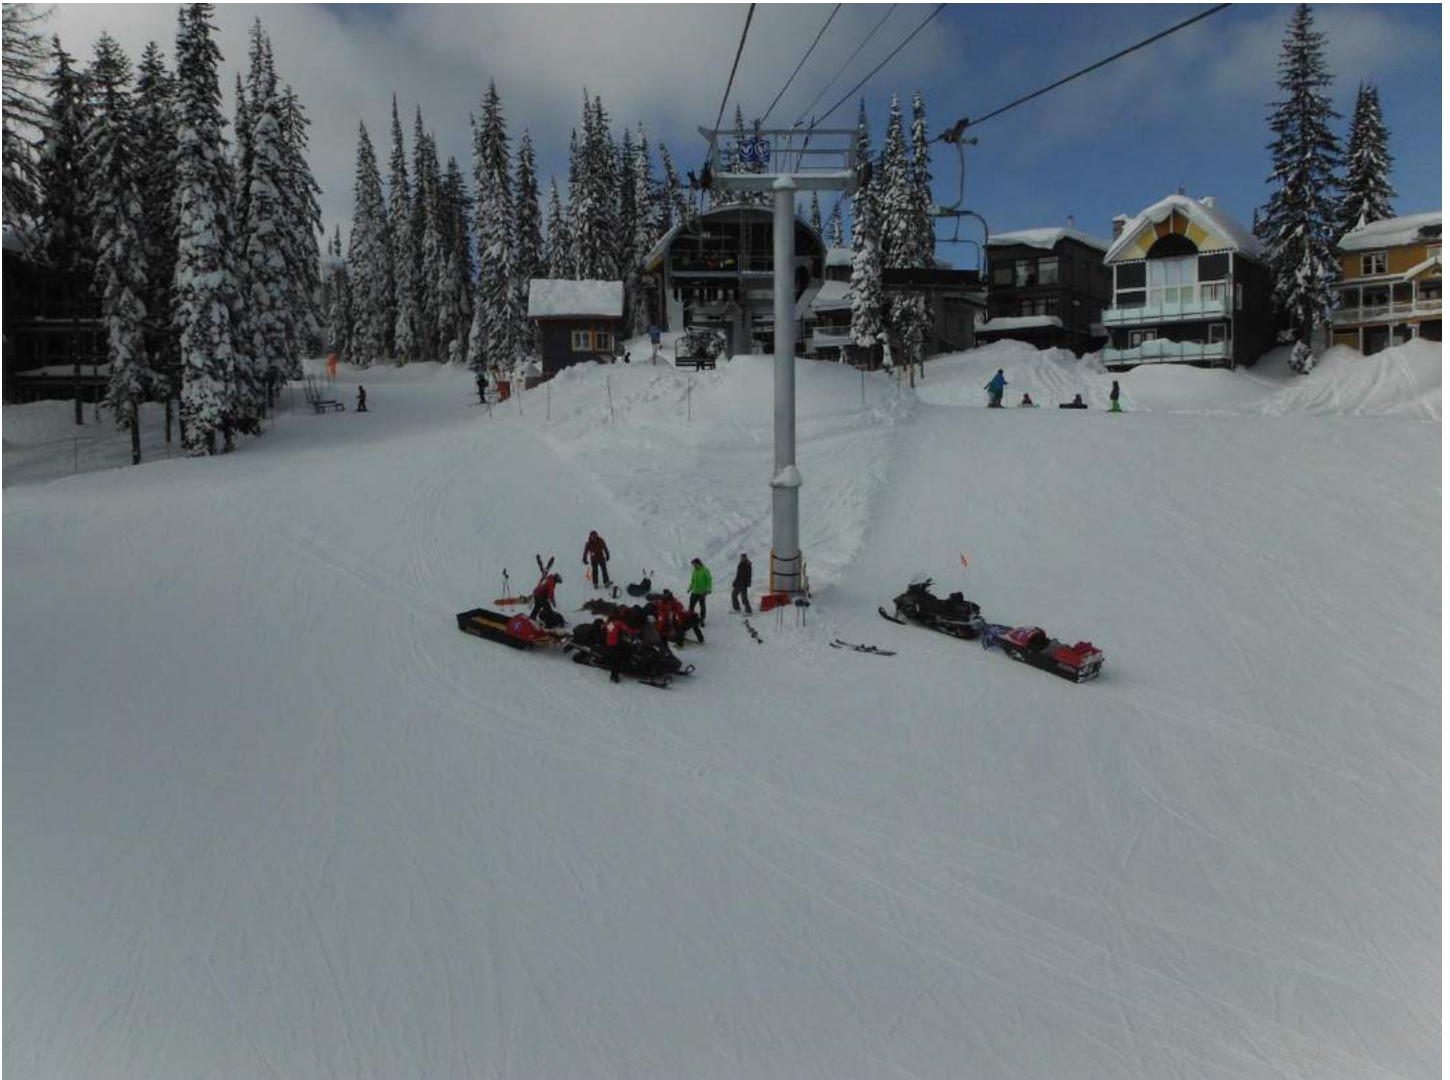
Unload Station and area where passenger fell
