**KICKING HORSE MOUNTAIN SKI RESORT  
GOLDEN EAGLE EXPRESS  
LEITNER-POMA OF AMERICA GONDOLA**

**HANGER ARM FAILURE**

TECHNICAL SAFETY B.C.  
2889 East 12 Avenue  
Vancouver, B.C.  
V5M 4T5

File Number: 605-J215610  
EGBC Permit Number: 1001973  
Date: January 28, 2026

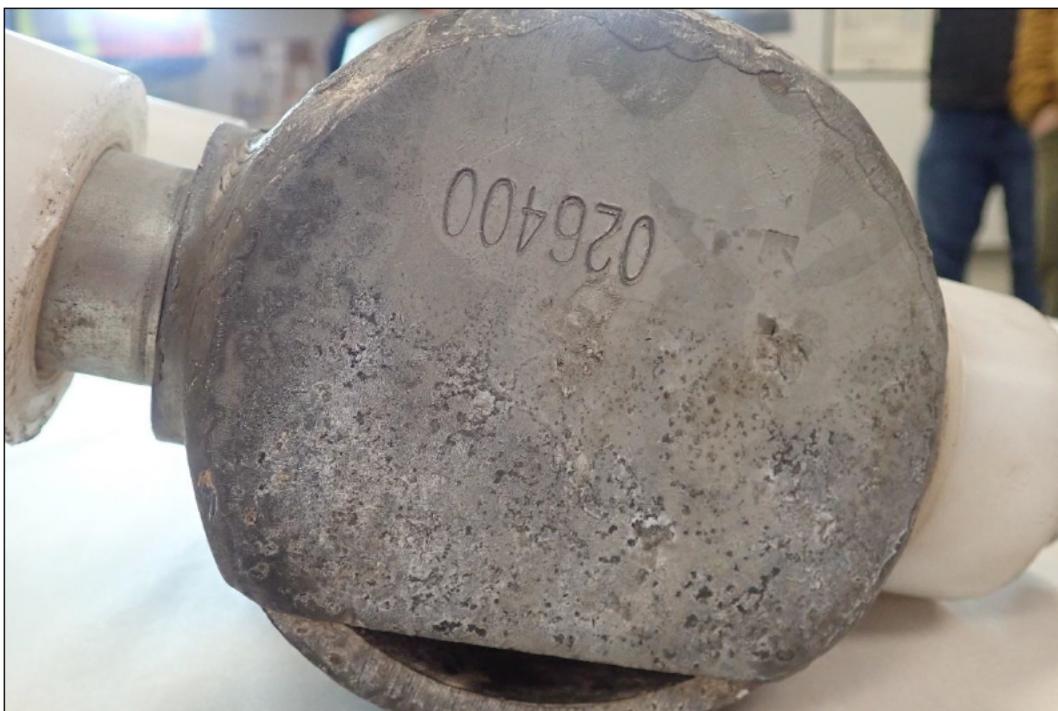
**Figure 4** Serial number on fractured hanger arm.

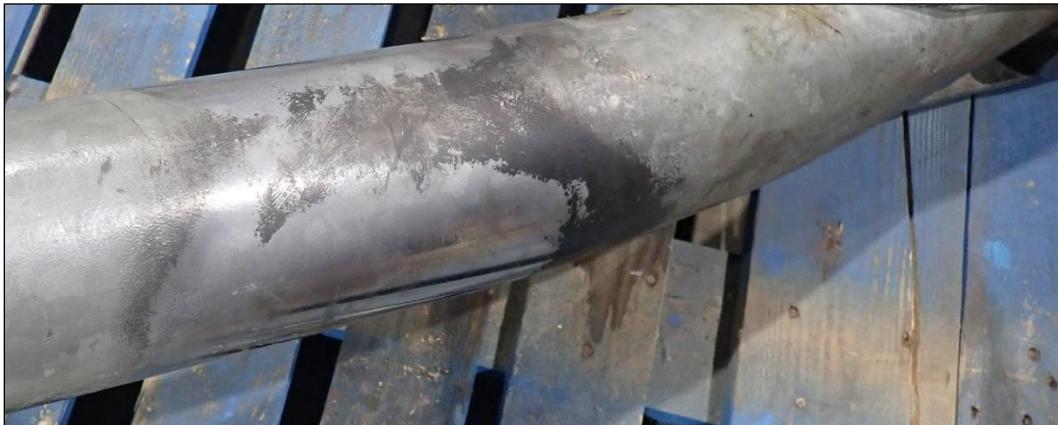
No other cracks were found on the fractured galvanized surface. Evidence of rubbing was found at one location on the arm surface (Figure 13), and a large dent was present on a reinforcing bracket near the upper attachment pin (Figure 14). This damage likely occurred from contact with some of the station hardware while the gondola was in operation. The impact required to create the observed bracket deformation was severe and likely contributed to some part of the arm fracture history.

**Figure 13** Shiny galvanizing from contact with unknown hardware during normal operations.

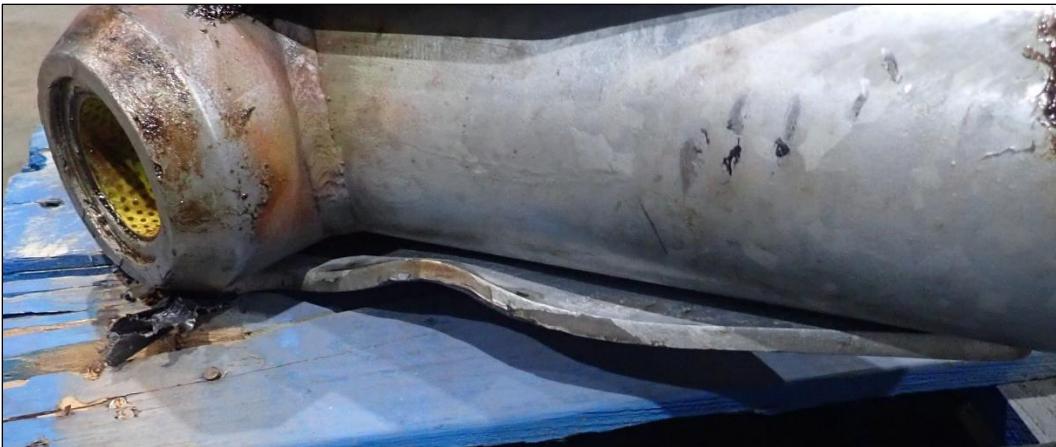
**Figure 14** Close-up view of deformation in upper reinforcing bracket.

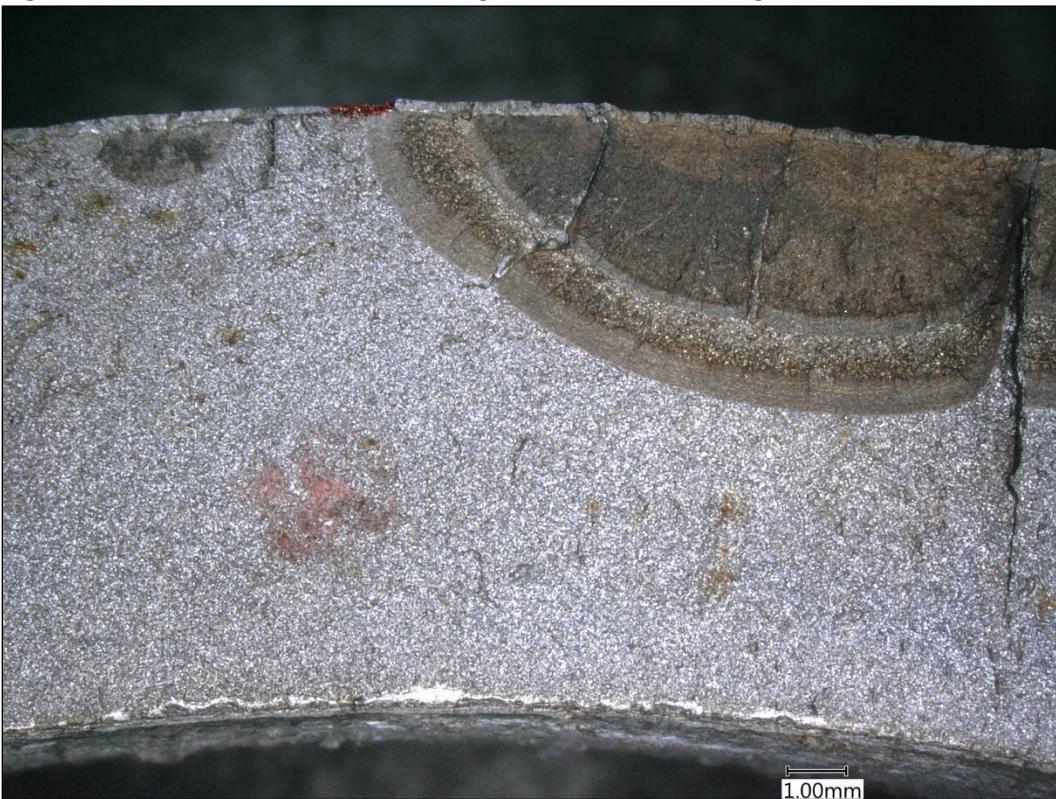
**Figure 41**      Back to intrados at 6:00 position.

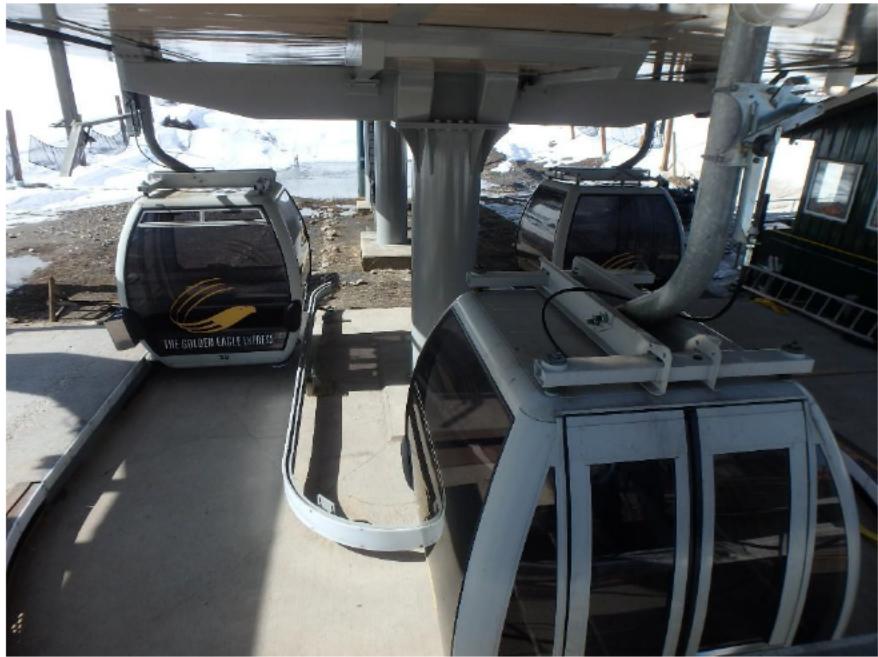
*Photo 1:*

General view of Gondolas and Gondola Arms.

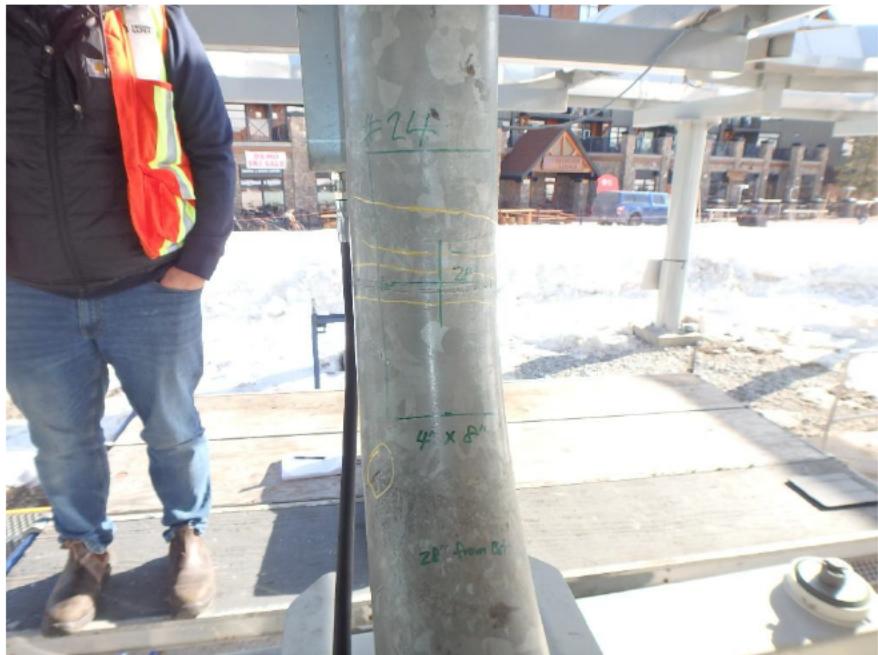
*Photo 2:*

Typical view of the suspect area where ultrasonic examinations were performed.

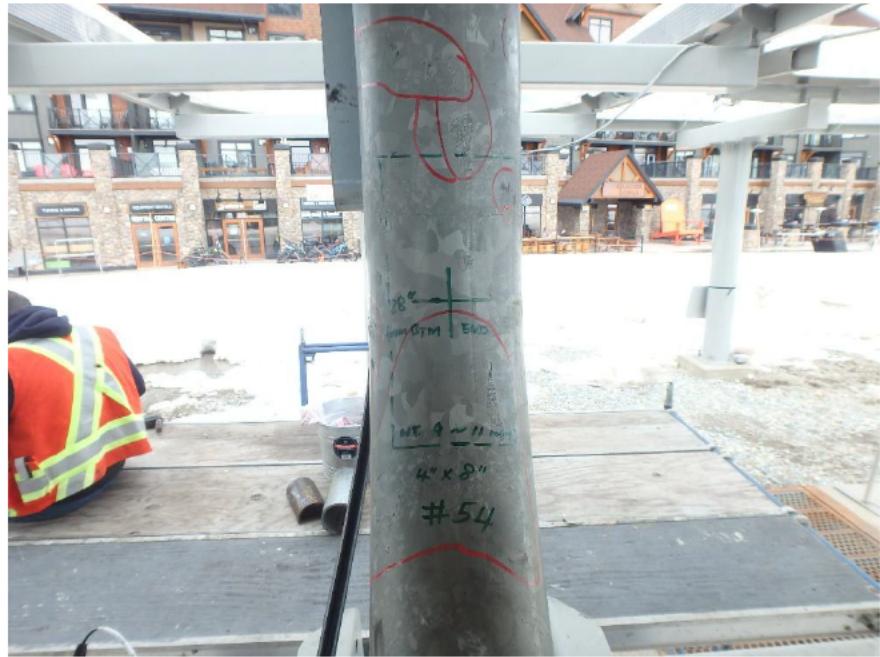
*Photo 3:*

Typical view of the suspect area where ultrasonic examinations were performed.

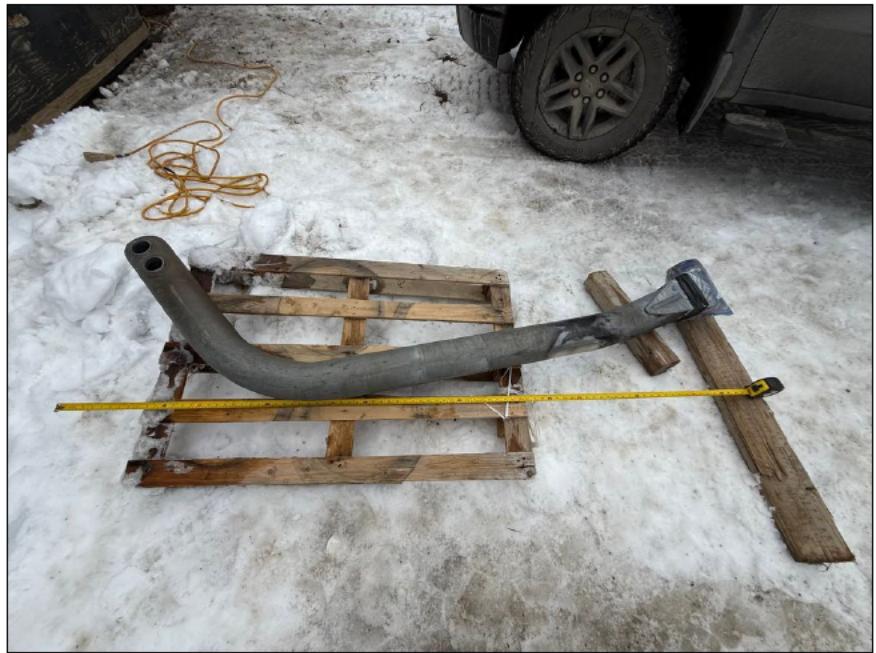
*Photo 1:*

Arm serial # 026600.

General overview.

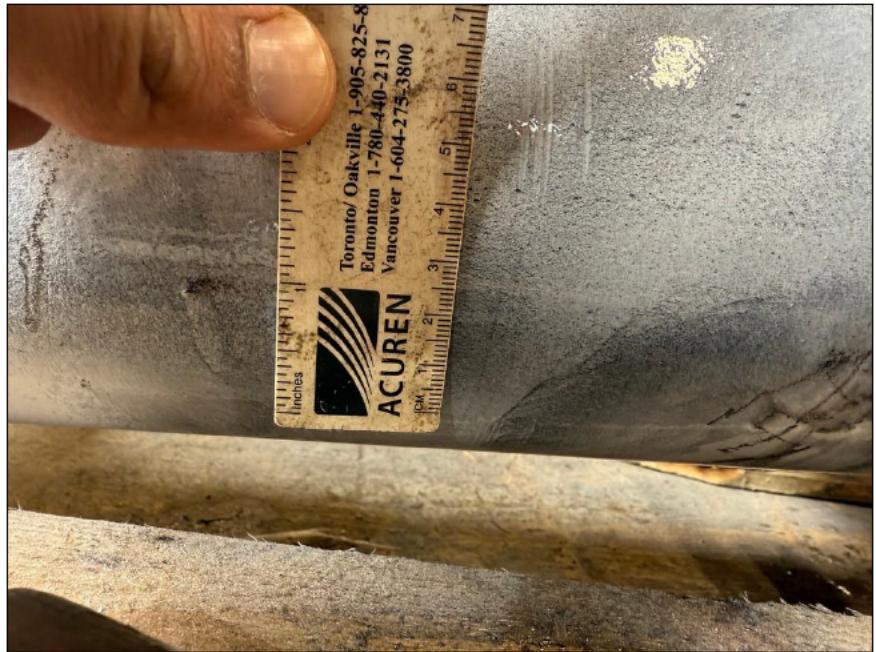
*Photo 2:*

Arm serial # 026600.

Indication 1.

Faint linear indications approximately 10 inches above the lower bend area of interest. These indications were removed with gentle grinding of a flapper disc.

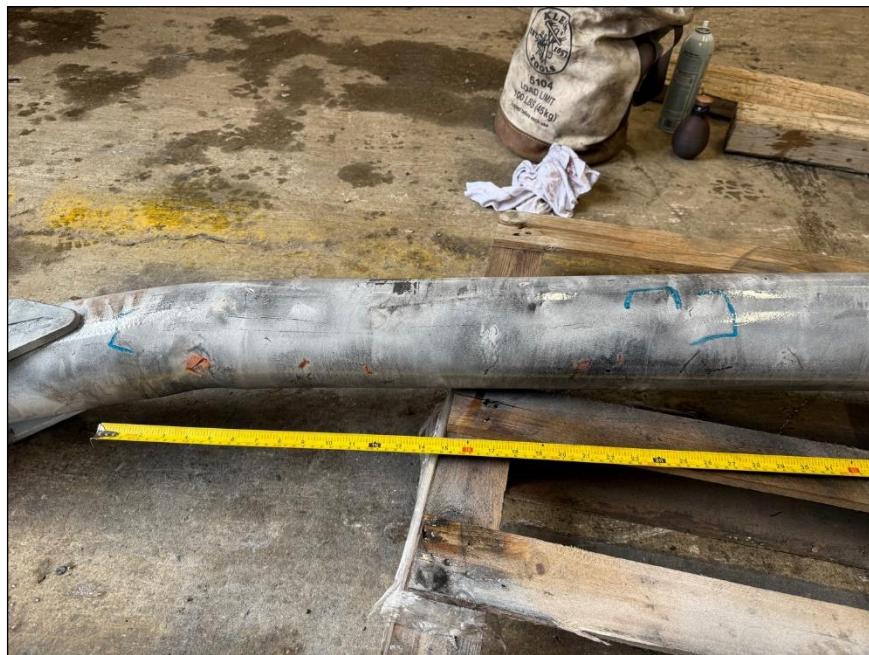
*Photo 3:*

Overview of approximately 26 inches of suspect indications near top of arm overview as seen with wet visible magnetic particle examination before grinding.

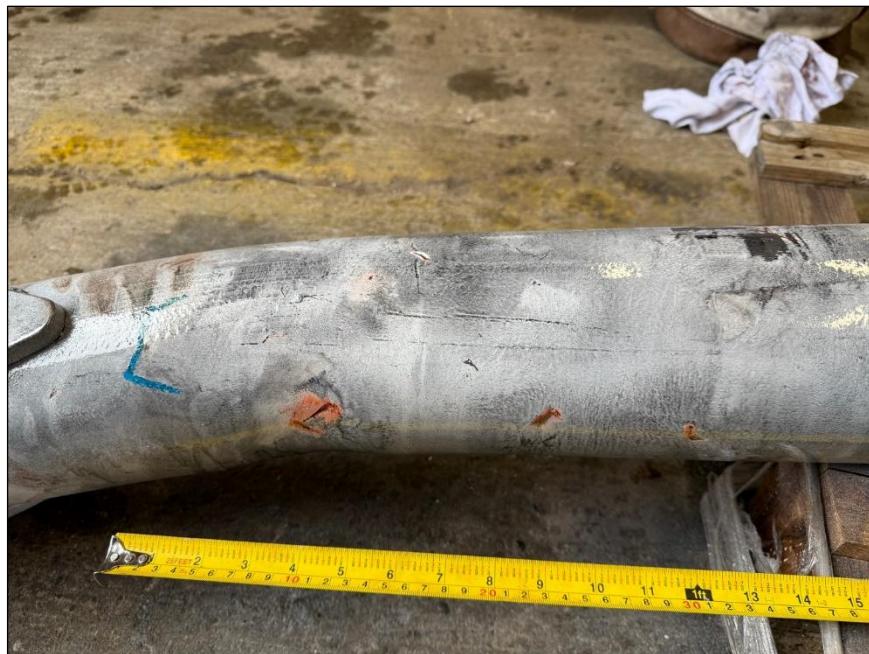
*Photo 4:*

Arm serial # 026600.

Indication 2.

Close-up of approximately 26 inches of suspect indications near top of arm overview as seen with wet visible magnetic particle examination before grinding.

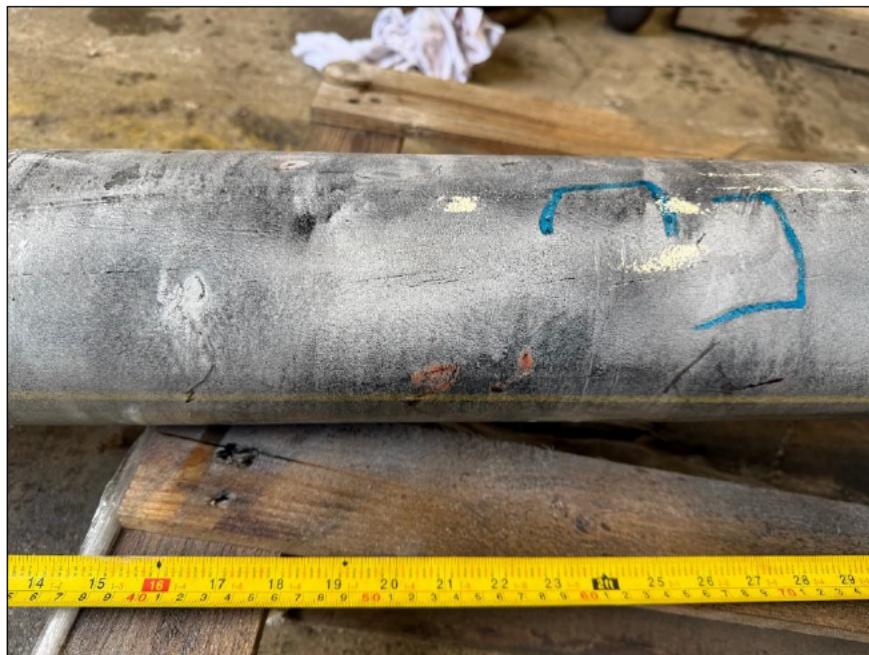
*Photo 5:*

Indication 2.

Close-up of approximately 26 inches of suspect indications near top of arm overview as seen with wet visible magnetic particle examination before grinding.

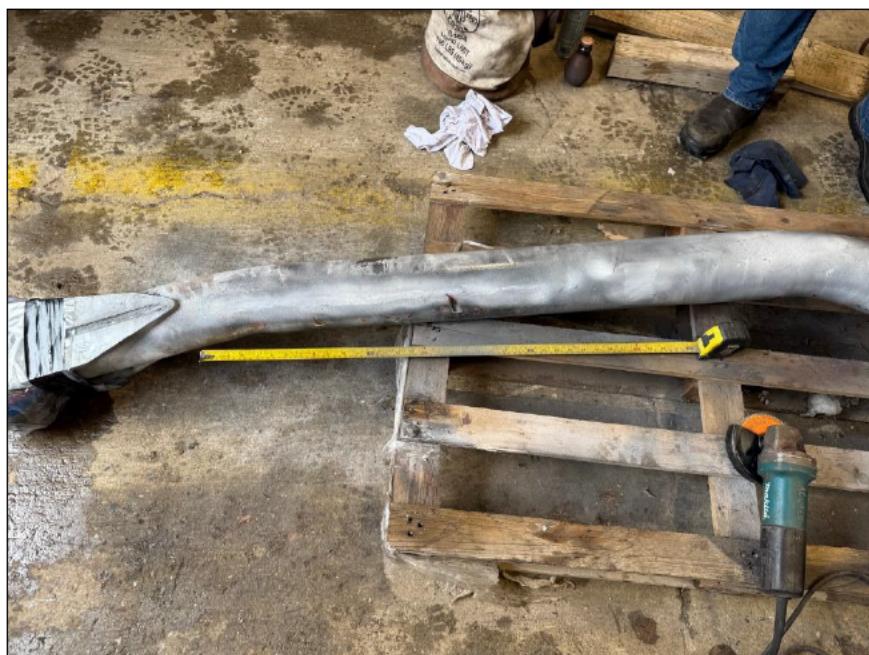
*Photo 6:*

Arm serial # 026600.

Overview of approximately 26 inches of suspect indications near top of arm **removed** after light buffing/grinding.

MT performed on suspect areas did not show any more indications.

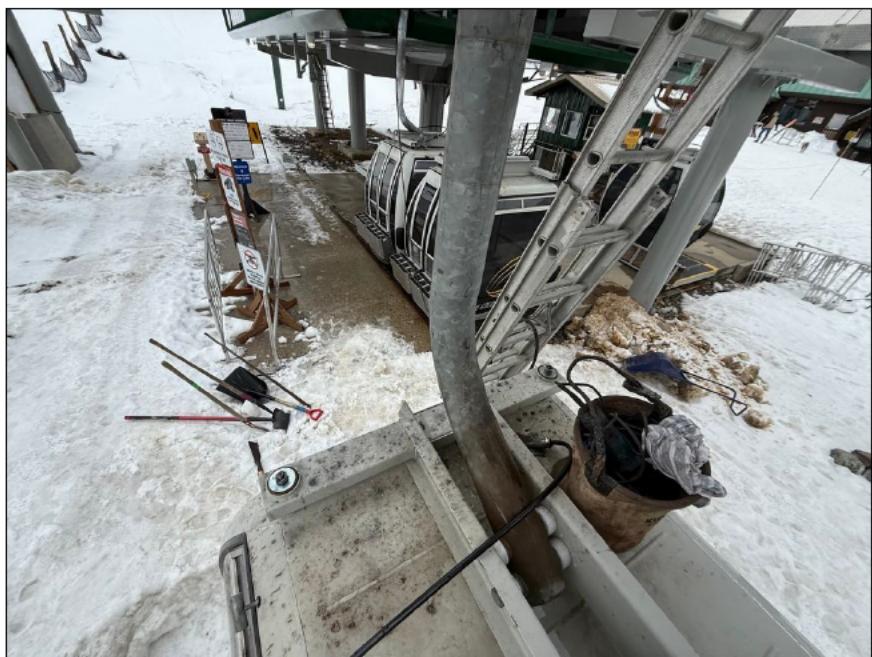
Cabin # 21, Arm serial # N/A.

General overview as accessible.

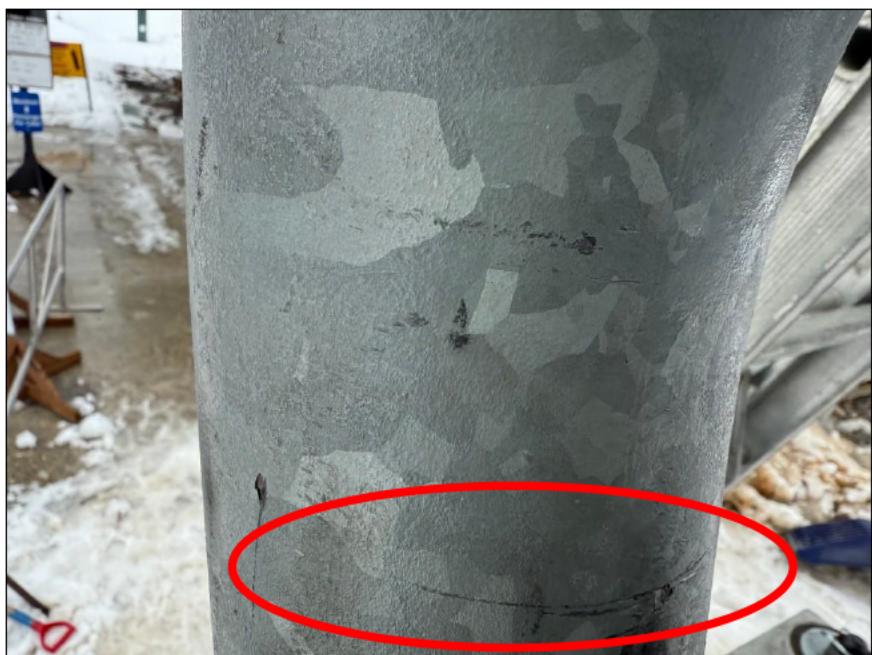
*Photo 8:*

Cabin # 21, Arm serial # N/A.

Indication 3.

Close-up of suspect areas seen visually prior to MT approximately 3" below start of bottom bend.

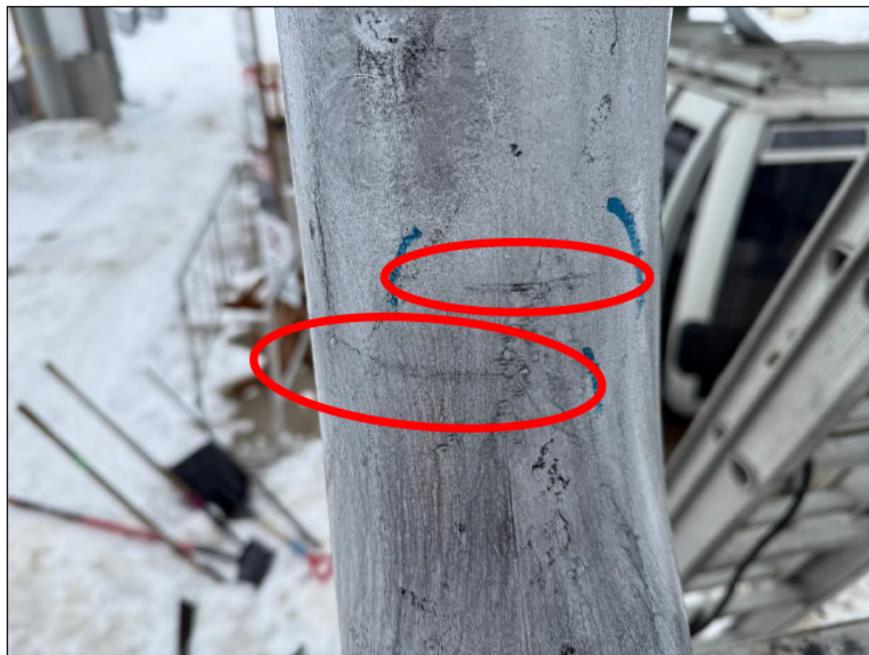
The top transverse indication runs approximately 2" axially.

The bottom transverse indication runs approximately 4" axially.

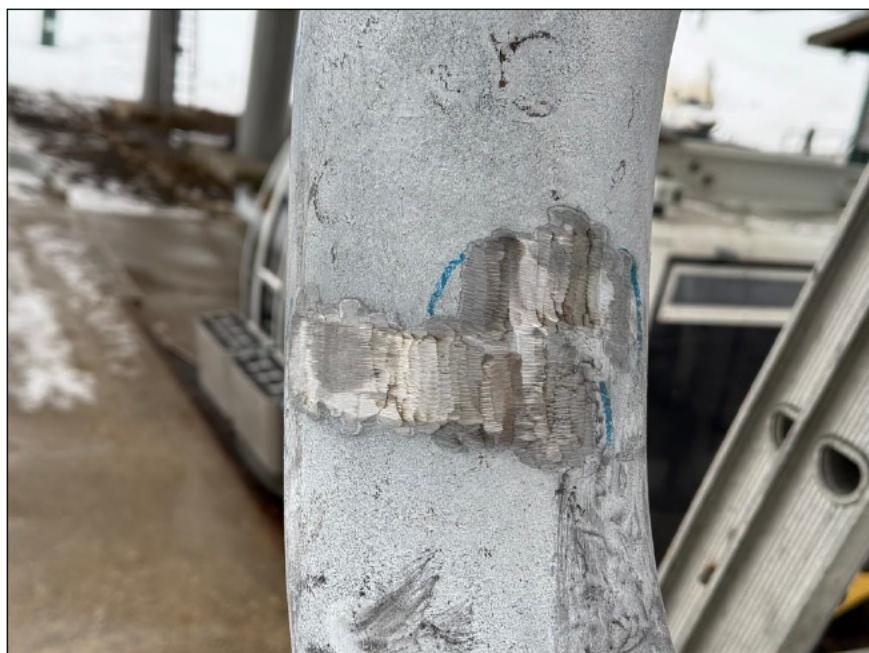
*Photo 10:*

Cabin # 21, Arm serial # N/A.

The top transverse indication runs approximately 2" axially.

The bottom transverse indication runs approximately 4" axially.

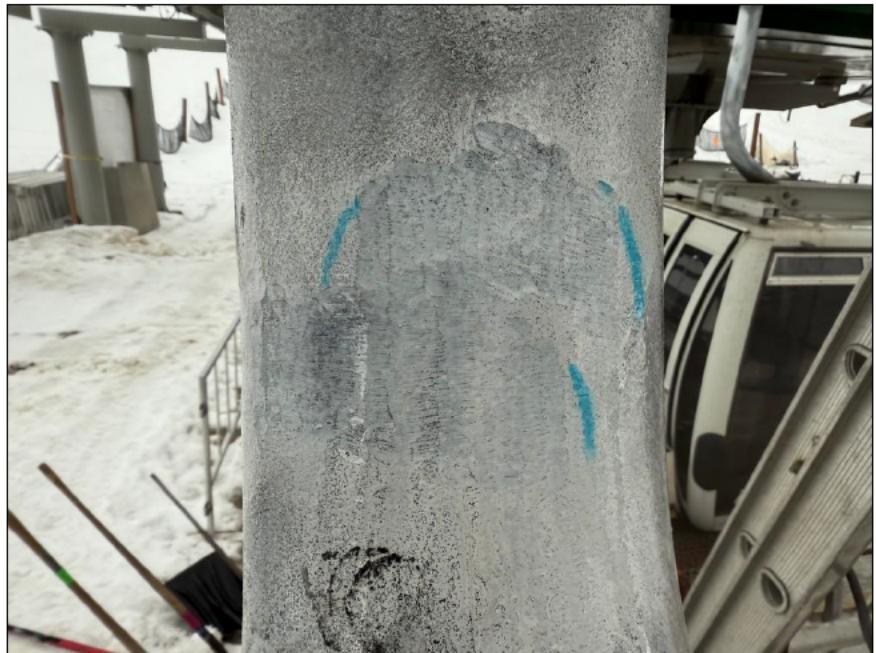
The top transverse indication runs approximately 2" axially.

The bottom transverse indication runs approximately 4" axially.

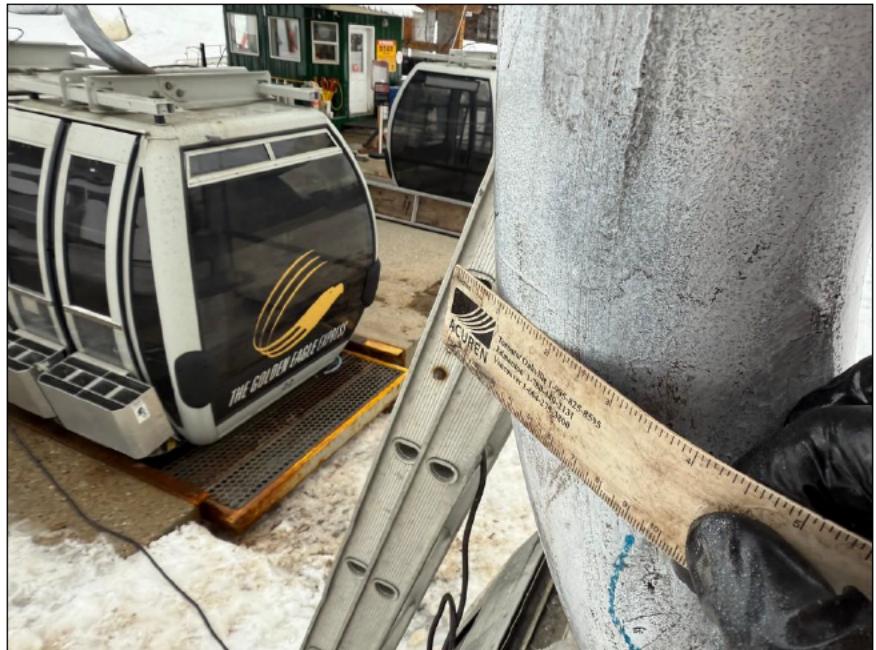
*Photo 12:*

Cabin # 21, Arm serial # N/A.

Length approximately 2".

Located on the outside of the arm approximately 1" below the start of the lower bend.

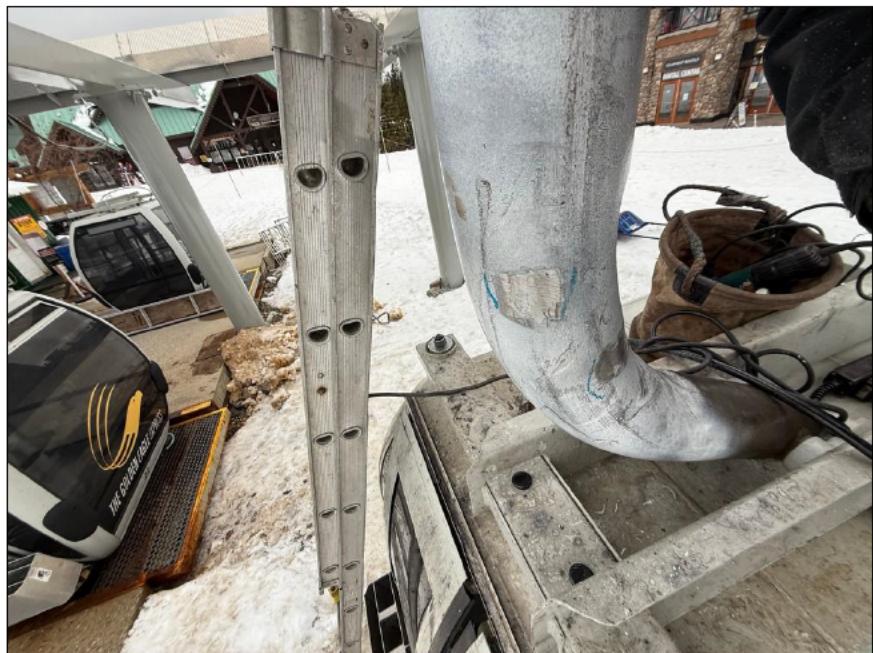
*Photo 13:*

Indications 5.

After grinding indication out with stone.

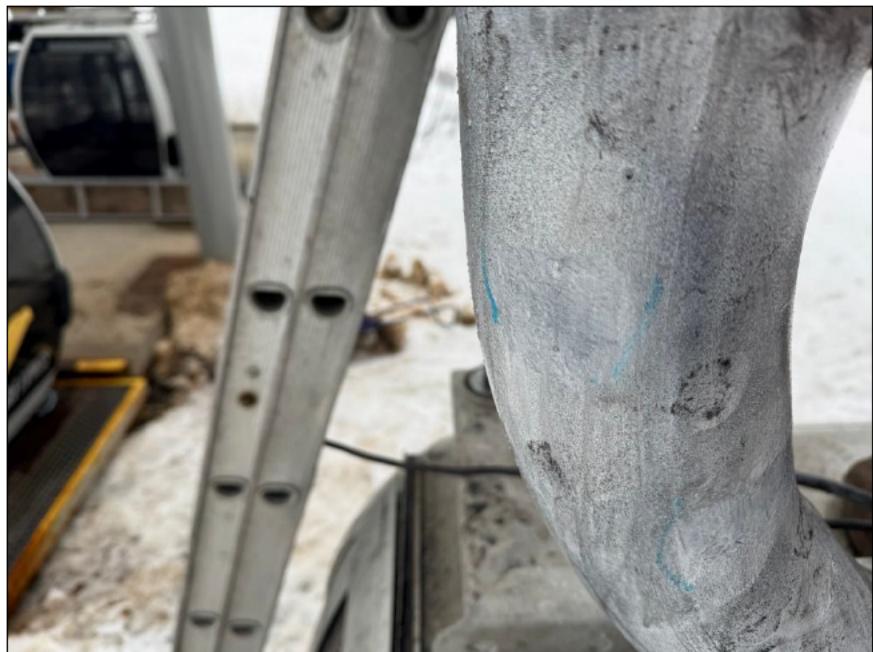
*Photo 14:*

Cabin # 21, Arm serial # N/A.

Indications 5.

After confirming indication was removed with MTOK.

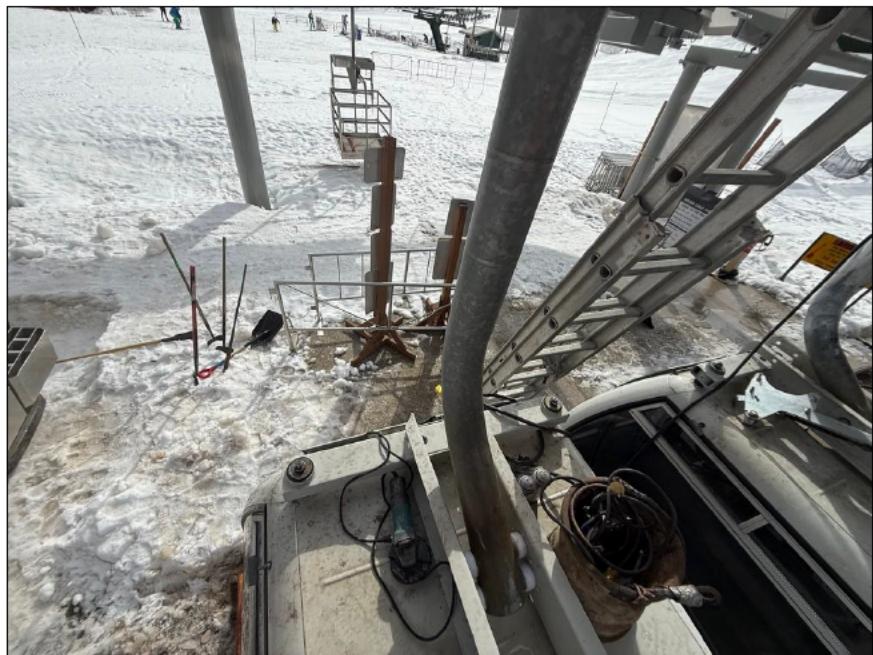
Cabin # 22, serial # 024400.

Overview photo as accessible.

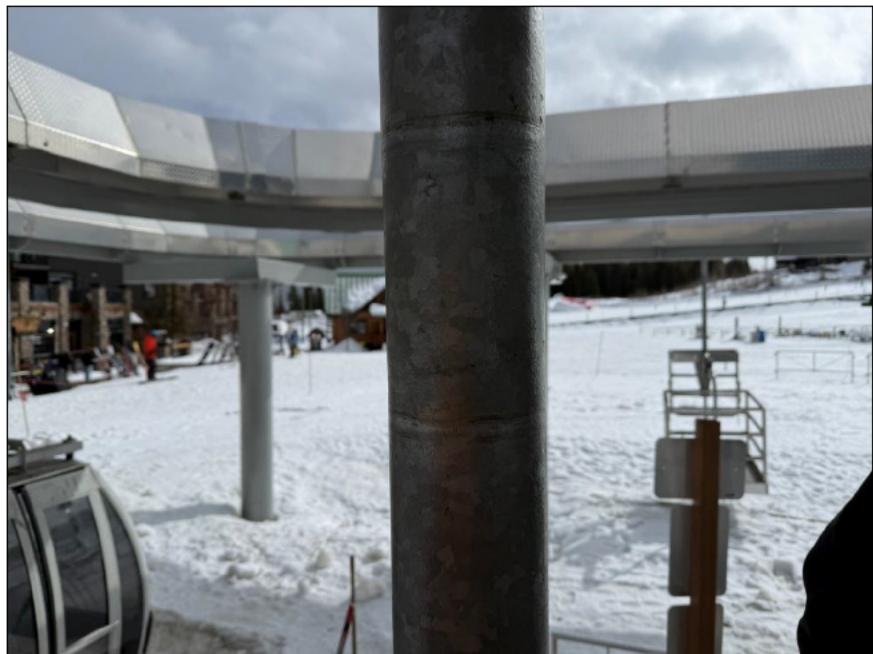
*Photo 16:*

Cabin # 22, serial # 024400.

Typical mechanical marks due to U-bolt clamps at two sections.

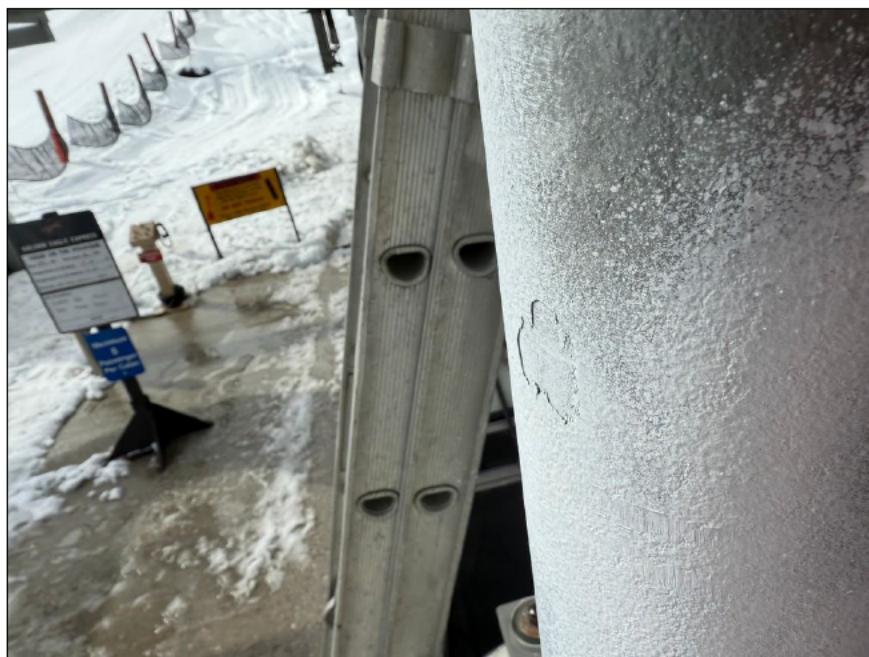
Cabin # 22, serial # 024400.

Typical section with galvanized coating removed.

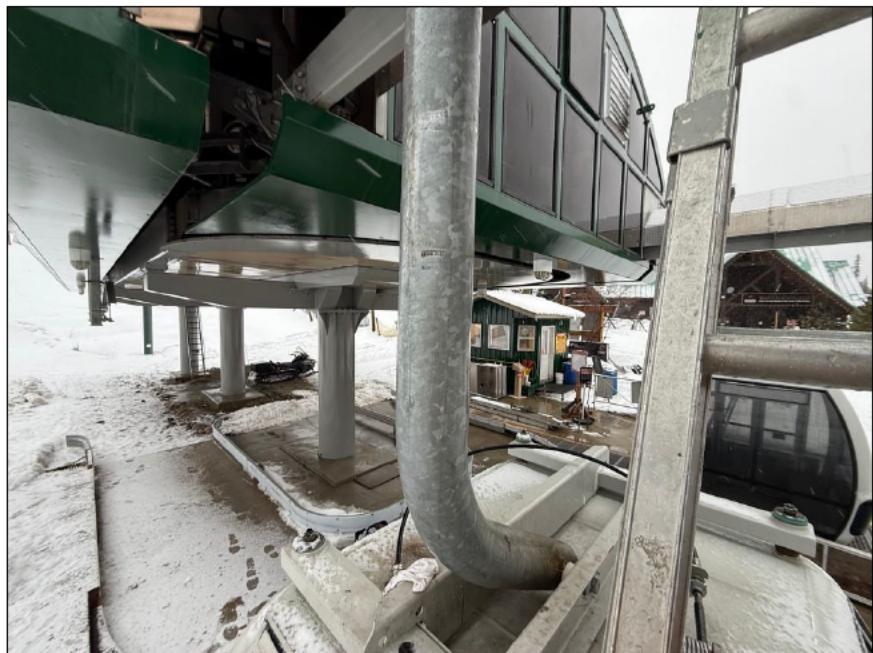
*Photo 19:*

Cabin # 23, serial # 026800.

Overview photo as accessible.

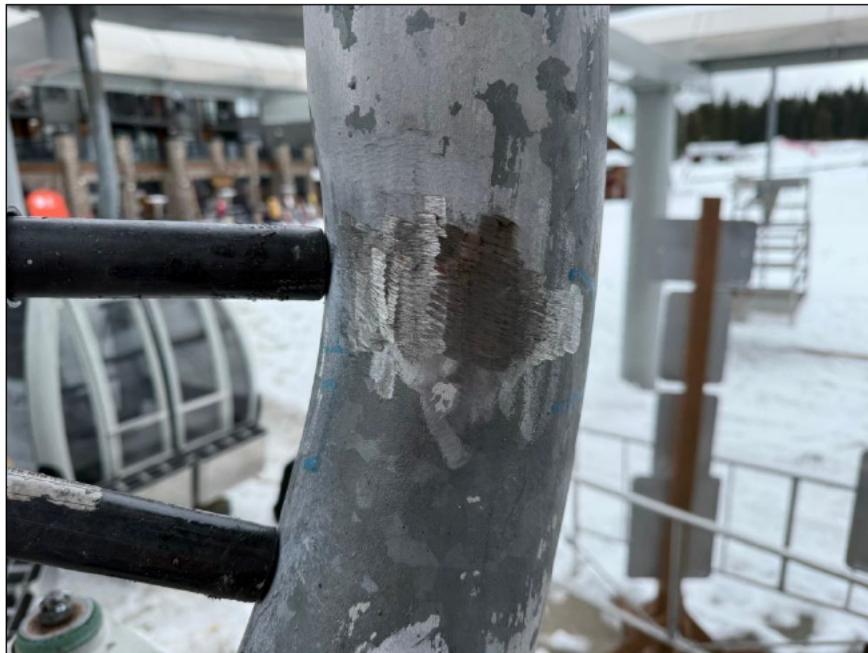
Found on the inside section, approximately 2" below start of bottom bend.

The approximate thickness in the area is between 0.400" – 0.420" and the indication and galvanized coating was removed for remaining 0.380".

Indication was removed by grinding stone.

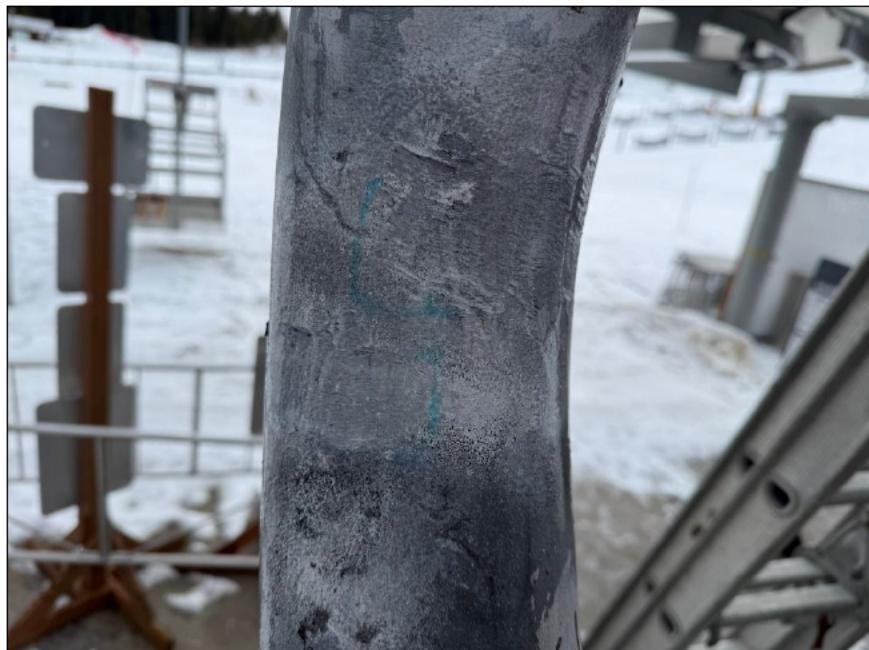
Indications 6 & 7.

Both locations were MTOK after grinding the indications out.

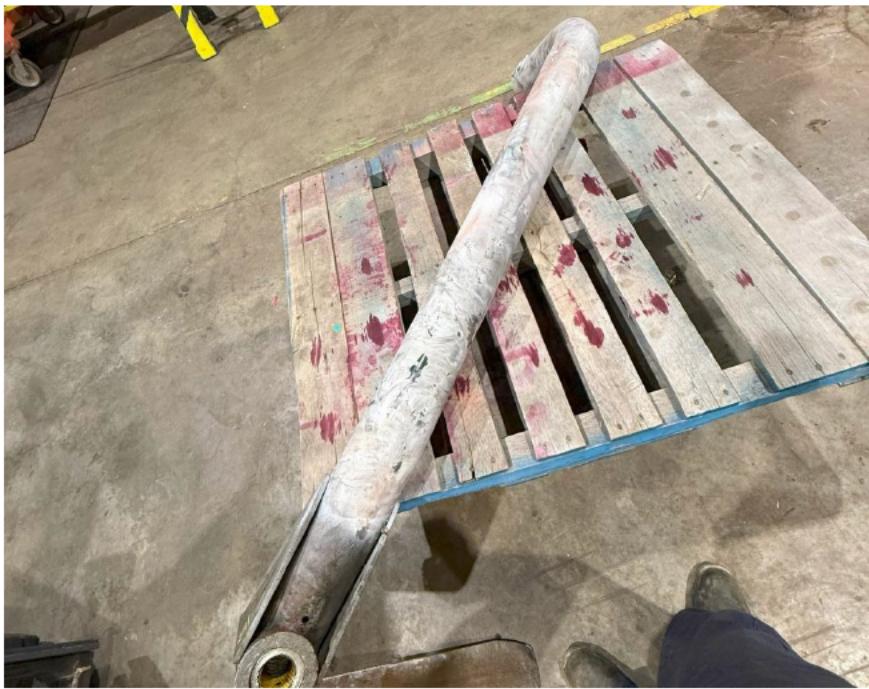
*Photo 1:*

Overview of the Inspected item

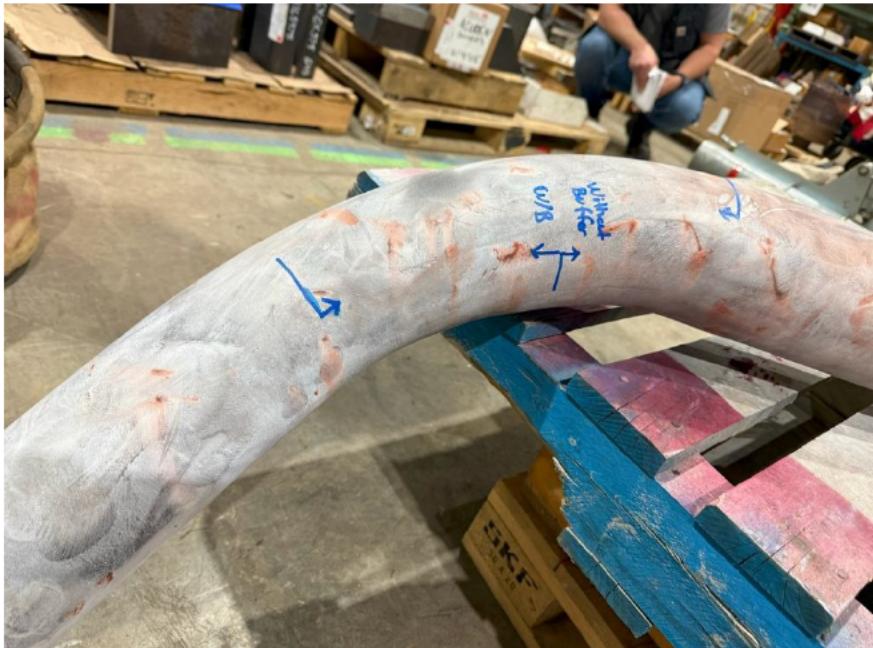
*Photo 2:*

Overview of the MT Inspection area.

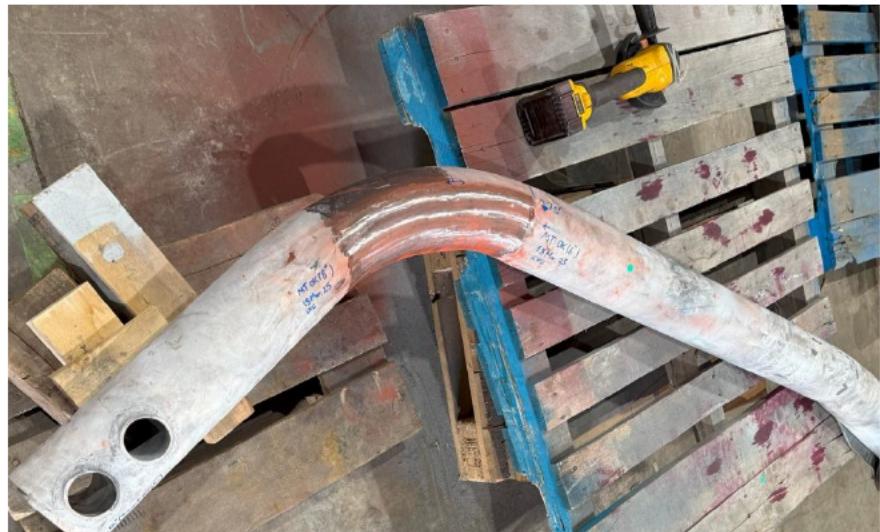
*Photo 3:*

Overview of the MT inspection area.

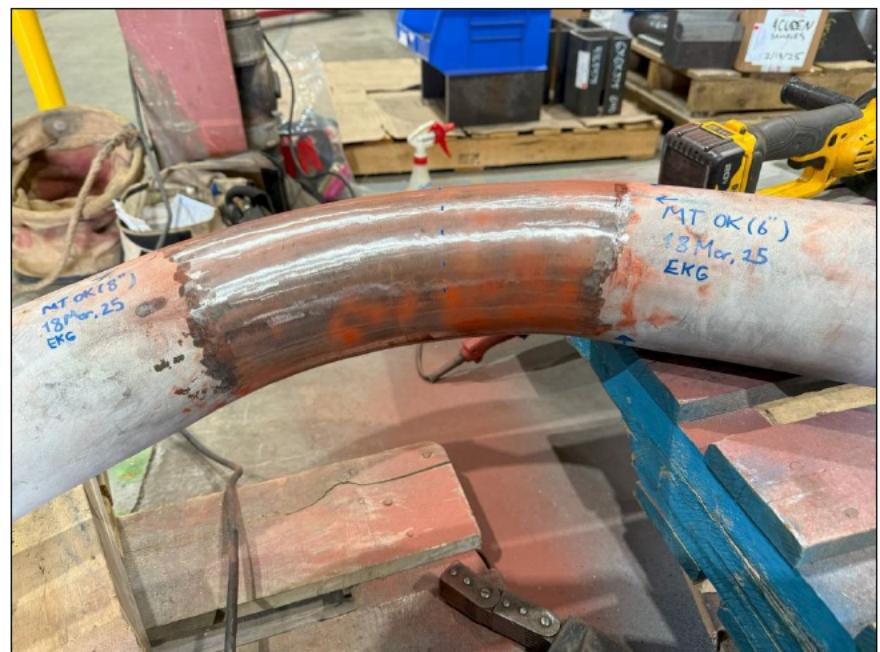
*Photo 4:*

Overview of the 8" and 6" length MT area

MT OK
